**Hammond River Angling Association
New Brunswick Environmental Trust Fund**

Hammond River Water Quality Monitoring Project
Project No: #150094
Final Report

March 1, 2016

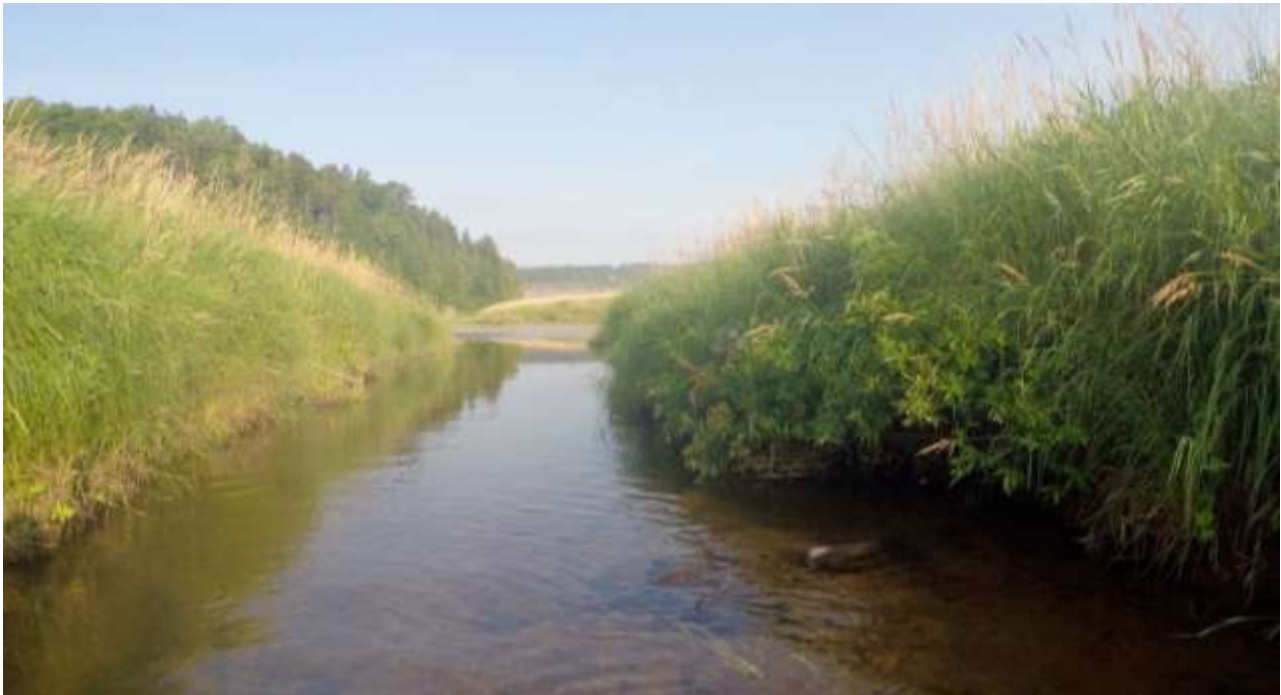
Figure 24 (top right): Substrate at Bradley Brook. *Photo by H. Bradford Aug 17 2015.* Figure 25 (top left): Substrate by percentile at Bradley Brook. *Chart by H. Bradford.* Figure 26: Right and left bank of Bradley Brook facing downstream (toward the conflux). *Photo by H. Bradford Aug 17 2015.*

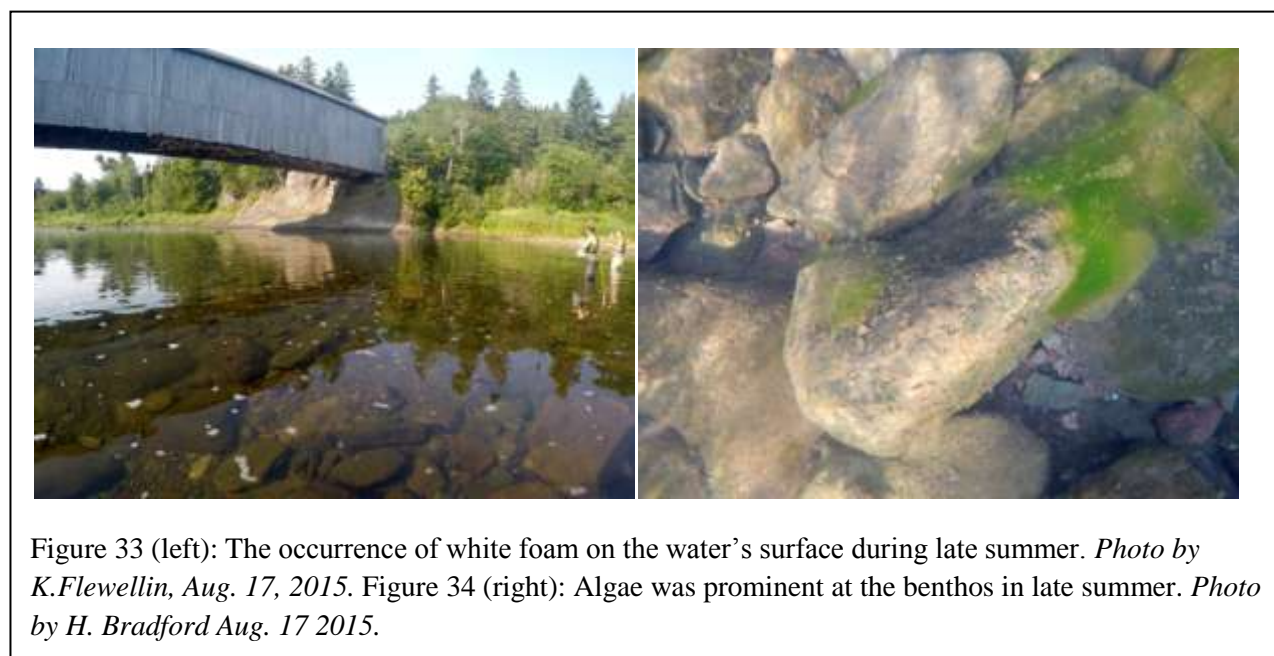
Figure 33 (left): The occurrence of white foam on the water’s surface during late summer. *Photo by K.Flewelling, Aug. 17, 2015.* Figure 34 (right): Algae was prominent at the benthos in late summer. *Photo by H. Bradford Aug. 17 2015.*

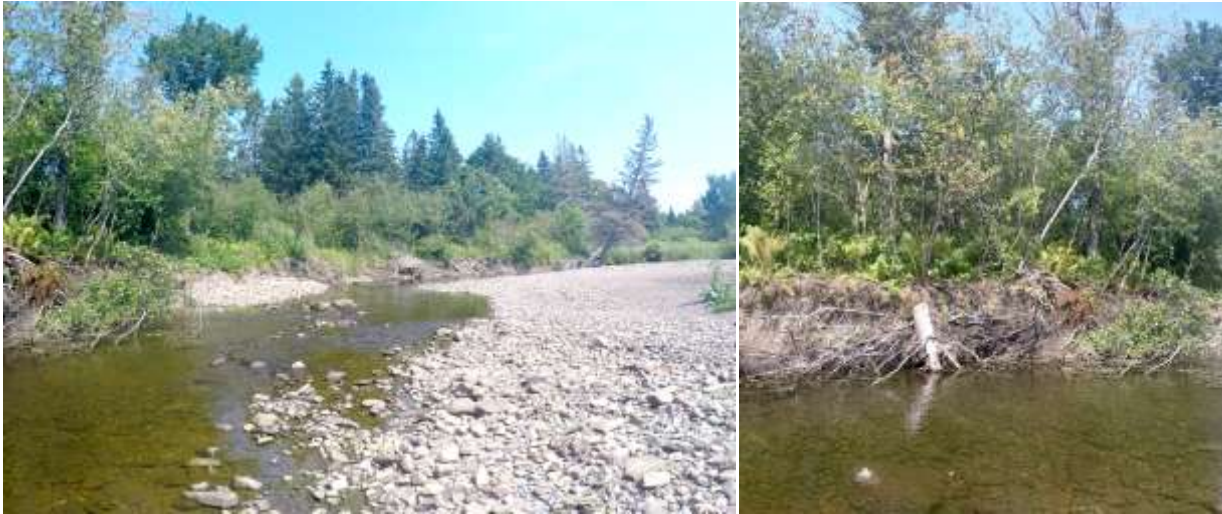
Figure 69 (top left): Cross section of the Hanford Brook site facing upstream, slanting trees indicate left banks instability and the right bank is sustained by its predominately boulder substrate. Figure 70 (top right): Severe undercutting is visible on the left bank, along with slanting trees. Figure 71 (bottom left): Substrate by percentile. *Chart by H. Bradford.* Figure 72 (bottom right): Comparison of exposed substrate and summered substrate in late summer. *All photos by H. Bradford Aug 20 2015.*

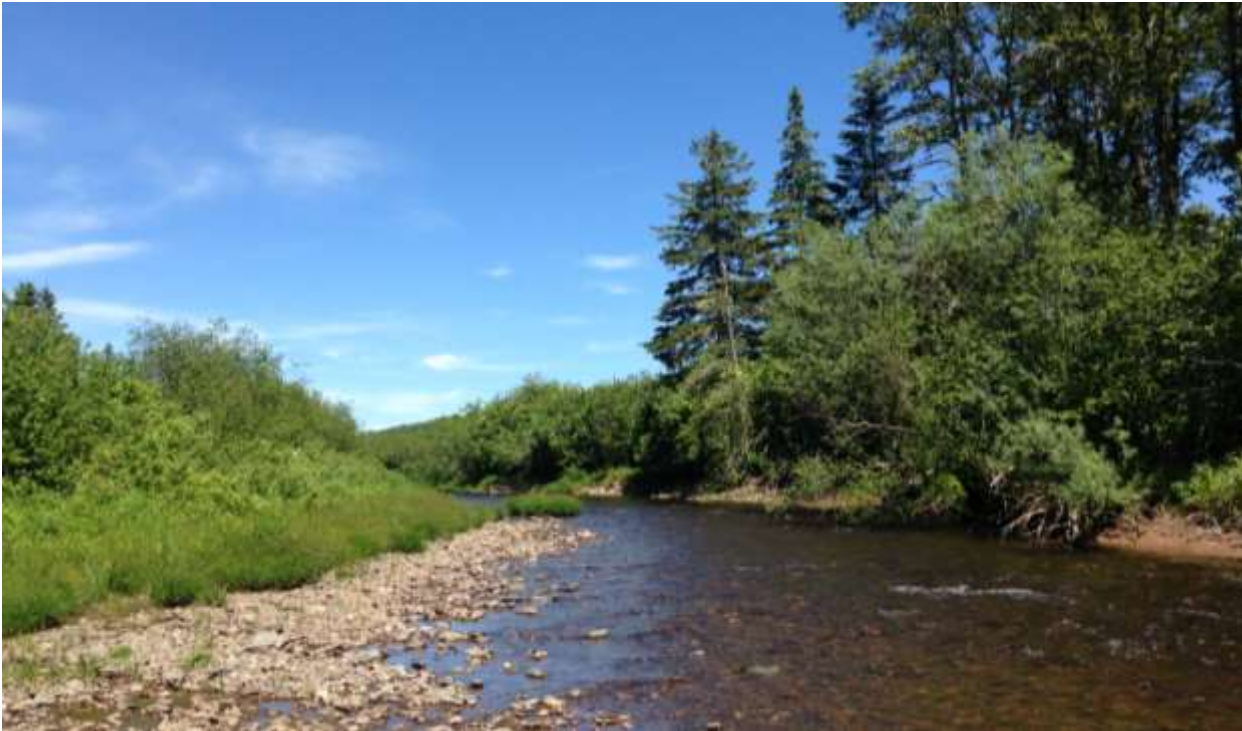
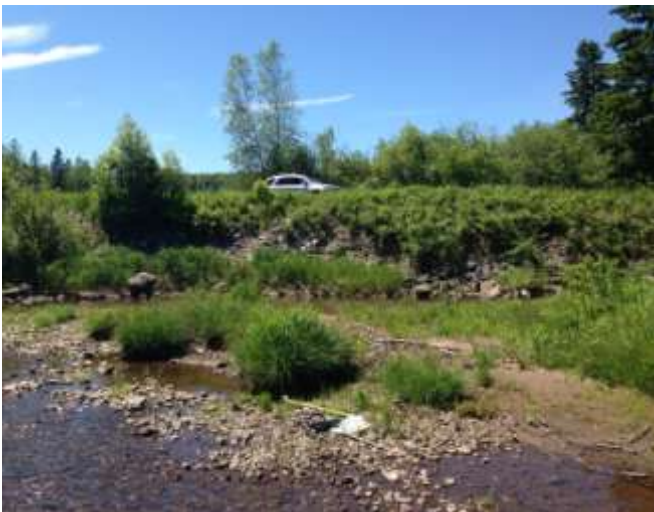
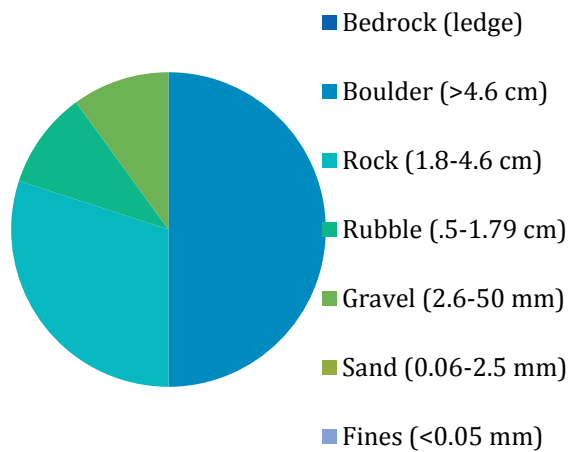
Figure 82 (top): A cross-section of the river at the Hillsdale site, facing upstream. *Photo by H. Bradford June 17 2015.* Figure 83 (bottom left): The left bank is significantly impacted from long term tree removal, and appears to be previously stabilized with rock. *Photo by H. Bradford June 17 2015.* Figure 84 (bottom right): Substrate by percentile. *Chart by H. Bradford.*

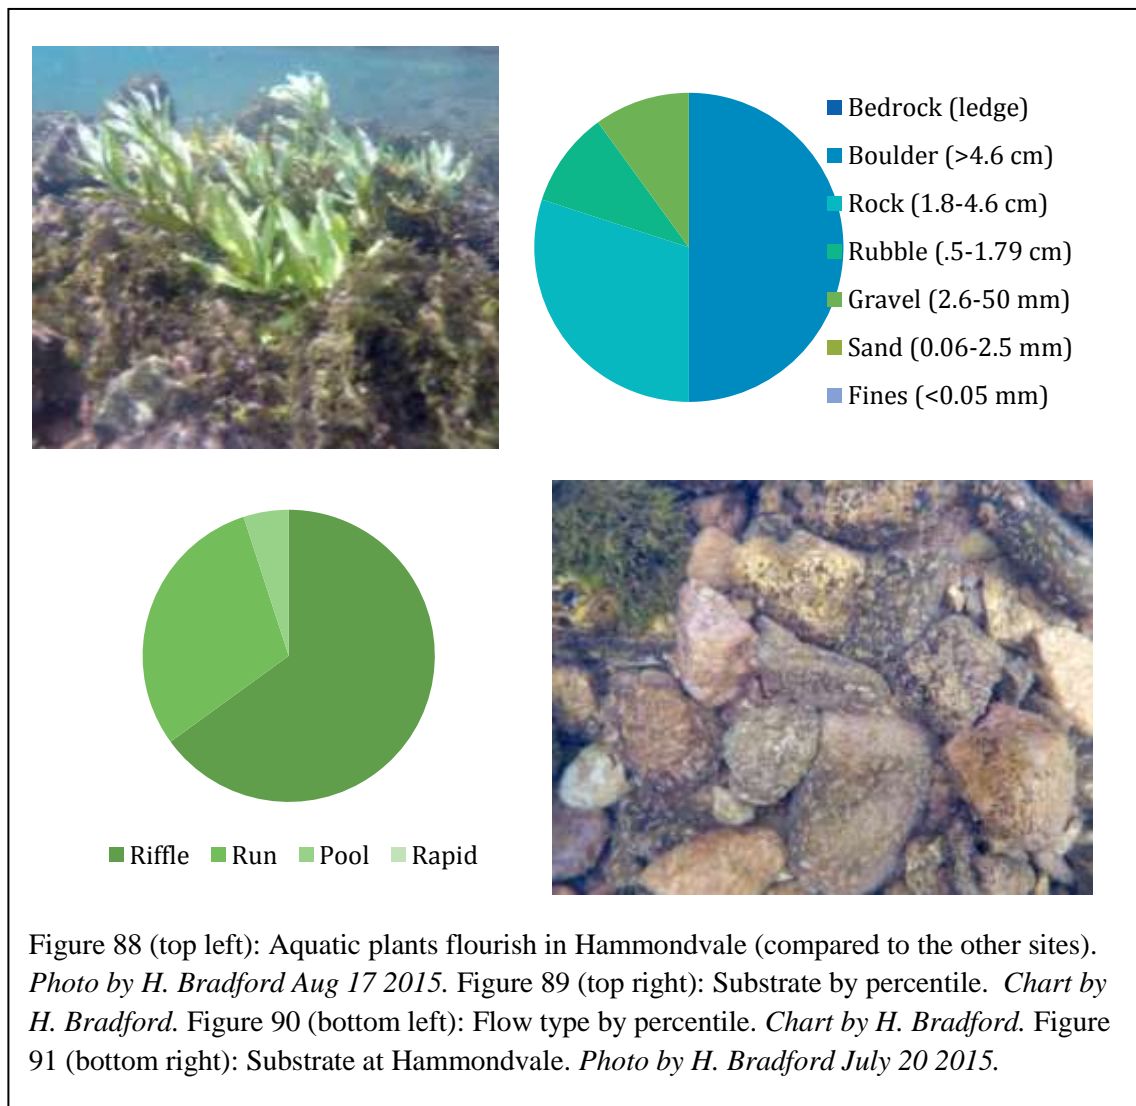
Figure 88 (top left): Aquatic plants flourish in Hammondvale (compared to the other sites). *Photo by H. Bradford Aug 17 2015.* Figure 89 (top right): Substrate by percentile. *Chart by H. Bradford.* Figure 90 (bottom left): Flow type by percentile. *Chart by H. Bradford.* Figure 91 (bottom right): Substrate at Hammondvale. *Photo by H. Bradford July 20 2015.*
