The Hammond River Watershed Management Plan

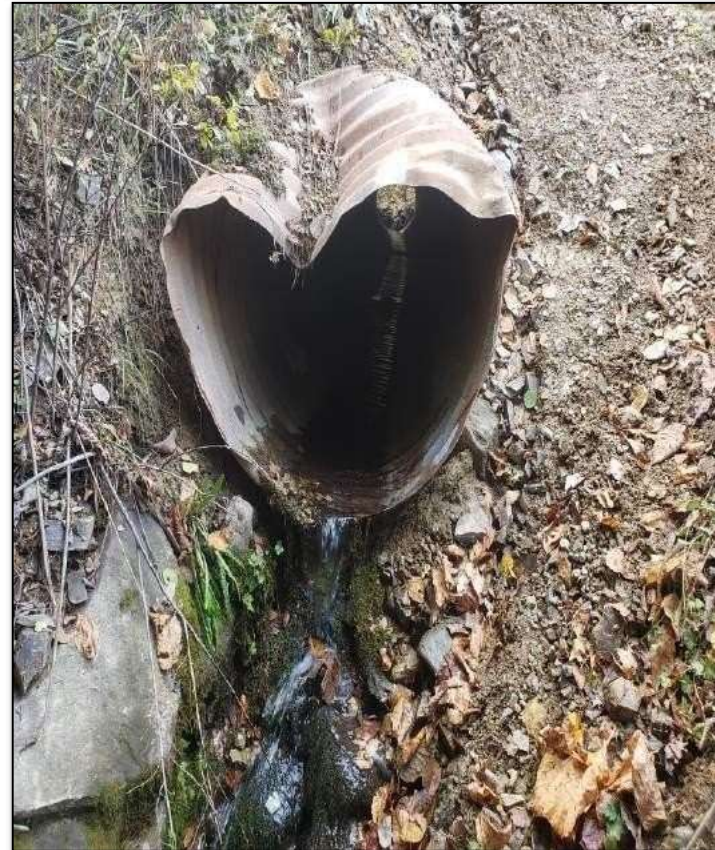
Figure 9. A deformed, poorly sloped, eroding, rusted culvert that does not allow fish passage, that was located on the Shepody Road in the Markhamville area on a dirt logging road. It's a real beauty! *Photo: S. Blenis*

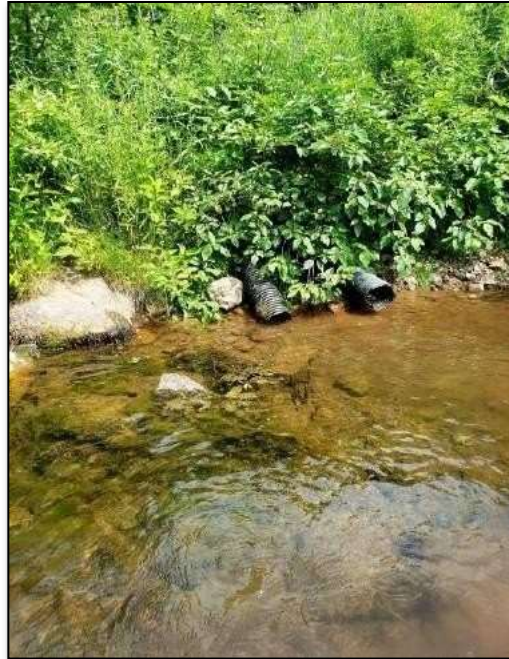
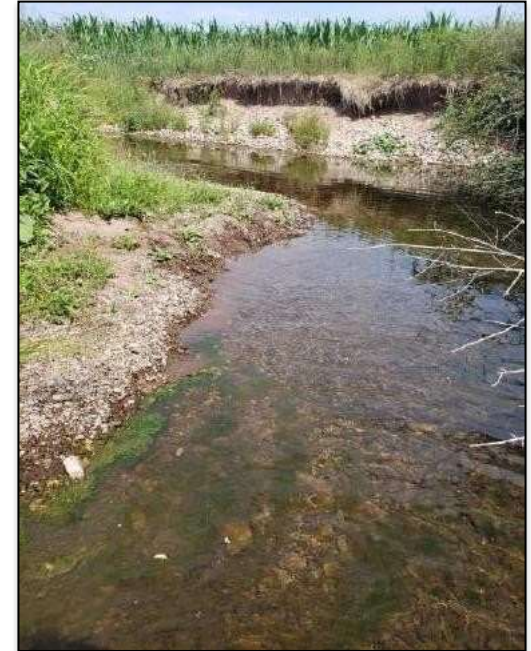
Figure 31. Evidence of nutrient loading & erosion in Hammondvale.
Figure 32. Observed 2 drainage pipes from the field entering the watercourse. This area was willow staked in the summer of 2020. *Photos: S. Blenis*

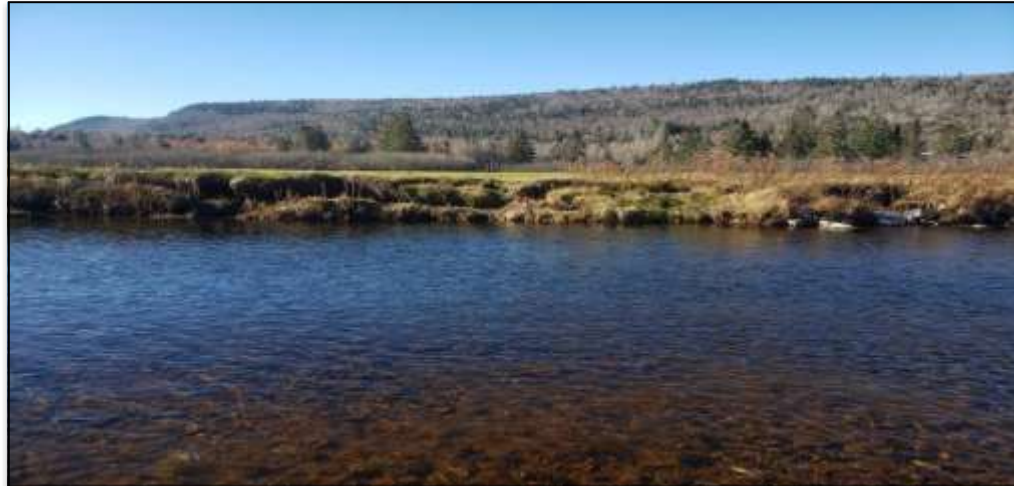
Figure 38. Hayfield with no riparian buffer and degrading banks.

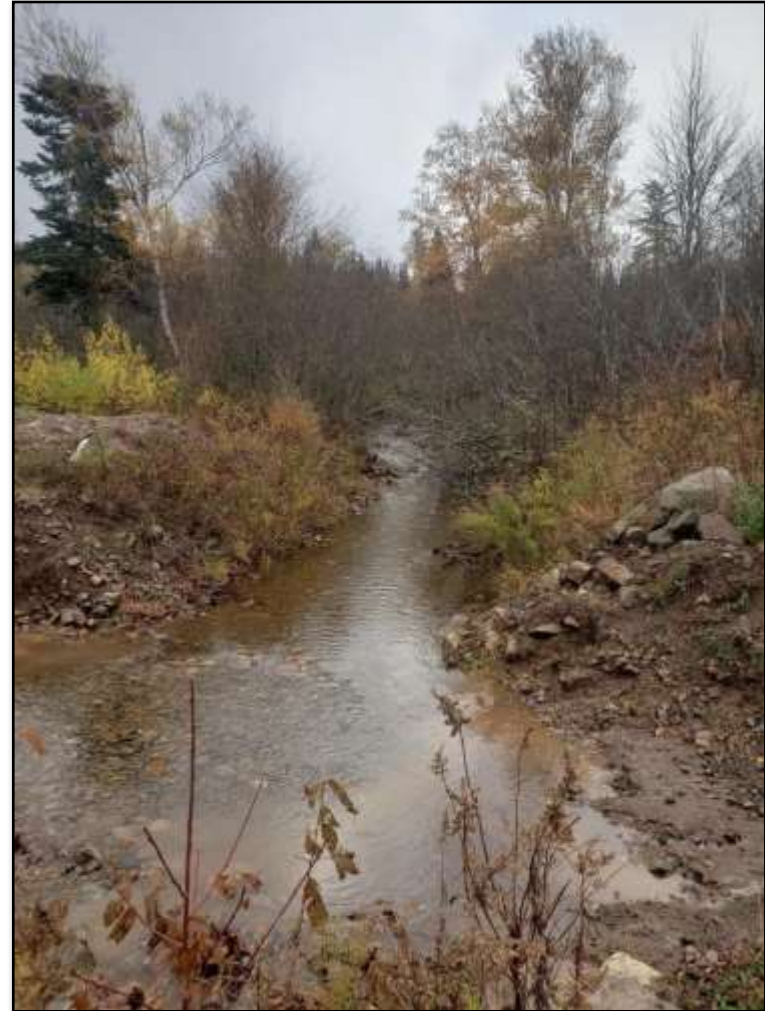
Figure 42. Upstream view of Duffy Brook, showing the degradation caused by trucking through the brook without proper ford, bridge, or culvert. *Photo: S. Blenis*

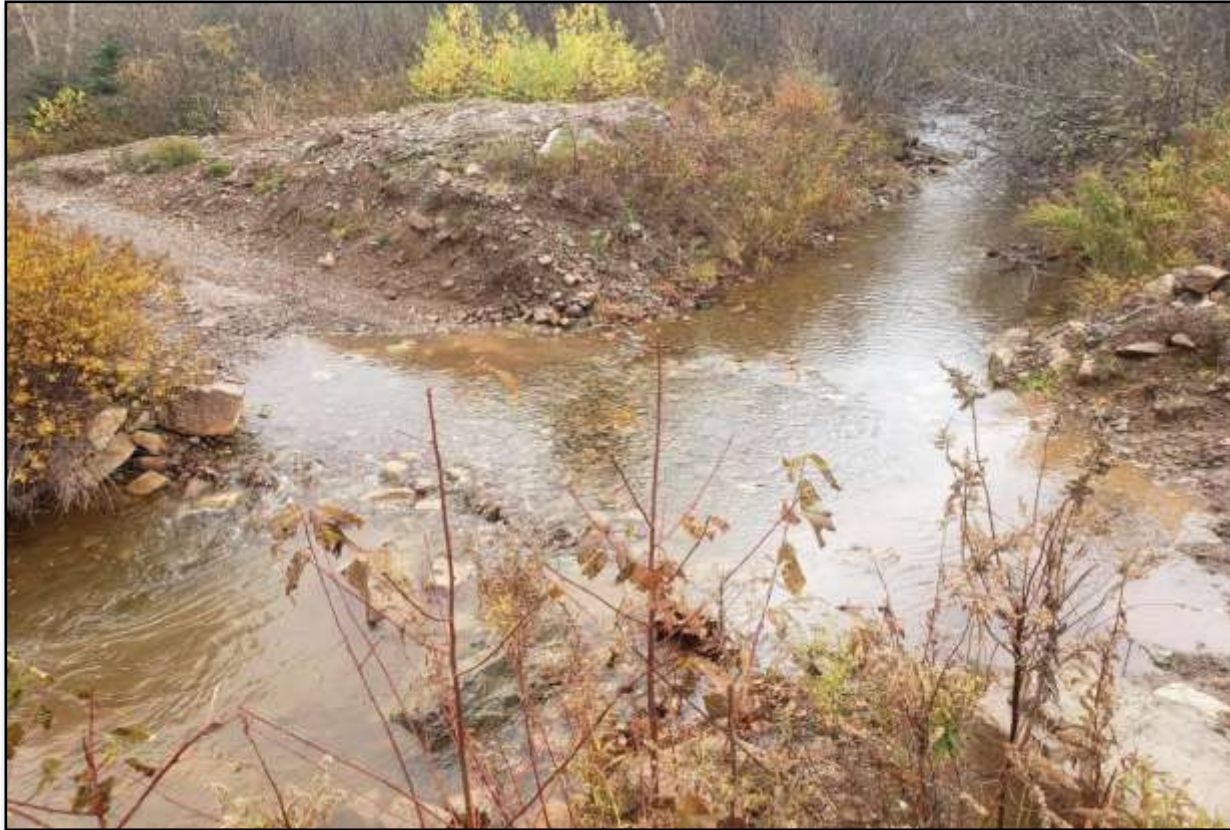
View of Duffy Brook as it intersects with a dirt road. HRAA needs to discuss this site with the Department of Environment and create a solution (culvert). Turbidity and Total Suspended Solids are anticipated to be in the high range for this site, detracting from the overall excellent cold-water source this brook provides to the Hammond River. Duffy Brook has the potential to be a **Class A** or **Class O** Brook, given its high dissolved oxygen content and no point source pollution; however, this section needs remediated. *Photo: S. Blenis*

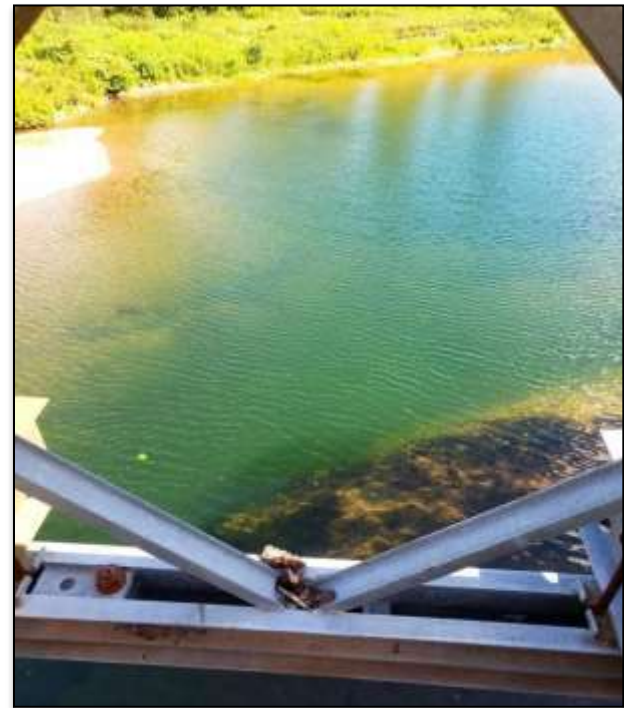
Figure 58. Silver Hill Pool August 26th- severe filamentous algae growth changed the water to turquoise. Samples came back negative for cyanobacteria. *Photo: S. Blenis*

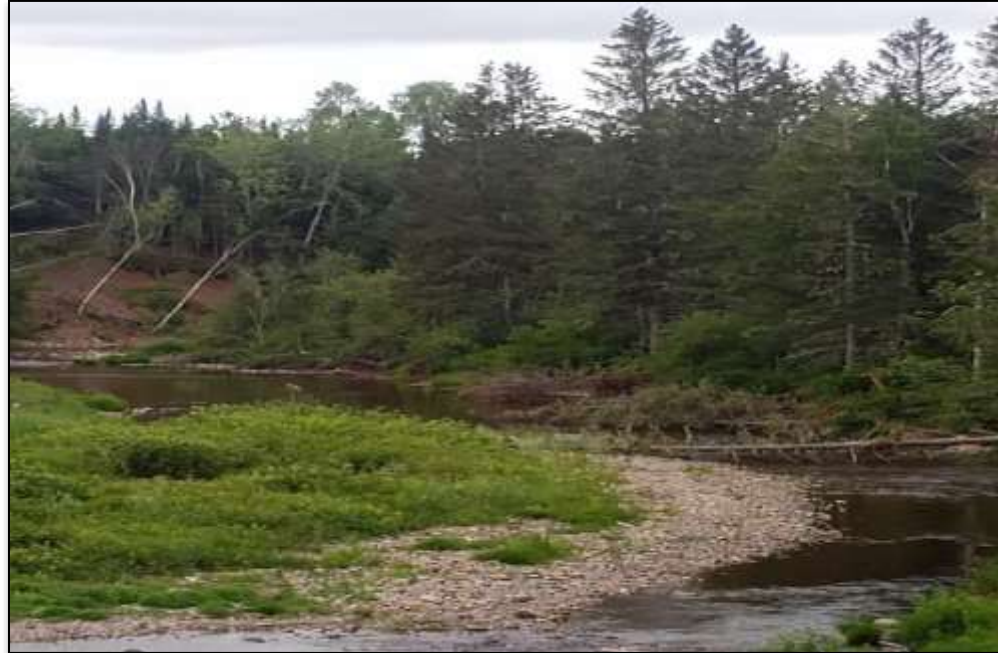
Figure 59. Extreme bank erosion, increasing sediment loading and woody debris into the receiving environment. *Photo: S. Blenis*

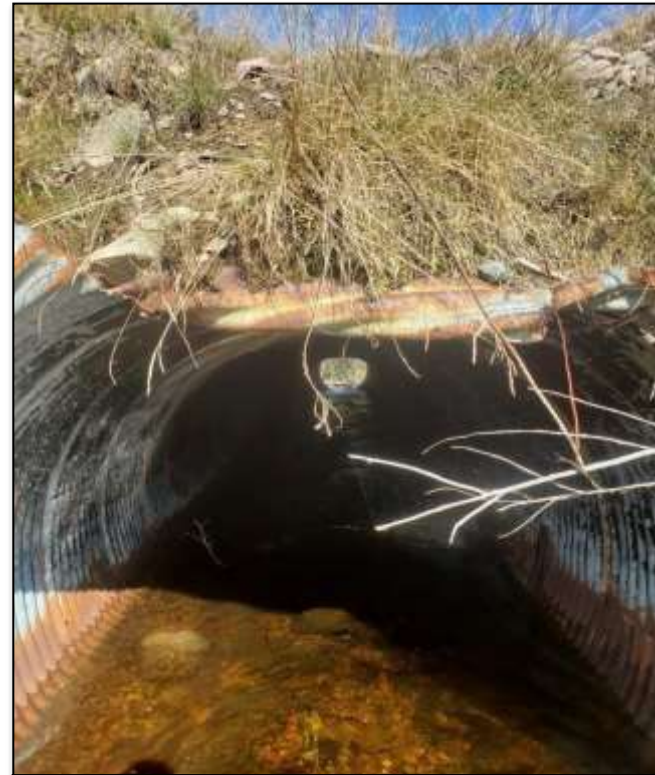
Figure 82 . An extremely compromised culvert under route 111 and connects the beaver area of Isaac Brook to the main outflow of the brook. The bottom of the culvert has completely rusted out, and the culvert has become compacted, with severe erosion issues on the crown. This culvert receives a high priority ranking for repair, as it possesses a future safety concern for traffic. *Photo: S. Blenis*

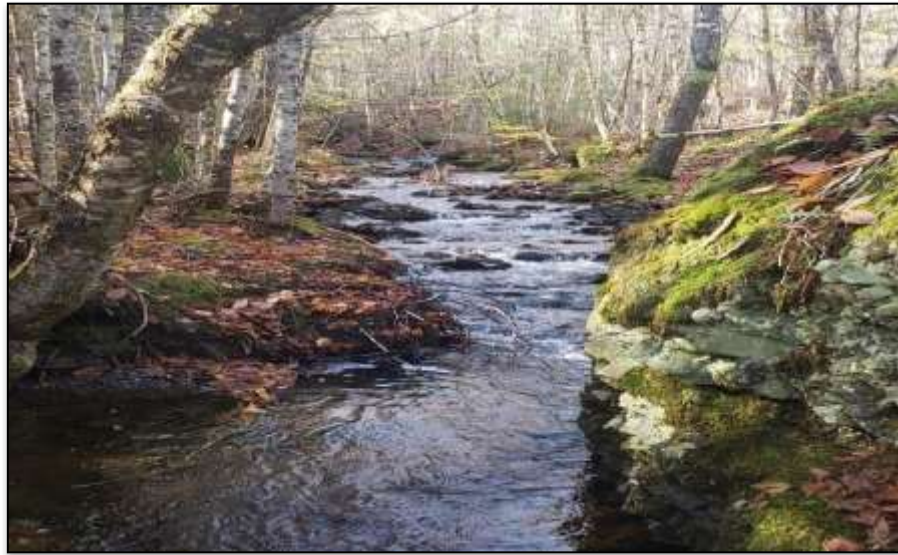
Figure 92 & 93. Older concrete arch culverts clogged with leaf litter, and another upstream view of the stunning Clyde Brook.

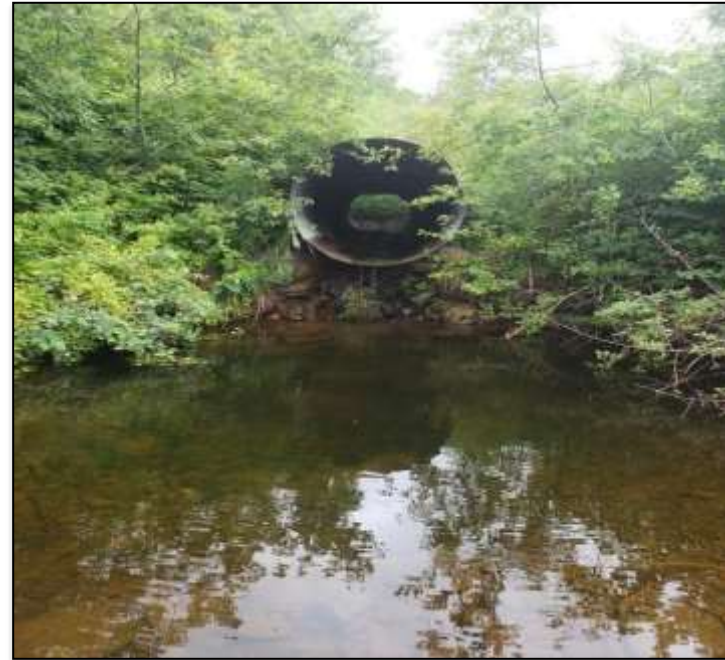
Figure 1. The hung culvert in Twin Brook. Primary option would be to replace current structure with bridge or open-bottom pipe-arch. Secondary option would be to armor banks downstream and construct fish ladder. Removal of obstruction would allow upstream access to approximately 1700 meters of good quality salmonid spawning and nursery habitat. Average bankfull width is approximately 2.5 m. Upstream access would be restored to a total area of approximately 4,250 m² of habitat. Significant additional erosion around the pool occurred in November 2020 after a heavy rainfall event. Landowner is willing to allow HRAA to replant.

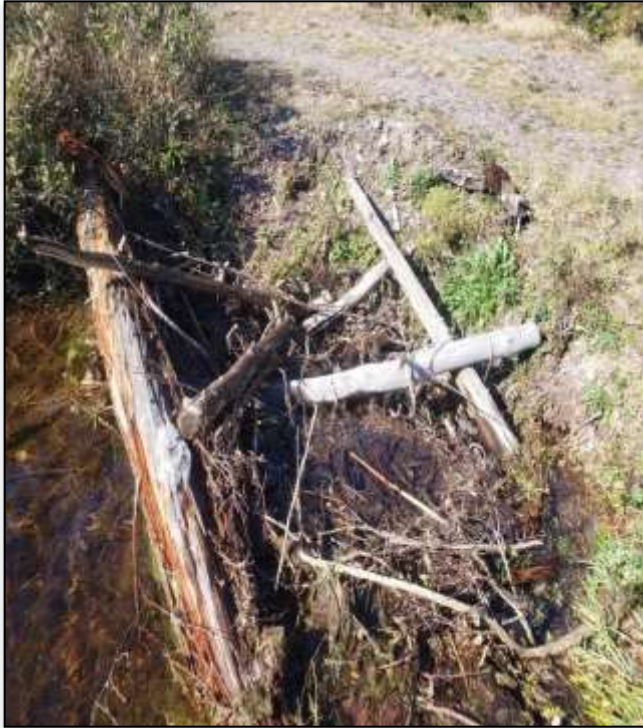
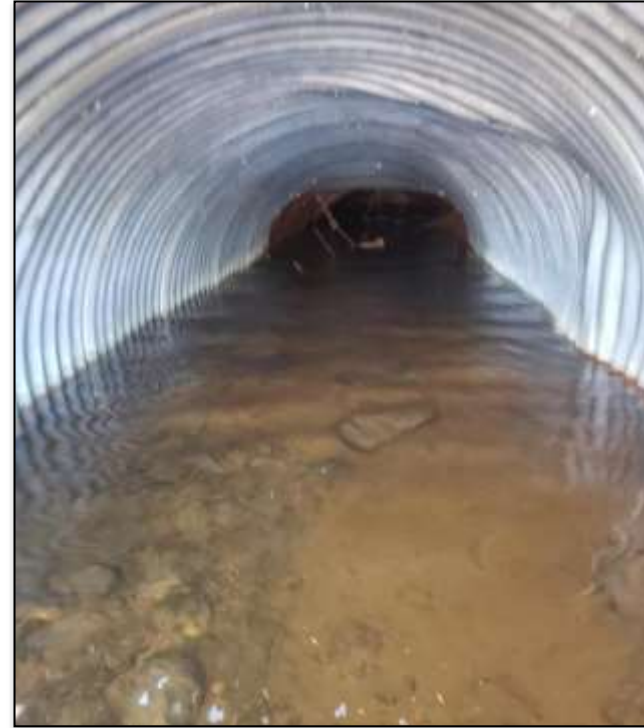
Action Points: The main culvert, that allows flow from Tracy Lake into Isaac Brook, is severely compromised. It is currently completely compacted with organic debris, rocks, and sediment, allowing zero flow. The road that travels overtop of this culvert leads to a JD Irving Ltd woodlot, and HRAA should work with the landowner to install or repair this existing culvert. A smaller, plastic culvert was recently installed; however, it allows for a much smaller flow rate into Isaac Brook. This smaller culvert will not be sufficient during high rain events, and the access road will be susceptible to wash out, and the receiving environment may be compromised. Addressing this culvert issue to allow for proper flow into Isaac Brook is a priority. **Figure 120** and **Figure 121**: blockage and compromised culvert.

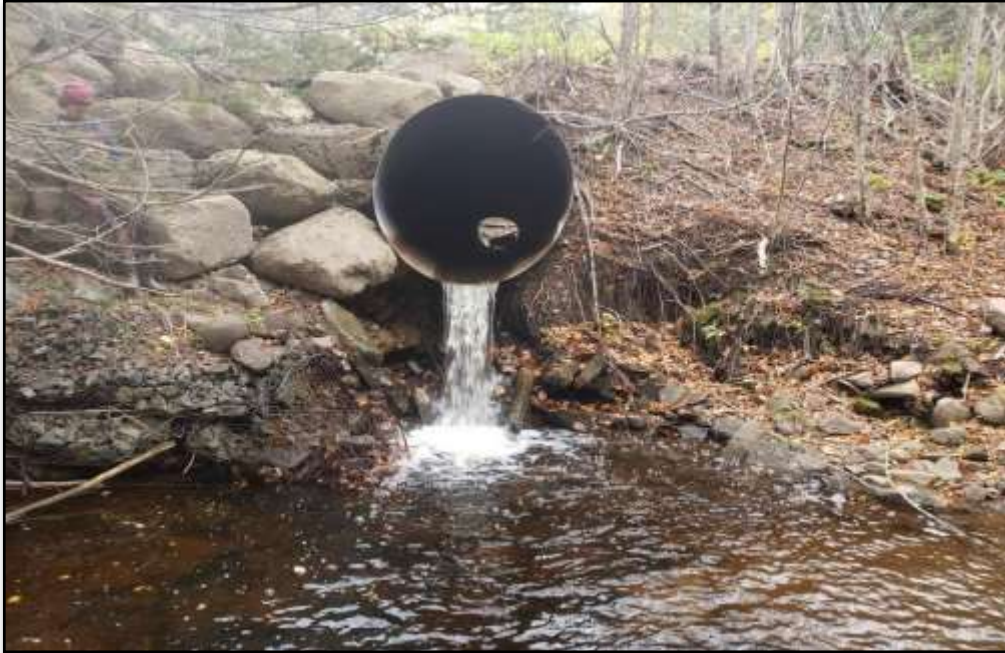
Figure 156 (a,b,c): A severely compromised culvert in the upper reach of Brawley Brook, at the historic 2nd electro-fishing site. This culvert does not allow fish passage, nor does it allow human passage, as the floor of the culvert is almost completely rusted out and it is not safe to walk through. The middle section of the culvert has become severely compacted, and this culvert poses a safety concern for traffic. This culvert is the #1 priority for replacement out of all culverts assessed in 2020.

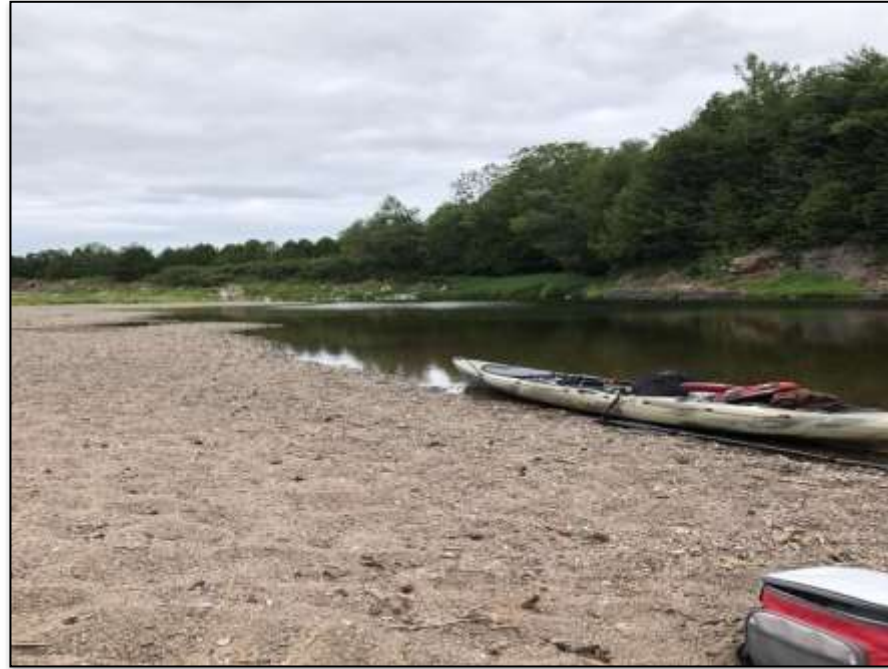
Figure 166. Degradation of the riverbanks. Area should be a priority for restoration to ensure minimal sedimentation into the river, especially given it is a known salmon spawning ground.

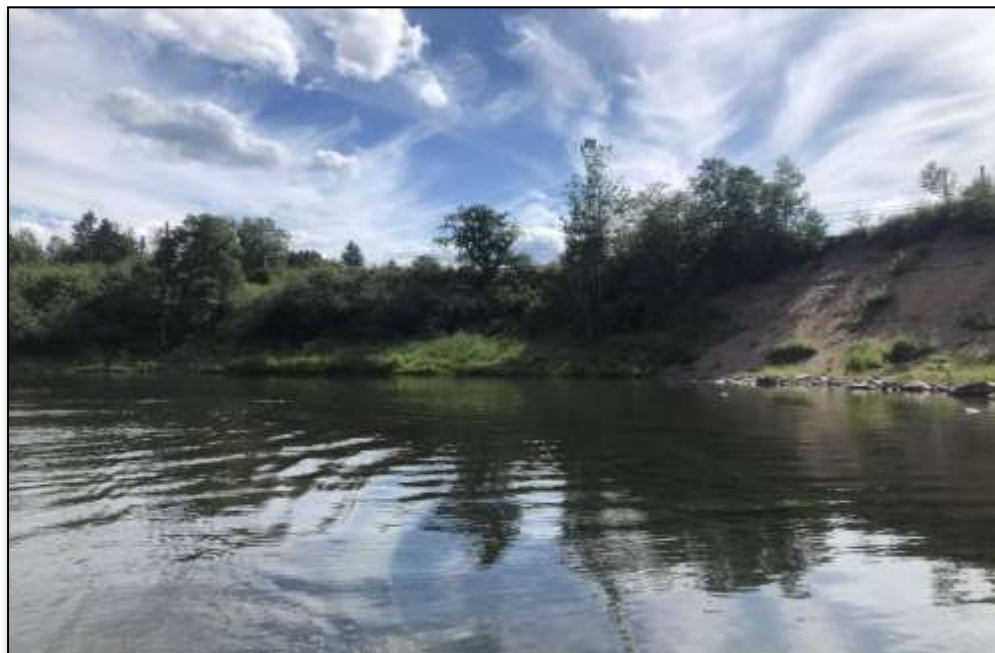
Looking upriver from Crowley's Pool, showing the proximity of the eroded bank to the road. *Photo: J. Kelly*

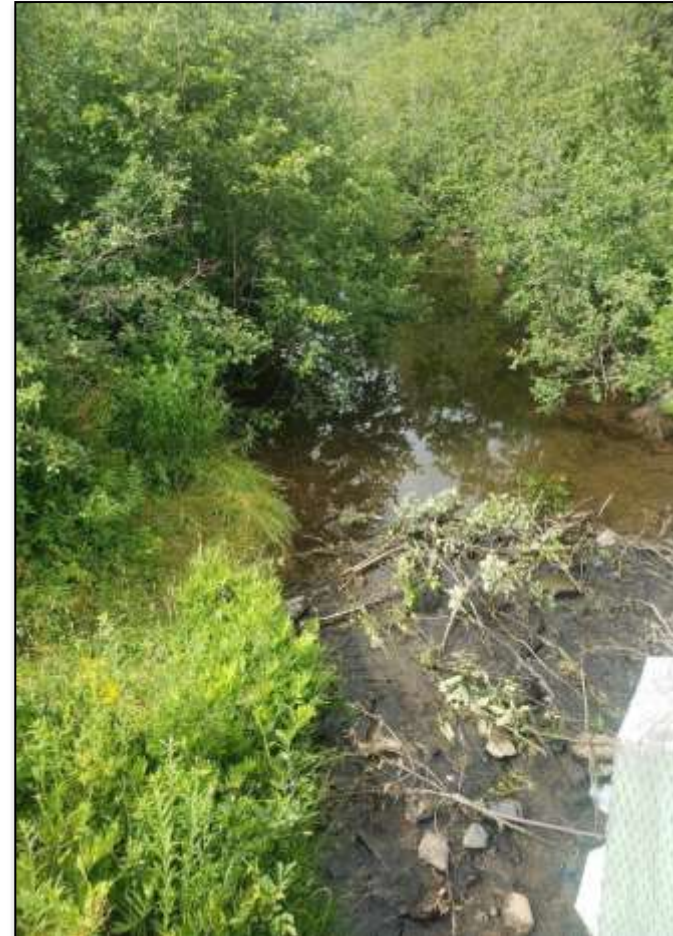
Figure 180. The beginning of another beaver dam in Bradley Brook. It was also noted that someone had been placing rocks across Bradley Brook, to make a dam or pool below the bridge.
Photo: S. Blenis

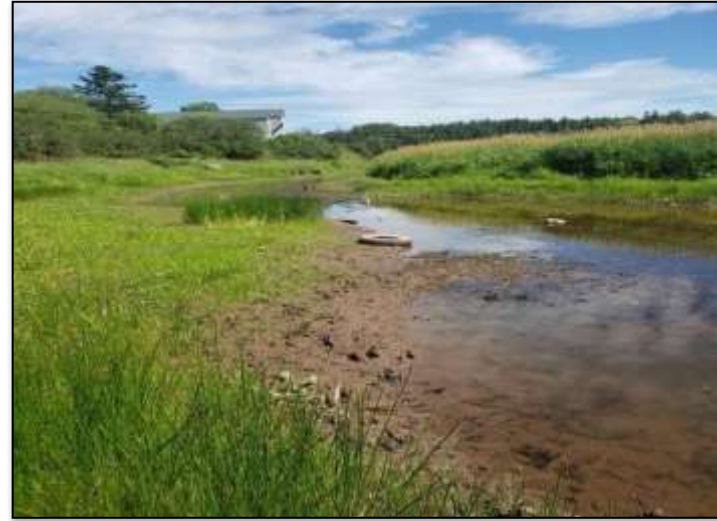
Figure 196. Degraded riparian zone lower Palmer Brook. *Photo: S. Blenis*

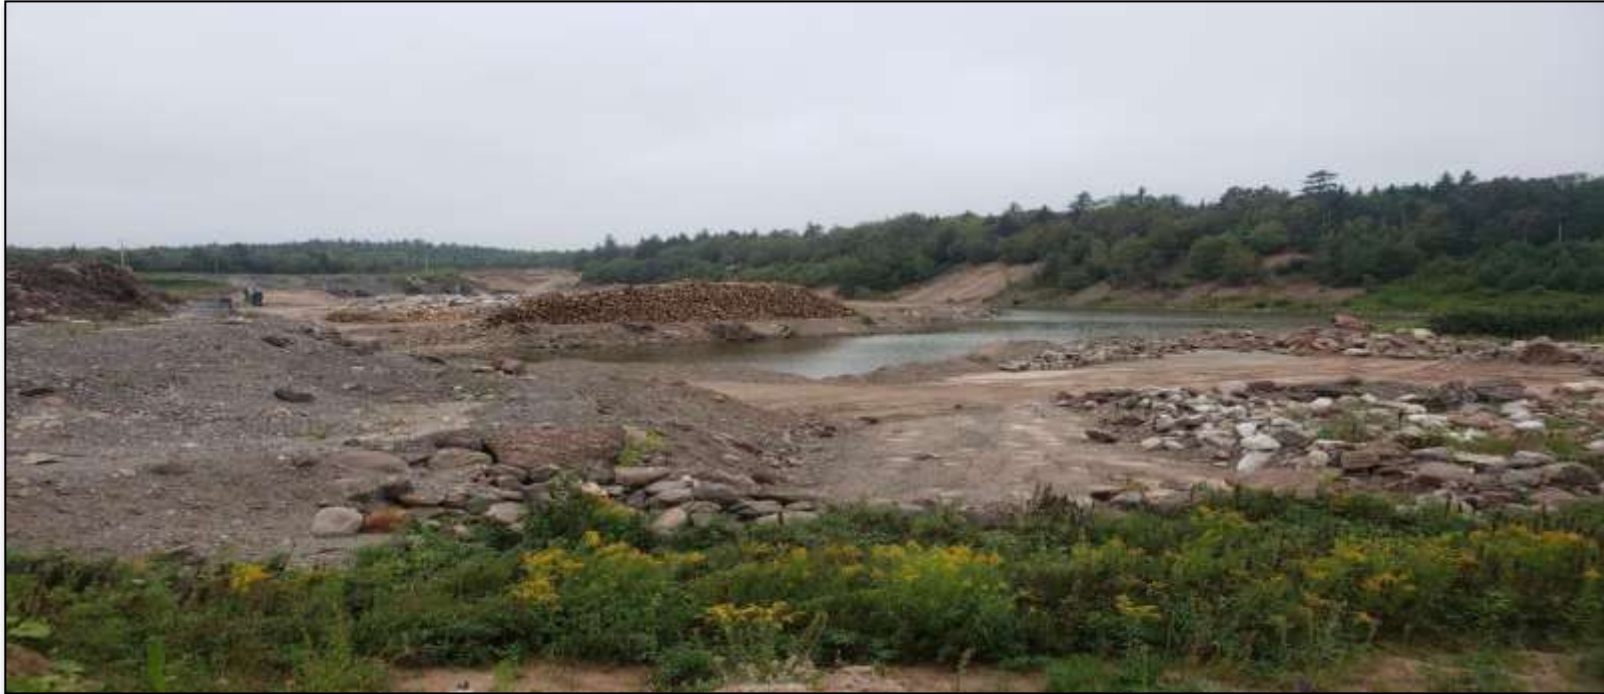
Figure 199. Renforth Pit Lake flows into Palmer Brook, and it visually appears to be the most stressed lake within the watershed. It is located near a large lumber and aggregate operation. It is unclear if this lake has ever been stocked, but it is doubtful that this lake provides acceptable fish habitat. This lake will be included in the upcoming *2021 Lake Assessment*. Given surrounding industrial activity, it is recommended that HRAA include an extremely vigorous water quality sampling program, including organic and inorganic parameters, and expanding to include microplastics, BTEX and hydrocarbons etc. There is a large amount of lumber (organic) debris in the lake; however, there are multiple long lengths of plastic pipe, roofing shingles, metal, and other sorts of garbage in the lake. The steep slope along the northern bank is experiencing a fair degree of erosion, and heavy rain events are depositing high levels of sediment into the lake. There is minimal vegetation surrounding the lake's edges, and summer water temperatures are anticipated to be high due to lack of crown closure and shade. *Photo: S. Blenis*

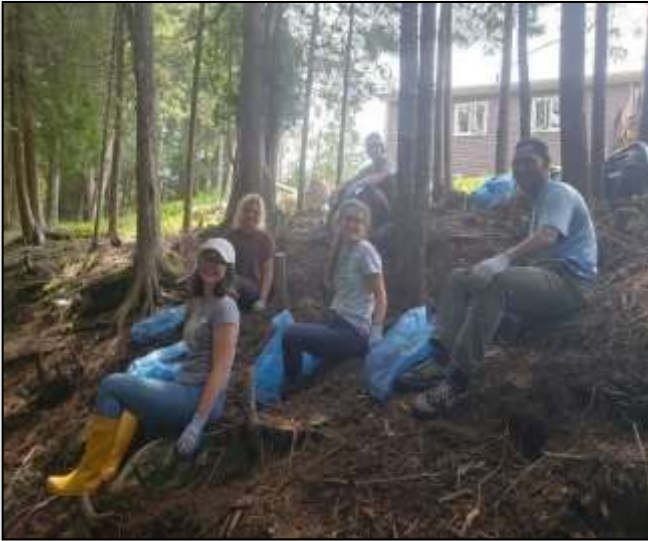
Figure 210 a. An area along the upper stretch of Palmer Brook was discovered during summer habitat assessments that had an entire bank of embedded garbage and debris. The garbage, which appeared to have been there for many years as it was firmly entrenched in the soil, and it was also found in the brook itself. Field staff recognized that this site was beyond the abilities of just 2 people attempting to clean up the site- it would have taken several days! Field staff discussed the issue with our awesome Nature Camp Councilors, and they agreed to lend us a hand and get the site cleaned up!
