V. Discussions and Conclusions

A. Water Classification

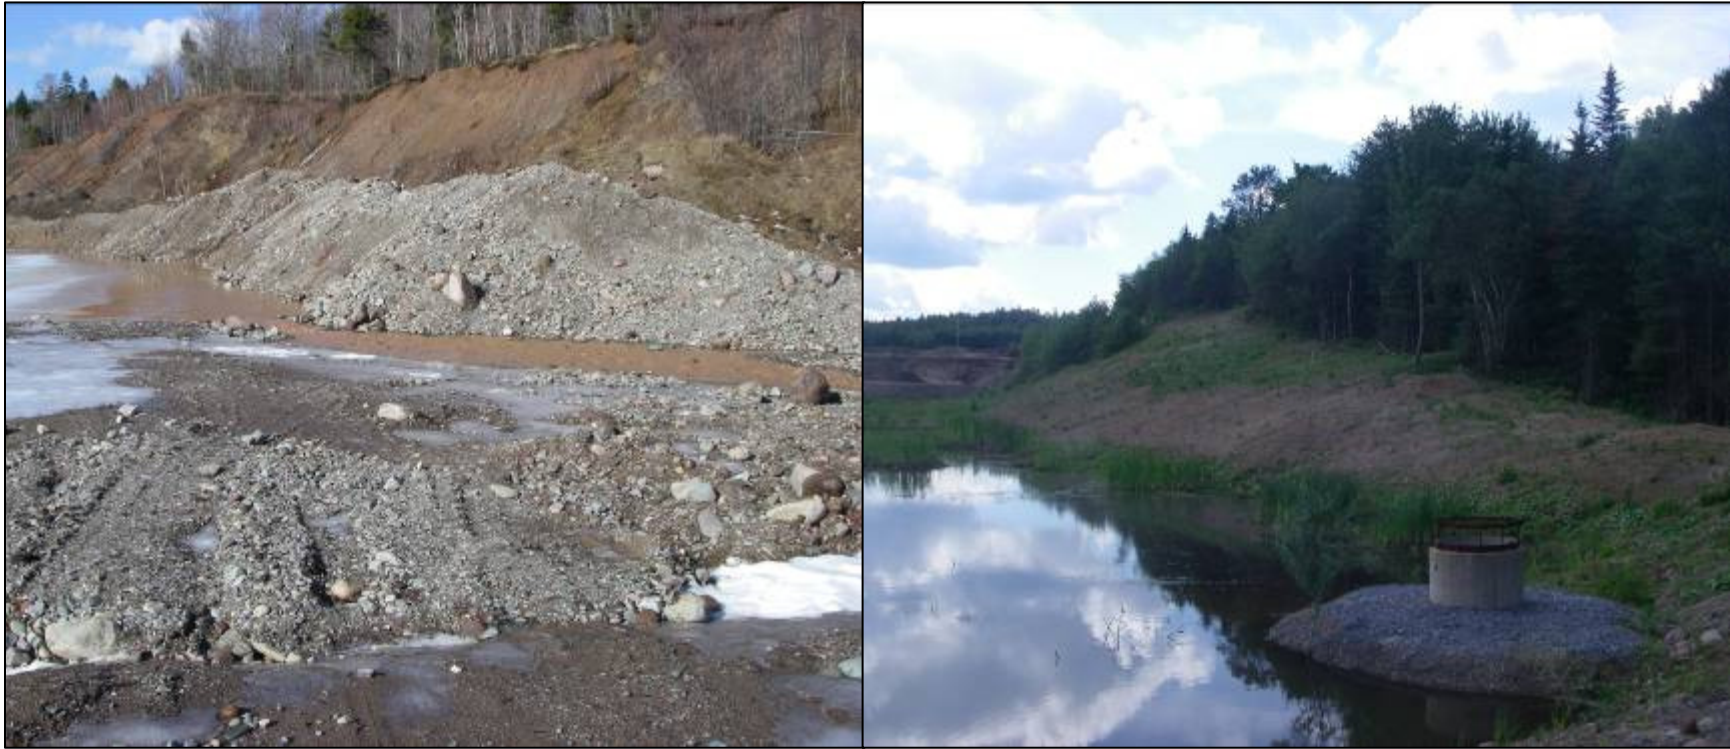
Figure 107. Renforth construction worked with HRAA staff and DENV to re-establish a degraded gravel pit reducing large flows of sediment to Palmer Brook. Photo on the left shows the Renforth pit in February of 2008 and the photo on the right show the same location in July 2008. A settling pond and standpipe was installed to regulate water runoff and prevent the sedimentation of Palmer Brook. *Photos S. Campbell.*

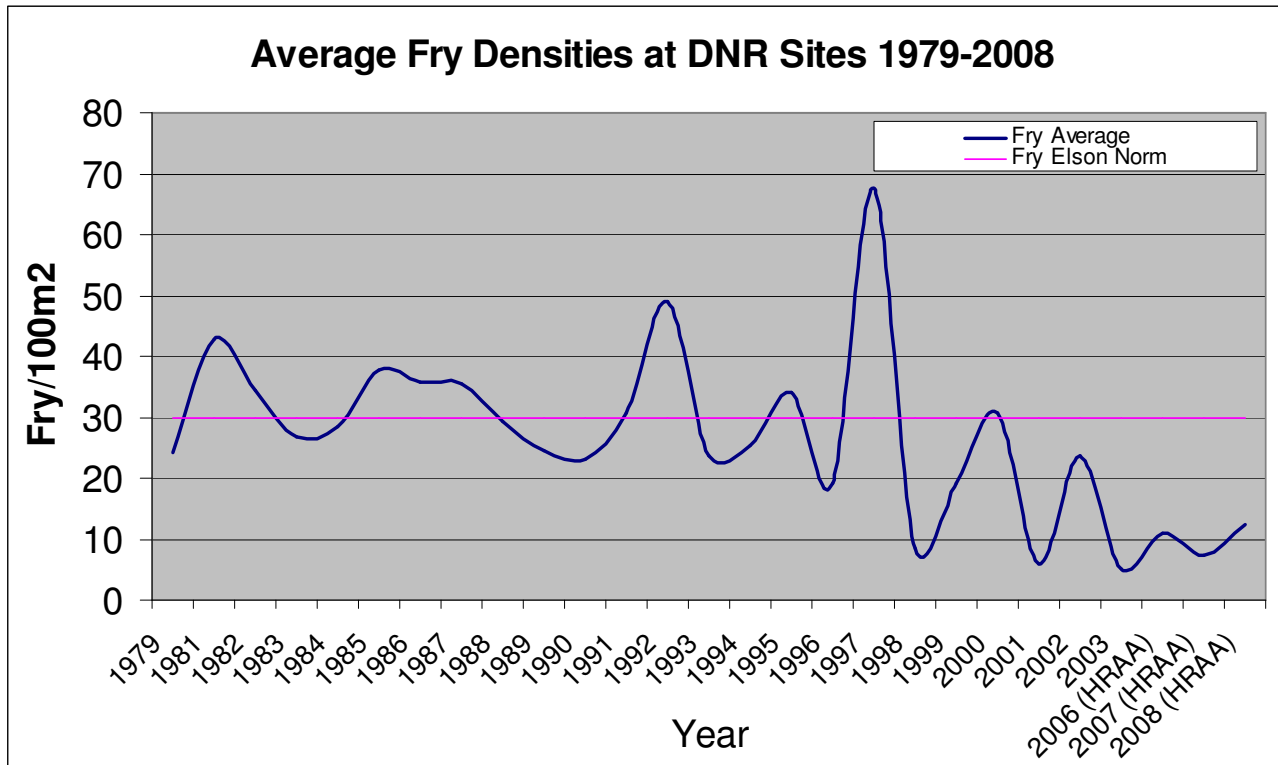
Figure 108. Average fry densities at the historical sites from 1979-2008. For each given year the average of was taken of all assessed sites. This could be from one to five sites, depending on the year. A clear decline in average fry densities is evident following the huge spike in 1997.

Figure 108 is a graph of the average fry densities at these sites between 1979 and 2008, and illustrates an alarming trend. Throughout the eighties and early nineties, the average fry density hovered around the Elson norm for fry. Then in 1997, there was a huge spike in fry numbers followed by a steady decline. The fry average now hovers around 10 fry/100m². This is about 1/3 of the historical average. Historical parr densities are very sporadic and no clear trend is evident from these numbers. Please refer to Appendix A for all electrofishing data.

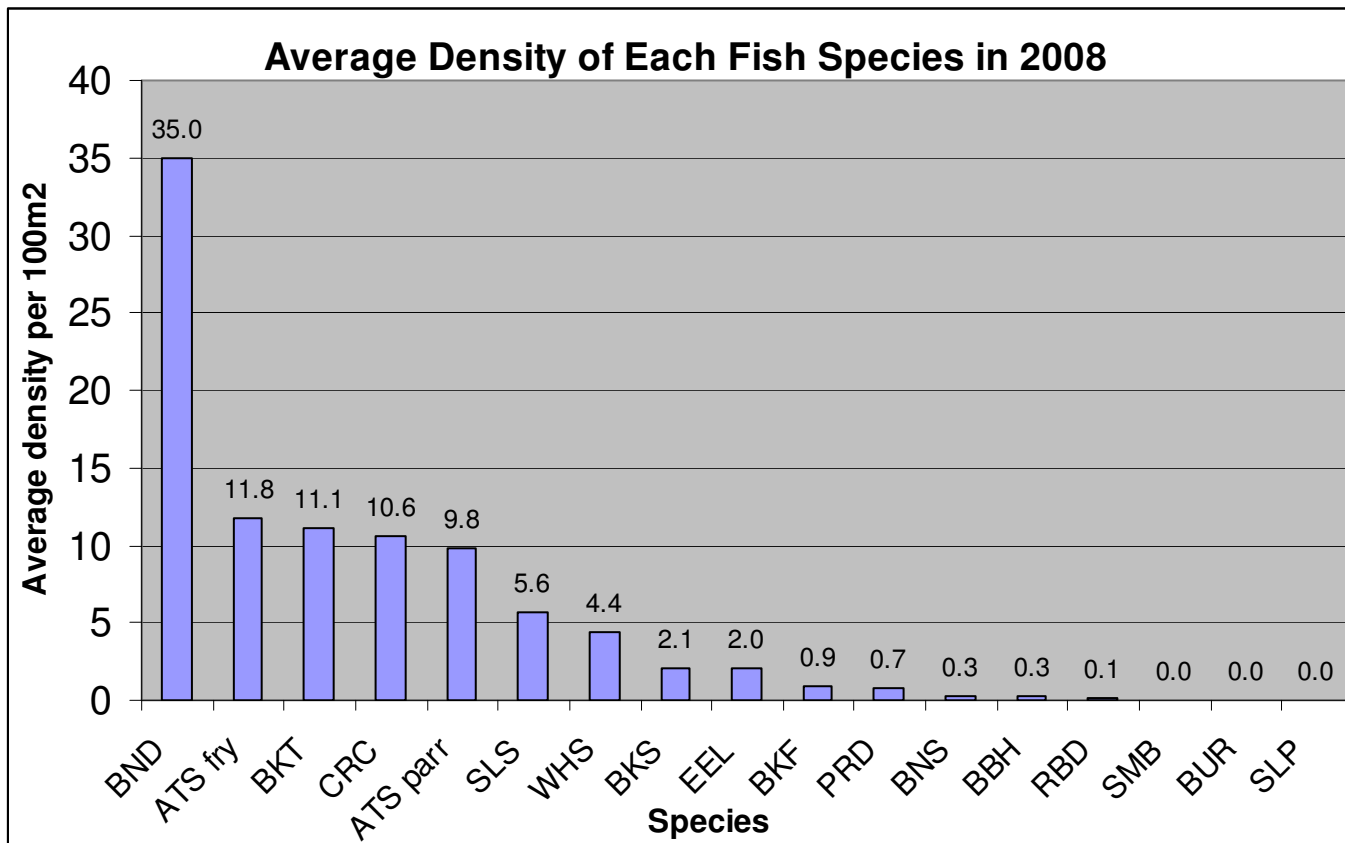
Figure 109. Bar graph depicting the average density of each species identified in the Hammond River Watershed during 2008 electro-fishing surveys.

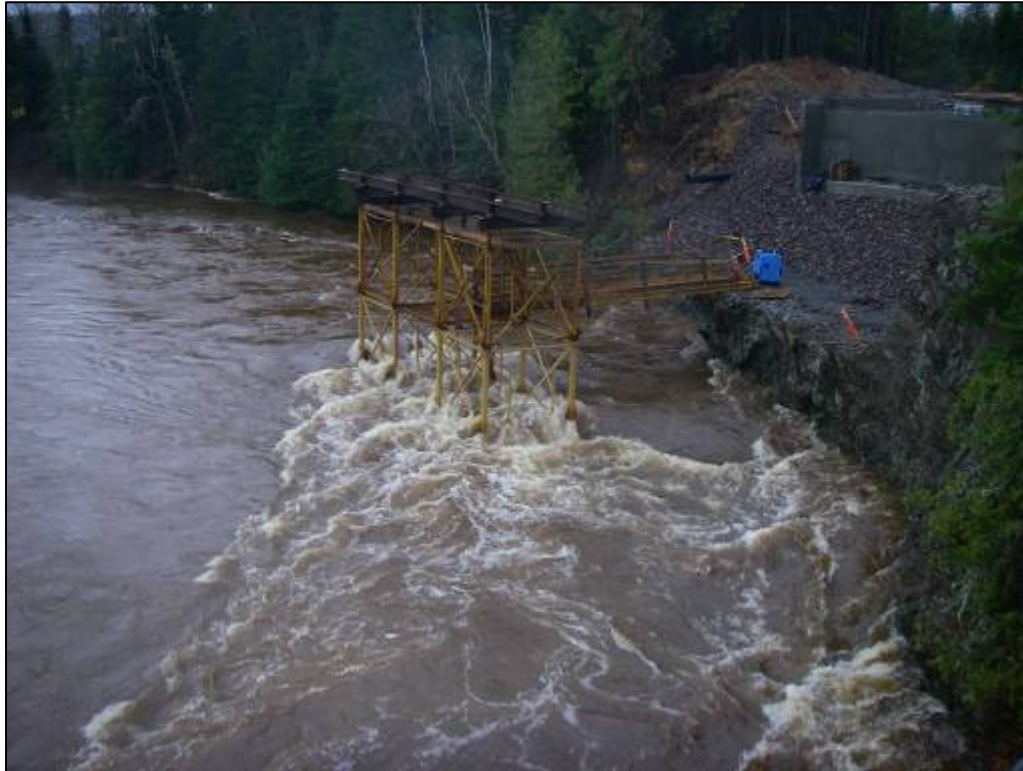
Figure 110. In late summer of 2008 contractors began to replace the Tabor Bridge. Photo shown of strong fall flooding taken following heavy rain events of late October 2008. Monitoring was conducted by HRAA staff and DENV to limit the impact of the construction on the river. *Photo T. Benjamin.*

Another major concern arose in the summer of 2008. Construction began to replace the bailey bridge above Tabor Bridge Pool. The site of construction is regarded as an ecologically sensitive site, containing a large Atlantic salmon pool and unique rock features. With construction in such a valuable region, it has caused a great deal of discontent amongst watershed enthusiasts and the greater community at large (Figure 151). HRAA

to have some minor level of control. Staff and volunteers worked tirelessly monitoring the on goings of the operation and consulting those responsible when issues arose. HRAA will continue to monitor the replacement efforts on the Tabor Bridge Pool and the removal of the former bailey bridge.

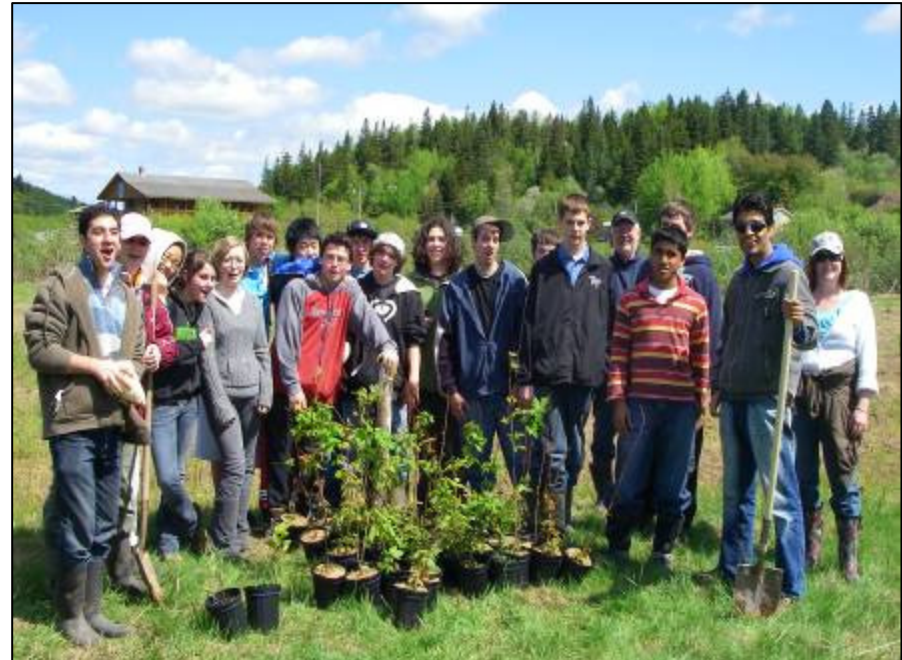
Figure 111. A group of high school students volunteering time and energy to help plant thousands of sapling trees in the HRAA field, spring 2008. *Photo G. Sayer*

One of the priorities of HRAA for many years has been the HRAA and Steele's field (Figure 111). Through many years of restoration work, the HRAA has been able to reclaim a high percentage of eroding fields. With a considerable amount of staff and volunteer work, this field has enabled the HRAA eco-reach to drop to a priority level of nine. There are still regions where erosion is creating sharp angles in the banks.

With the severe nature of the erosion, the river channel is beginning

to shift toward the field, creating large pools. Continued partnership with the Steele family is recommended to further the success of riparian zone and reduce erosion.

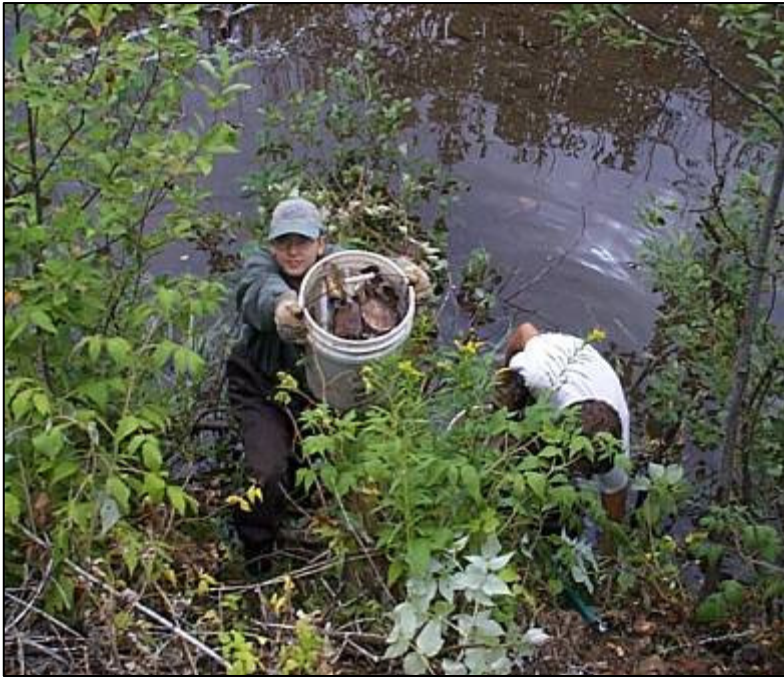
Figure 112. In the summer of 2001 staff and volunteers worked tirelessly to clean a dumpsite along the Markhamville reach, removing truckloads of waste.

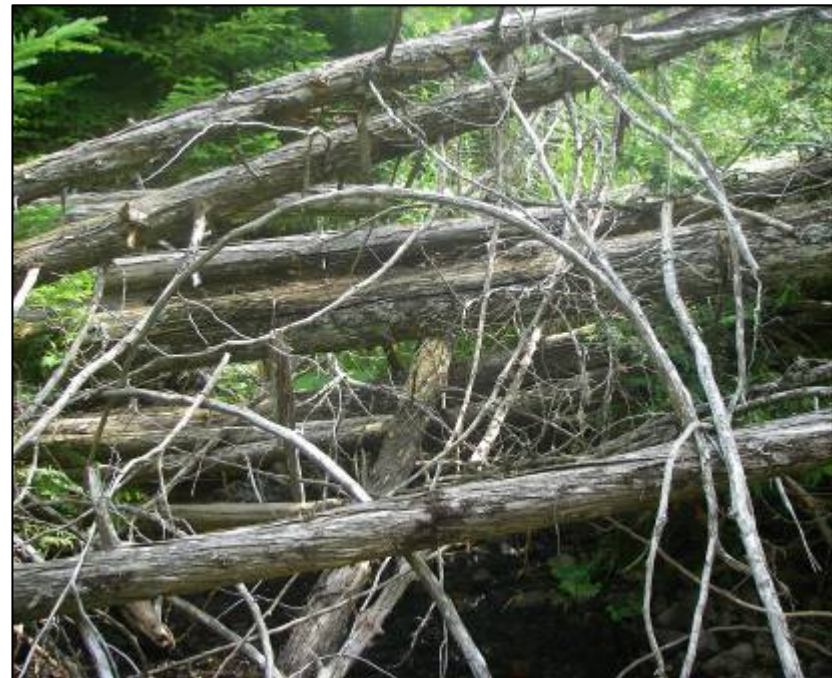
Figure 113. Bater Brook riddled with blown down trees following an over harvesting of timber. Photo A. White

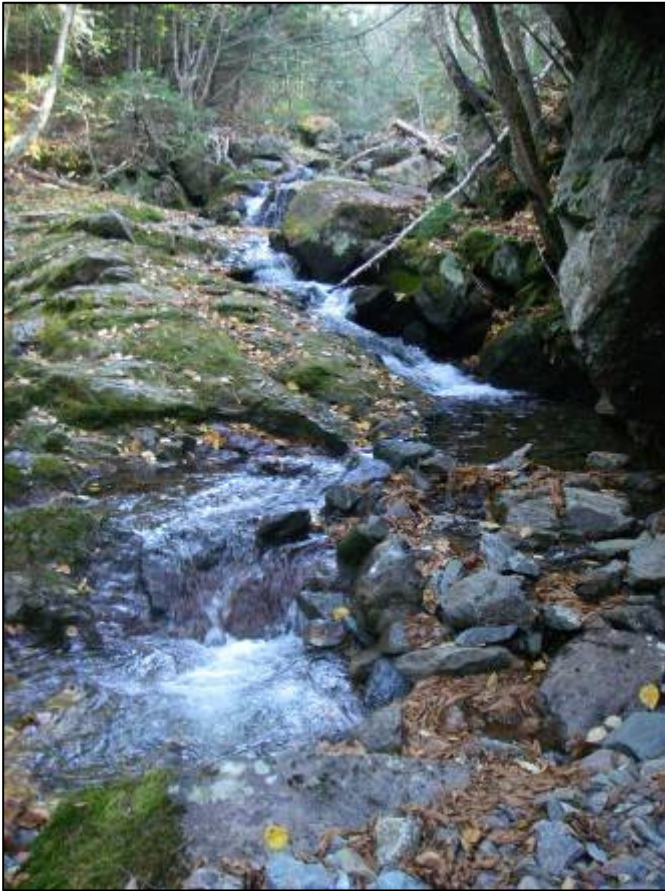
Figure 114. Donnelly Brook remains pristine but, any changes in the current land use this brook will be at risk of becoming degraded. *Photo S. Prosser*

The final three priority locations are Mill Brook, Donnelly Brook and Titus Brook. These three brooks are currently in pristine conditions with few problems. The three share on common concern, land use. With any changes in the current land use these brooks are at risk of becoming degraded. A monitoring and protection plan will be put in place to ensure these brooks continue to be healthy and productive. Also further studies will be conducted to create a baseline data on the stream habitat, through stream habitat assessments.
