## Hammond River Angling Association

# GETTING HANDS- ON IN THE HAMMOND

PROJECT NUMBER  
220209

PREPARED FOR:  
NB ENVIRONMENTAL TRUST FUND

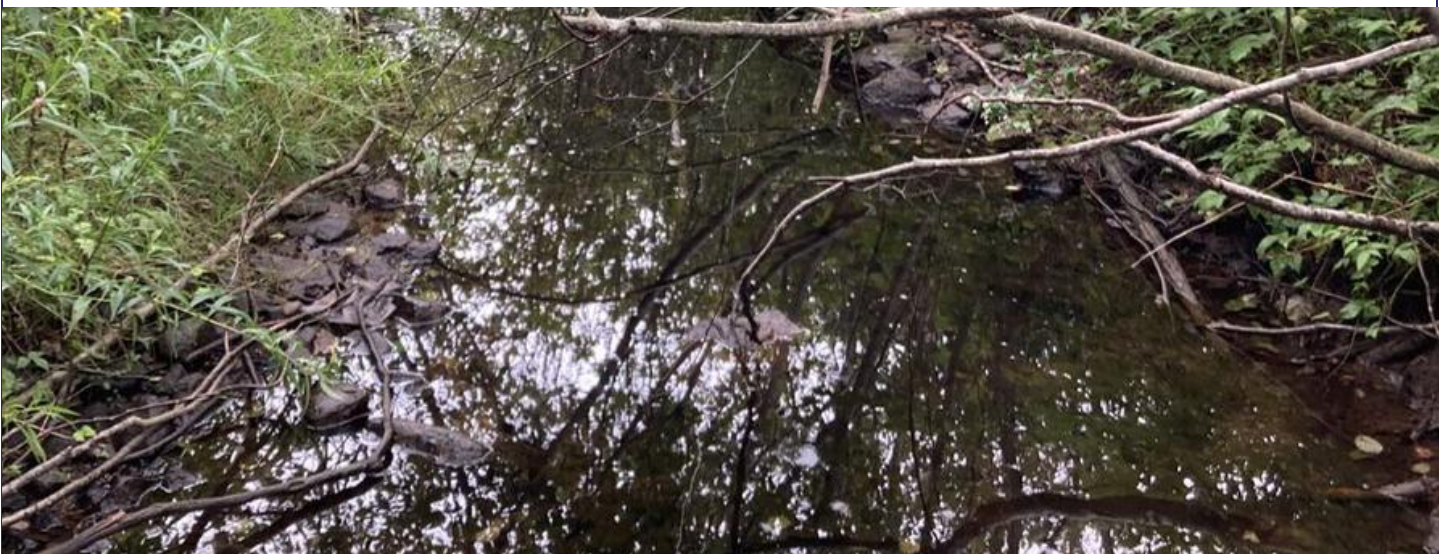
Additional investigation into the bacterial results of these two new tributaries is warranted in the future. Shown below: Snow Brook.

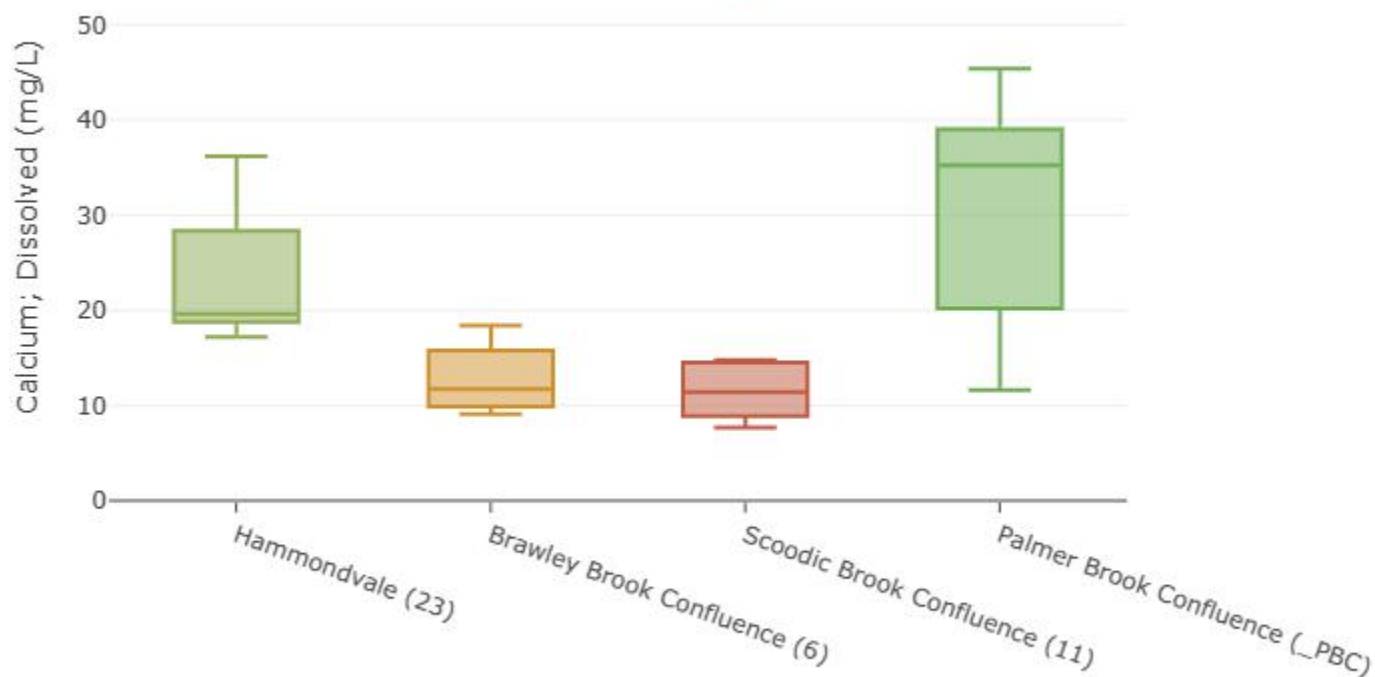
## Calcium

Calcium is naturally occurring from erosion and weathering of soils and minerals. It is an essential component of bone and cartilage for aquatic and terrestrial species. Calcium regulates the uptake of nutrients, promotes muscle tone and regular heartbeat in aquatic species. Typical freshwater calcium levels range from 4-100 mg/L. Typical seawater contains 400 mg/L of calcium. Like all living animals, freshwater fish need calcium for bones, scales, teeth, and other biological functions. Fish can absorb calcium from the water through their gills and their diet.

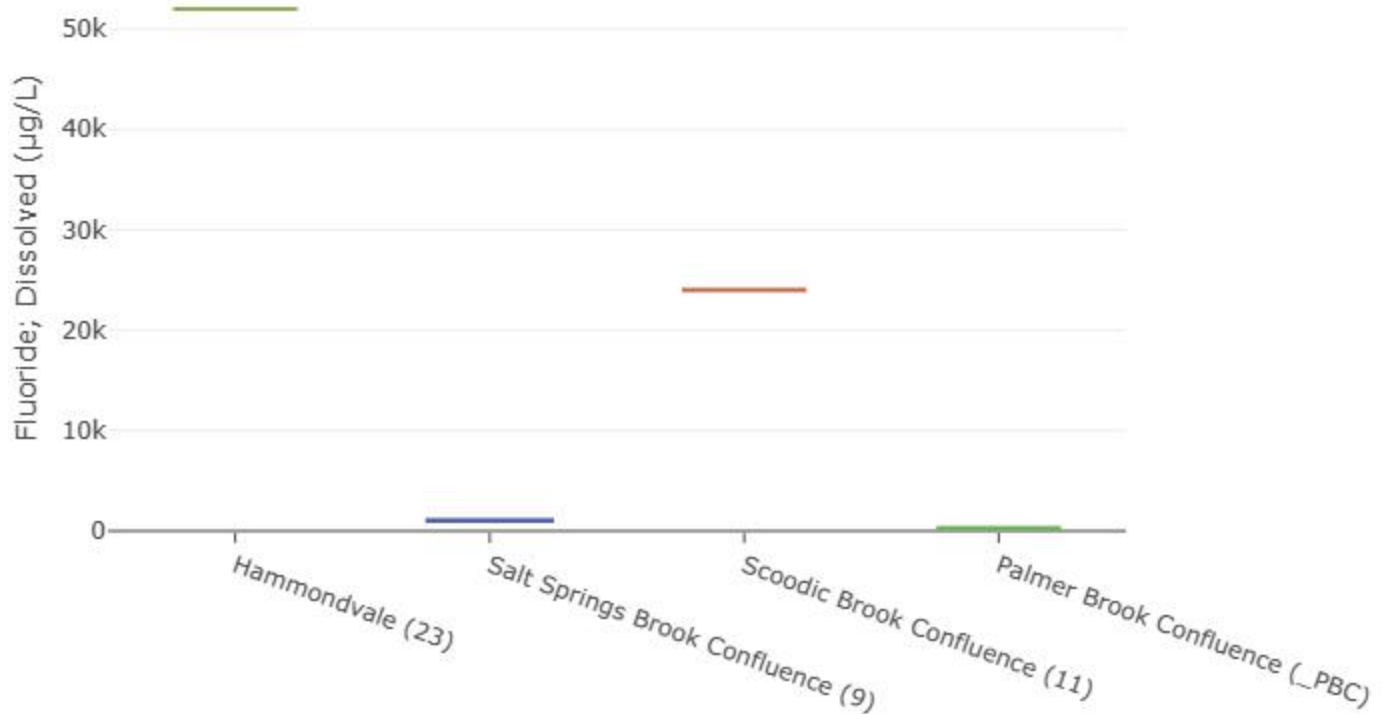
## Fluoride

Acceptable levels of fluoride for the protection of aquatic fish health with long term exposure is 120 µg/L. Fluoride is a naturally occurring element from soil and rock erosion. High levels of fluoride can result in fish and aquatic invertebrate toxicity.

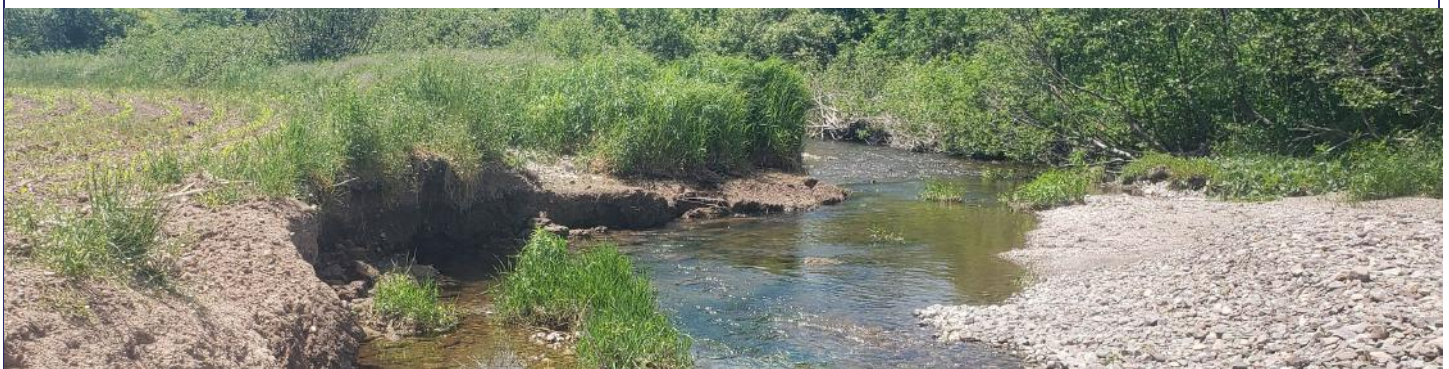
Only four tributaries yielded one positive test result for fluoride during the 2022 sampling period. It is interesting to note that the occurrence of fluoride corresponds with four tributaries that are experiencing high levels of erosion, and that these levels may be indicators that riparian restoration is required within these stretches. All positive fluoride results occurred post-heavy rainfall events in July. Shown below: erosion at Hammondvale.

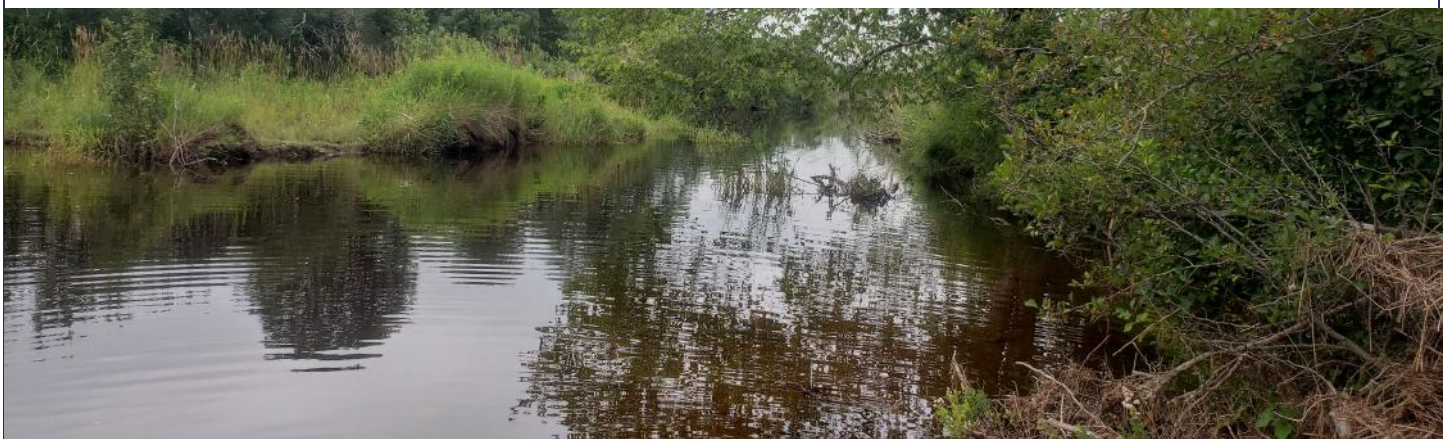
It is no surprise that Salt Springs Brook contains higher levels of sodium in comparison to other index sites within the watershed, from its naturally occurring salt caverns. Shown below: lower Salt Springs Brook.

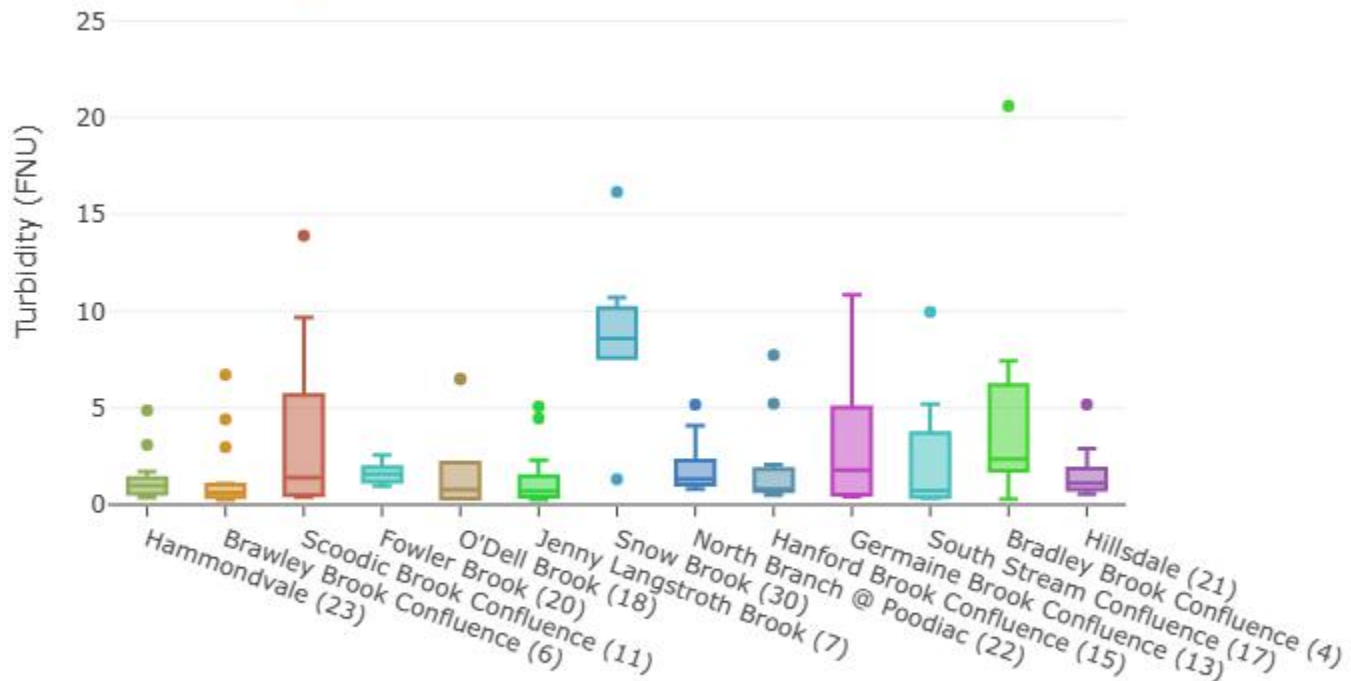
Acceptable levels of turbidity based on the Surface Water Monitoring Data as provided by the New Brunswick Department of Environment and Local Government is 10 FNU. Turbidity is an important indicator of the amount of suspended sediment in water, which can have many negative effects on aquatic life. Large amounts of suspended soils or clay may clog the gills of fish and kill them directly. High turbidity can also make it difficult for fish to see and catch prey, and it may bury and kill eggs laid on the bottom of lakes and rivers. The suspended sediments that cause turbidity can block light to aquatic plants, smother aquatic organisms, and carry contaminants and pathogens, such as lead, mercury, and bacteria. Sources of turbidity include clay, silt, and inorganic matter from natural sources. Turbidity is a measure of water clarity. Increased turbidity may be associated with an increased occurrence of bacteria or pathogens within the water.

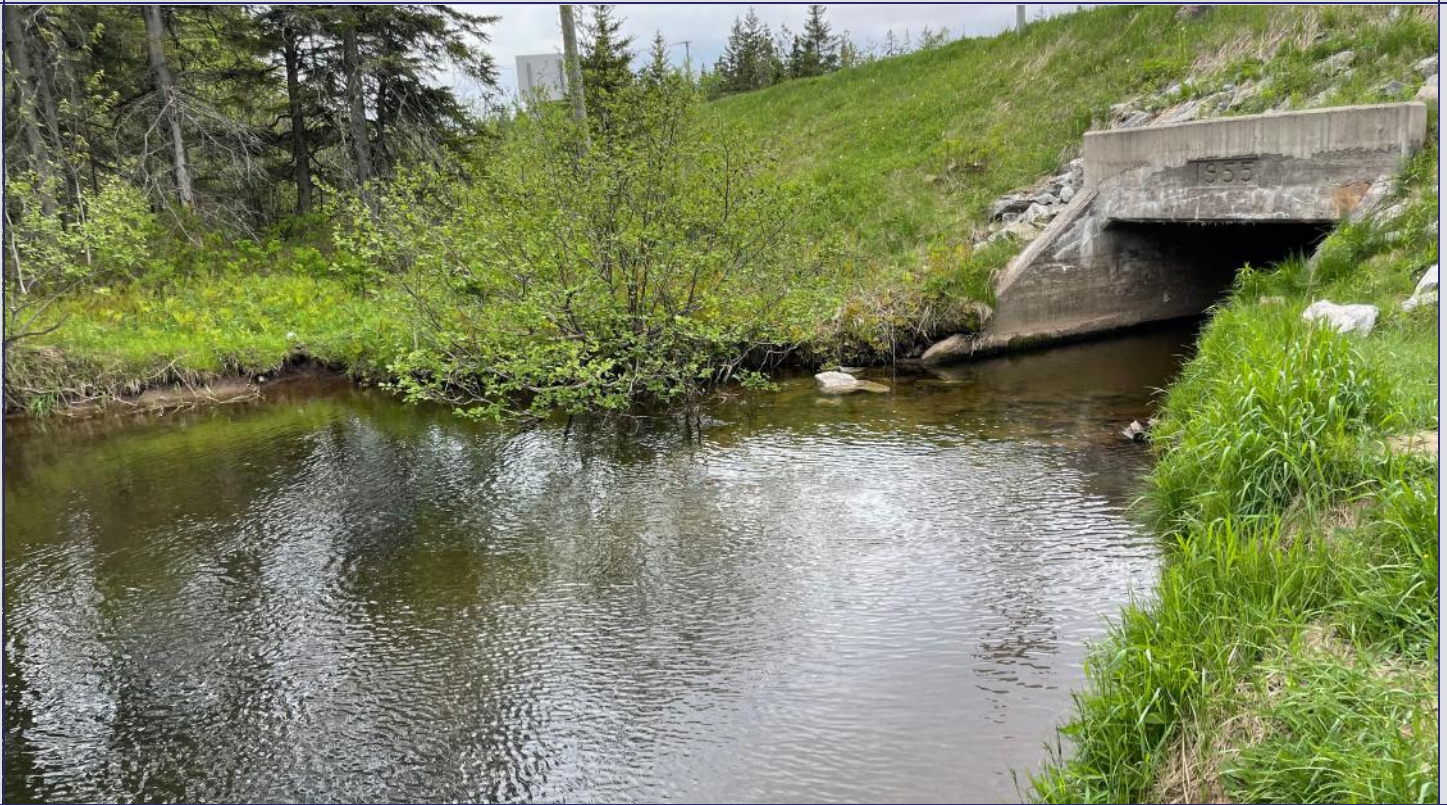
# PALMER BROOK

The Palmer Brook sub-catchment is located in the lower reaches of the Hammond River watershed and is 19.5 km<sup>2</sup> in size. Historically, the index site for water quality monitoring was closer to the confluence area, as the adjacent field was formally used for agricultural purposes, and it was advantageous to sample in close proximity; however, land use practices have shifted, and the field is now barren of cattle. As such, HRAA staff have moved the sampling site further upstream by approximately 900m, as the historical site required scaling a very steep slope to access the tributary.

The area surrounding Palmer Brook has been delineated as a Provincially Significant Wetland Area, and staff have documented a plethora of rare and endangered species within this zone. Unfortunately, the upper portion of Palmer Brook faces extreme pressure from industrial development, including new developments within the wetland area. It is paramount to continue to monitor Palmer Brook's water quality to ensure that these industrial expansions are not having a negative impact on the water quality, as the confluence of Palmer Brook serves as a critical staging area for migrating Atlantic salmon.

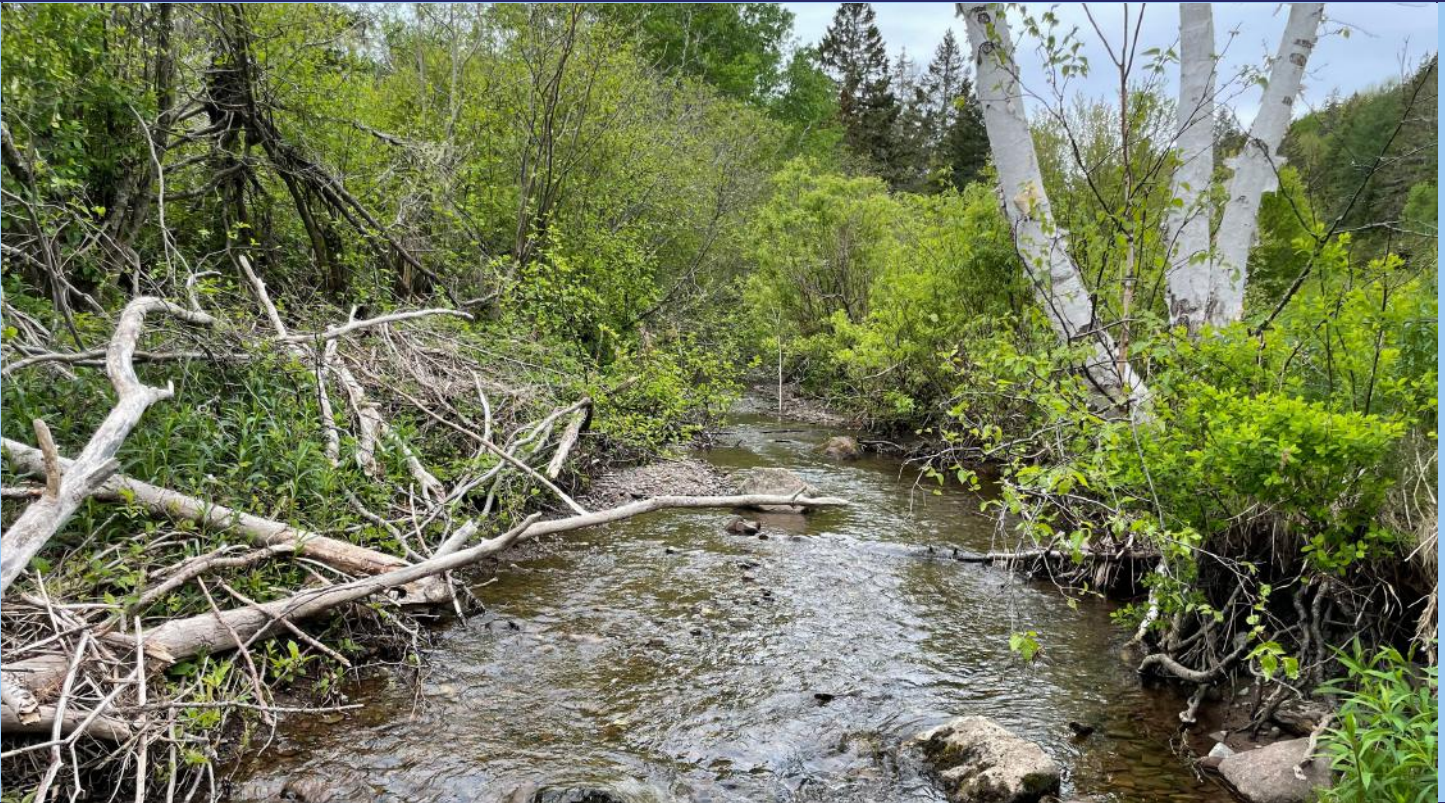
# BRAWLEY BROOK

Brawley Brook is 5 kilometers in length and has dropped down the WQI rankings from the 2021 period, from "Good" to "Marginal". Sodium, sulfate, and chloride were high in comparison to other index sites; however, it is anticipated that this is a result from road salts entering the watercourse from the bridge that crosses Brawley Brook near the confluence point.

Land use is mainly forest with minor residential development, and the substrate is a mishmash of bedrock (10%), boulder (20%), rock (30%), cobble (20%) and gravel (20%), and the substrate is <20% embedded. Exceptional crown cover on both the right and left bank, as the brook winds its way through a rich mixture of mature trees that range in species and age class. Shade on the brook is approximately 80%. The majority of the brook remains as it naturally occurs, with minimal disturbance.

Juvenile smallmouth bass have consistently been documented in Brawley Brook during electrofishing surveys and indicates that the brook contains ideal nursery habitat for smallmouth bass. Unfortunately, the upper portion of Brawley Brook contains a severely hung culvert (one that has since experienced failure, which will be discussed later on), and acts as a barrier to fish passage, creating habitat fragmentation with the upper reach of Brawley Brook.

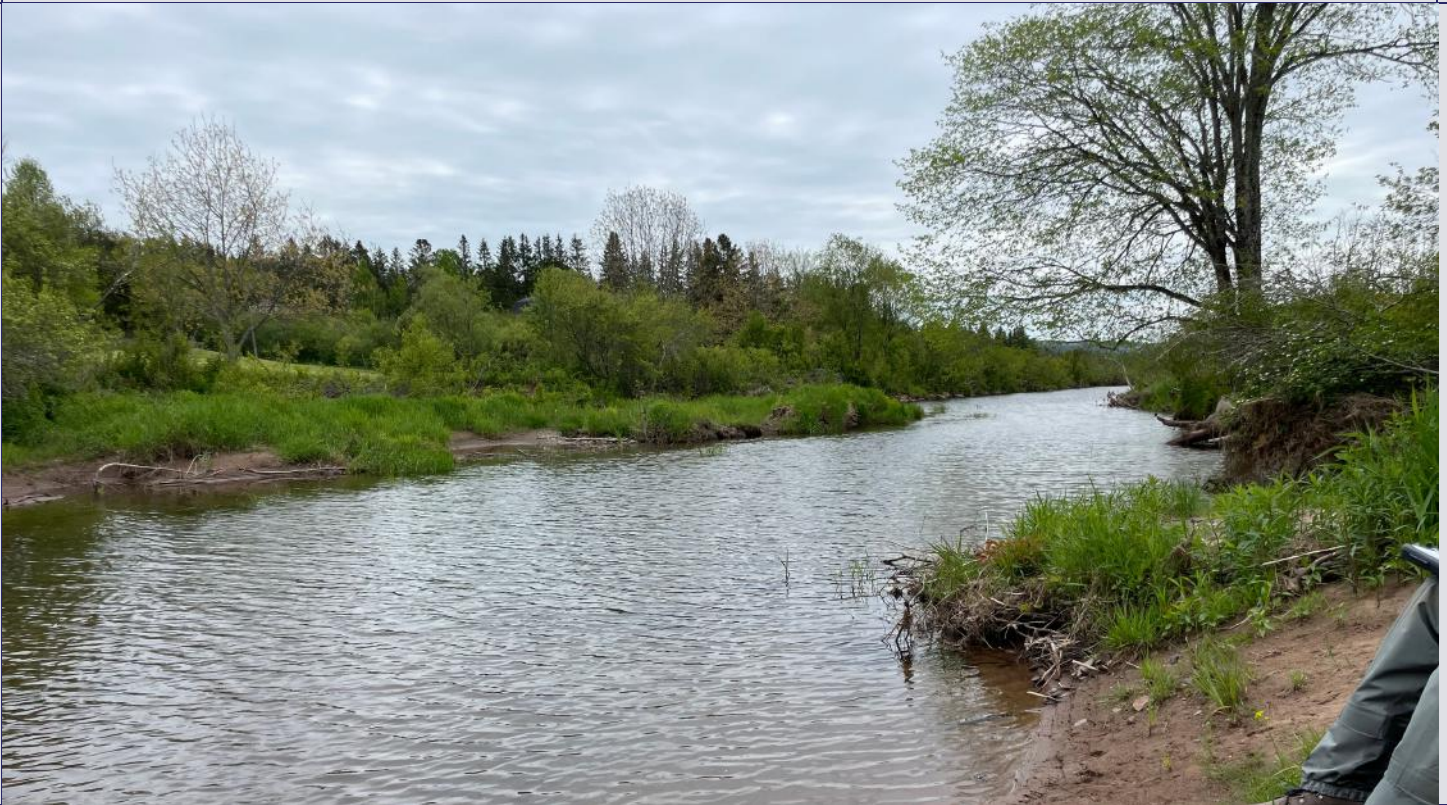
# Salt Springs Brook

Salt Springs brook is the longest cold-water tributary within the Hammond River watershed, with a total length of 22.5km. The land use varies throughout the Salt Springs region, ranging from agricultural, residential, industrial, and natural forest.

A mineral-rich deposit was documented in 1828 in the aptly named and newly formed settlement of Salt Springs. The salt deposit stretches the entire length of the tributary (the longest within the watershed) and connects to the North Branch of the Hammond River. "Indeed, so many saline springs discharge their streams into this river in this neighborhood that the taste of the water is perceptibly affected" (Weekly Observer, 1928).

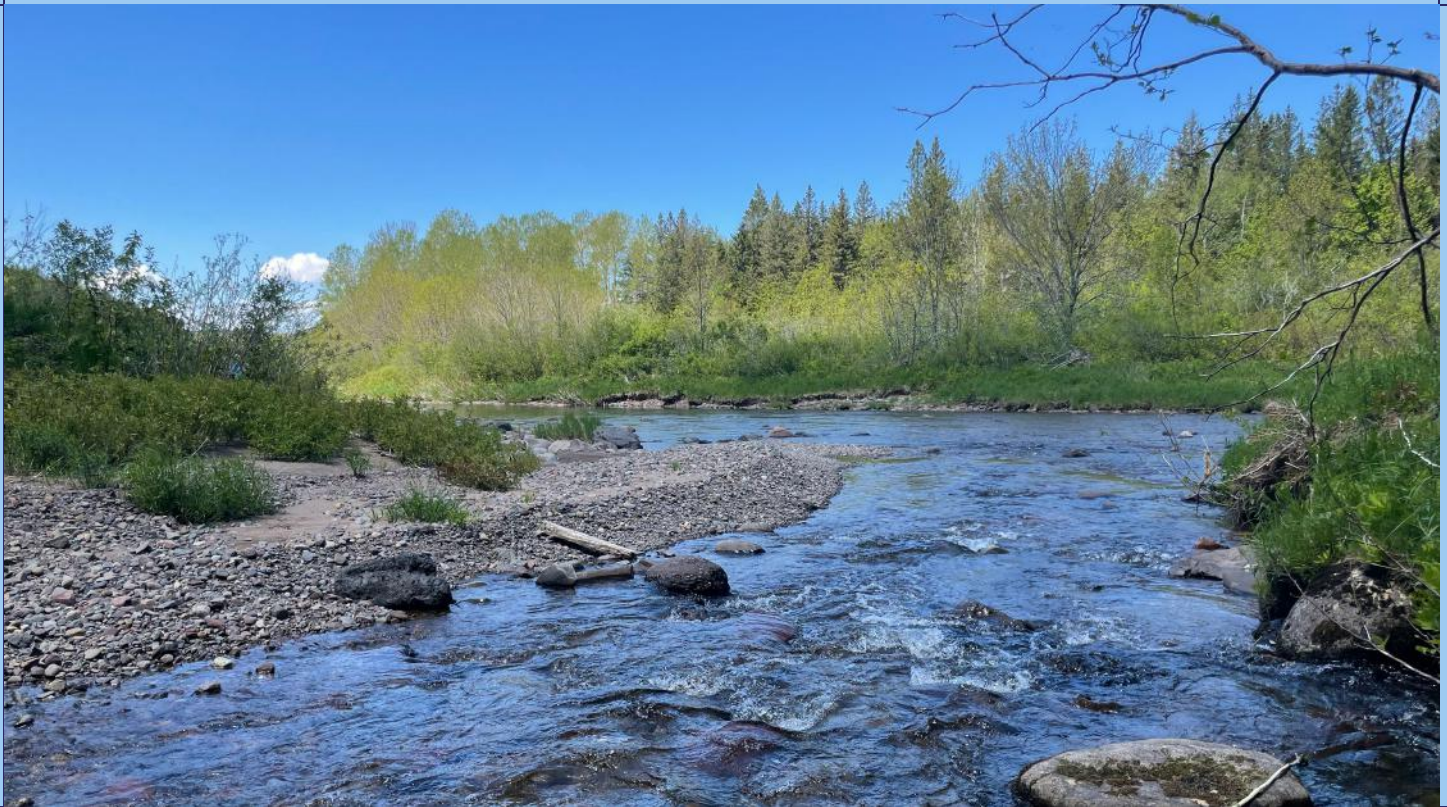
# South Stream

South Stream is located in Barnesville, and has a length of 13.5 kilometers, with its headwaters in the Caledonia highlands region of Upham Mountain. Beautiful crown closure along the upper portion of this tributary, with a mix of older hardwood and softwood trees. The lower portion of the brook, however, has minimal crown closure or riparian vegetation in the agricultural section.

South Stream receives a Water Quality Index rating of "Good", and it had one E. coli spike in July- this is a common occurrence for this tributary, as cattle have unfettered access near the confluence point, and E. coli spikes are fairly common in peak summer months when the cows are seeking out cold water resources to cool themselves. It is recommended that HRAA engage the landowner in 2023 and discuss limiting cattle access to the brook- HRAA has a longstanding history of working with landowners to install fencing which allows cows to have one access point to water instead of free-range within waterbodies.

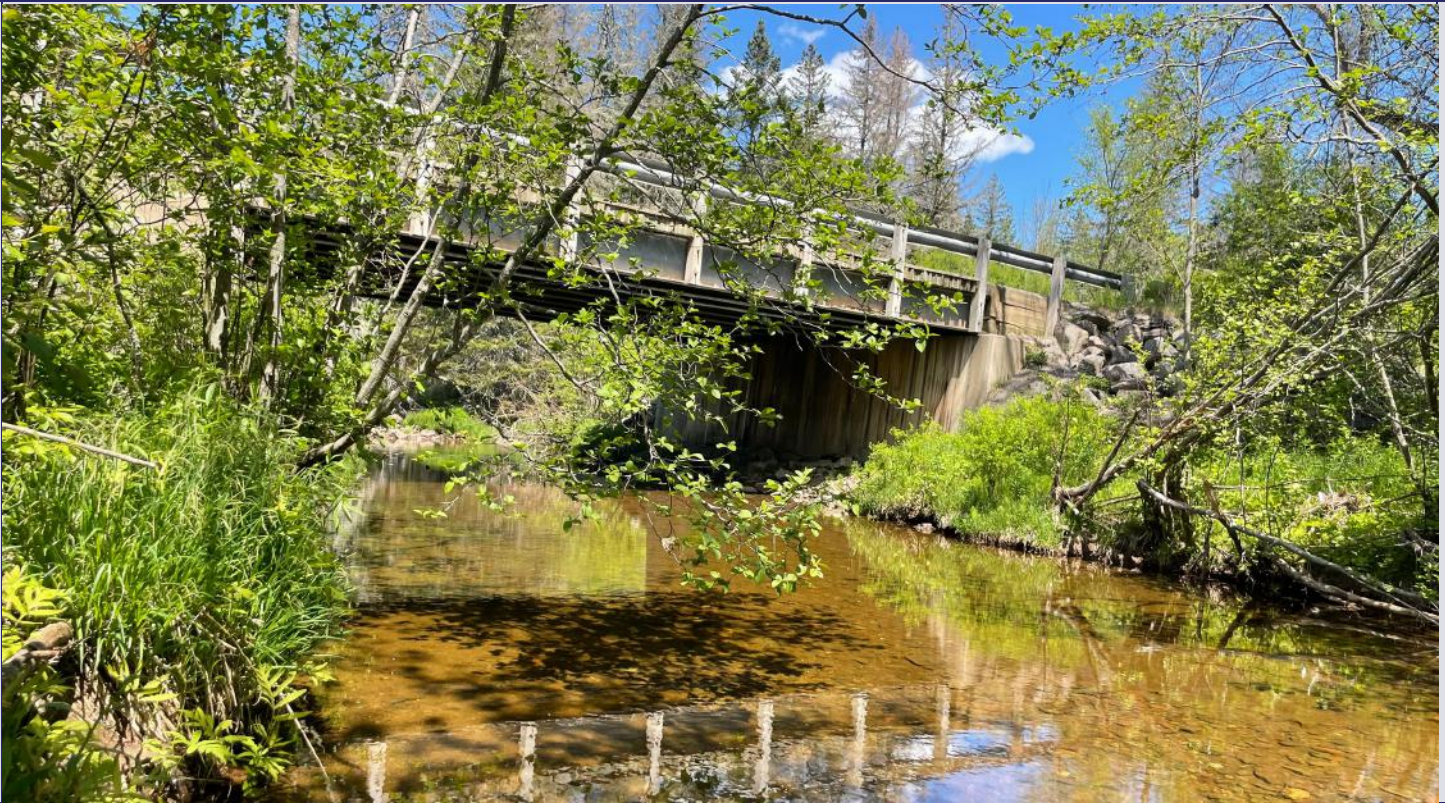
# Scoodic Brook

For over 20 years, Scoodic Brook consistently ranks as having the worst water quality within the watershed, which is very unfortunate, given that it flows into the known salmon holding pool of Firehall Pool. With a total length of 8.2 kilometers, the substrate is a mix of rock (20%), cobble (20%), gravel (20%), sand (20%), and silt (20%), and it is 50% embedded.

It is interesting to note that both the upper and lower sites of Scoodic Brook both exceeded levels of aluminum for the protection of aquatic life; however, the upper site contains an abundance of juvenile brook trout- juvenile Atlantic salmon have not been documented within this tributary in at least a decade. Arsenic has also been detected within this tributary; however, the levels are below guideline limits of 1.5 µg/L. In the early 2000's, HRAA worked with the landowner to limit cattle access to the brook; unfortunately, those fence posts have deteriorated, and cattle are now allowed to roam freely within a large section of Scoodic Brook, resulting in E. coli spikes above guideline limits, hitting peak contributions of 1400 CFU/100mL in 2020, 740 CFU/100mL in 2021, and 500 CFU/100mL in 2022, all occurring in the month of July.

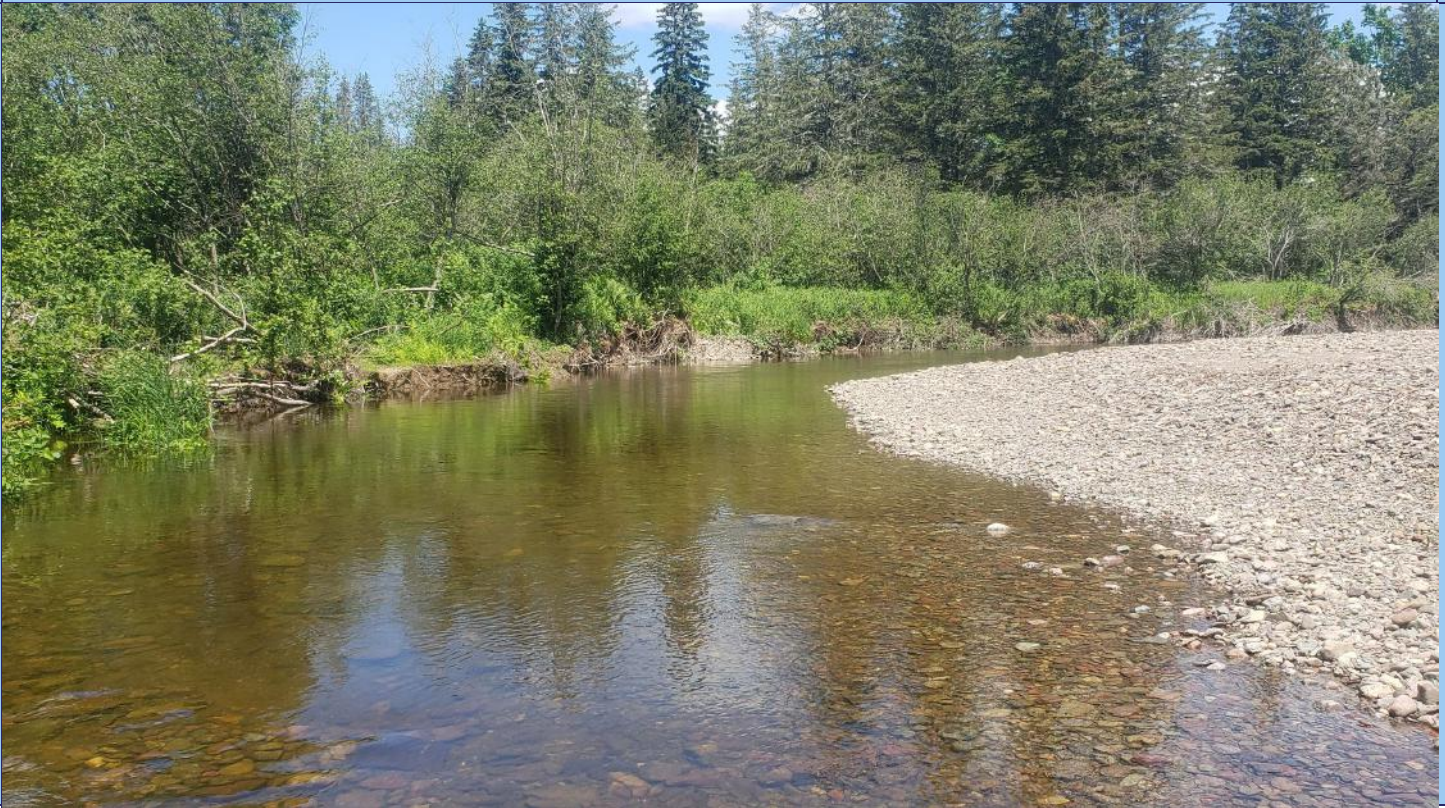
# Hanford Brook

Hanford Brook has a very large drainage area of 5,022 hectares, and receives water from Porter Brook, Isaac Brook, Jenny Lind Brook, Quigley Brook, Fletcher Brook, Porcupine Lake, Henry Lake and Tracy Lake- given its magnitude, HRAA staff will be forming an investigative proposal specifically around Hanford Brook.

Once again, Hanford Brook receives the top spot for the Water Quality Index. The vast majority of the brook is as it naturally occurs, with few anthropogenic stressors. The upper portion of Hanford Brook contains some of the Province's most significant fossil deposits, including trilobites, brachiopods, and other marine fossils. Several fossil specimens have been removed from Hanford Brook and are showcased in museums across the world.

Similar to Salt Springs Brook, Hanford Brook contains a high density of juvenile Atlantic salmon, and offers excellent spawning substrate for adults to make their redds. During the 2022 field season, HRAA staff noted all-terrain vehicle tracks along the beach and into the brook itself- should this behavior continue, it may be prudent to install signage encouraging the public to avoid driving vehicles in the waterbody and potentially impacting spawning salmon, their nests, or their young.

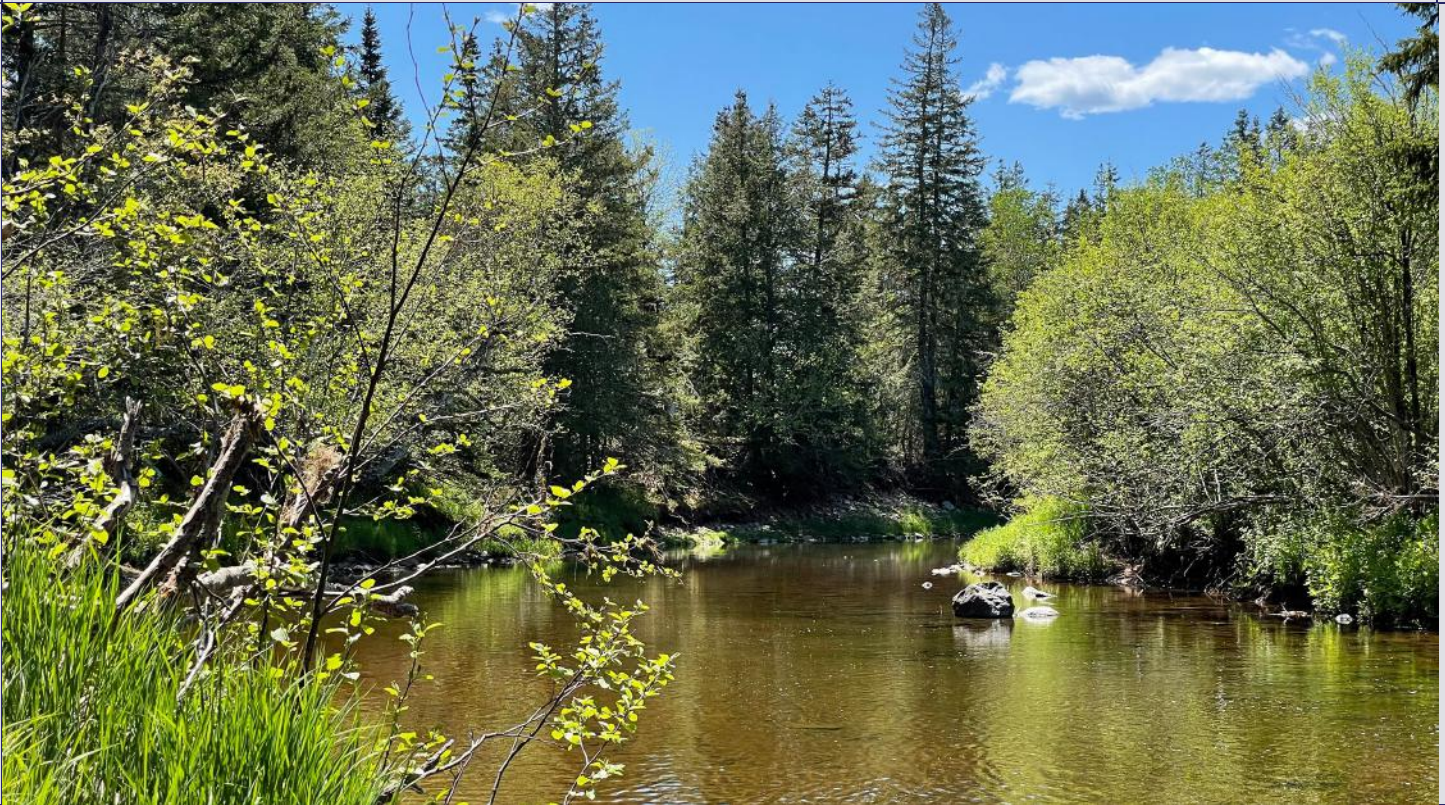
# Hillsdale

Hillsdale is part of the main stem of the Hammond River, located in the upper portion of the watershed. By mid-summer, Hammondvale and Hillsdale begin to develop significant algal growth during peak summer temperatures, and the water becomes increasingly turbid and tannin in color, indicating a shift from oligotrophic to mesotrophic.

The riparian zone is well vegetated with the majority of the banks comprised of trees and shrubs; however, there has been some scouring from ice that has led to erosion along the right bank. The weaker right bank vegetative riparian buffer and poor water drainage may contribute significantly to reductions in water attenuation, and filtration. Significant in-stream vegetation, including large patches of native milfoil, duckweed, filamentous algae, and grass are present.

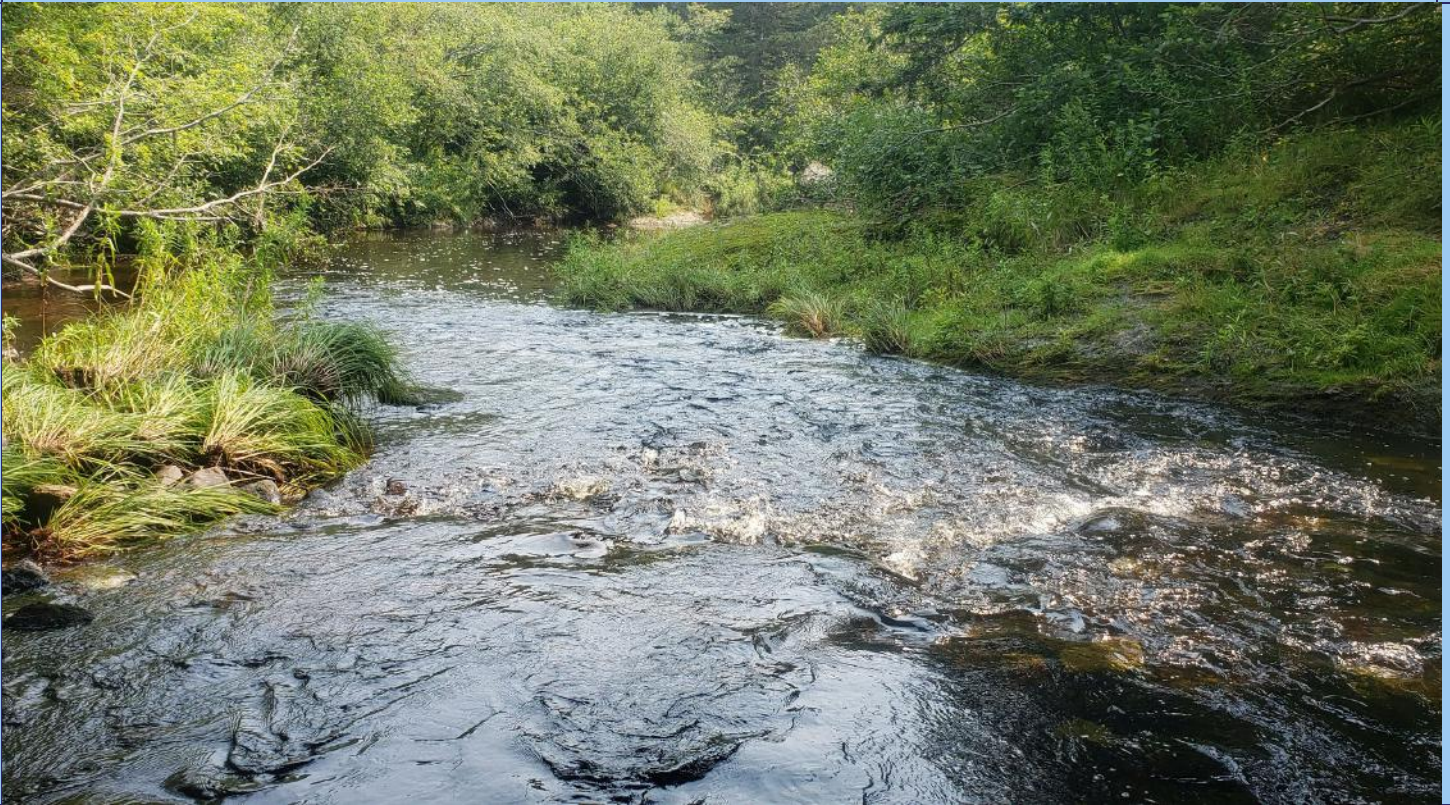
# North Branch

North Branch veers off from the Main Stem at the Hillsdale Bridge and travels northerly towards Cassidy Lake for 13.1km and receives water from Fowler Brook. The substrate in the lower section of North Branch is bedrock (30%), boulder (30%), cobble (20%) and gravel (20%). It offers excellent substrate for fish habitat and nursery area. Substrate is <20% embedded and its cascades and riffles offer excellent dissolved oxygen levels.

The North Branch offers excellent salmonid habitat and consistently produces juvenile Atlantic salmon during electrofishing surveys and environmental DNA sampling. During the 2022 freshwater mussel survey, HRAA staff documented a high abundance of Eastern Pearlshell mussel- not only are these mussels a great indicator of excellent water quality, but they also indicate a strong salmonid presence within the waterbody, as this species of mussels require salmonids as host species for their larva.

In 2022, staff noted that significant clear cutting had begun along the upper reach of the North Branch- monitoring turbidity and nutrient inputs will be critical in the 2023 season to determine if the cutting is having negative impact on its pristine water quality and excellent fish habitat. Additionally, the brine line runs parallel to the North Branch, and ongoing water quality should remain as a top priority for this stretch in order to ensure that any potential brine leaks are addressed immediately, or else they could have detrimental impacts.

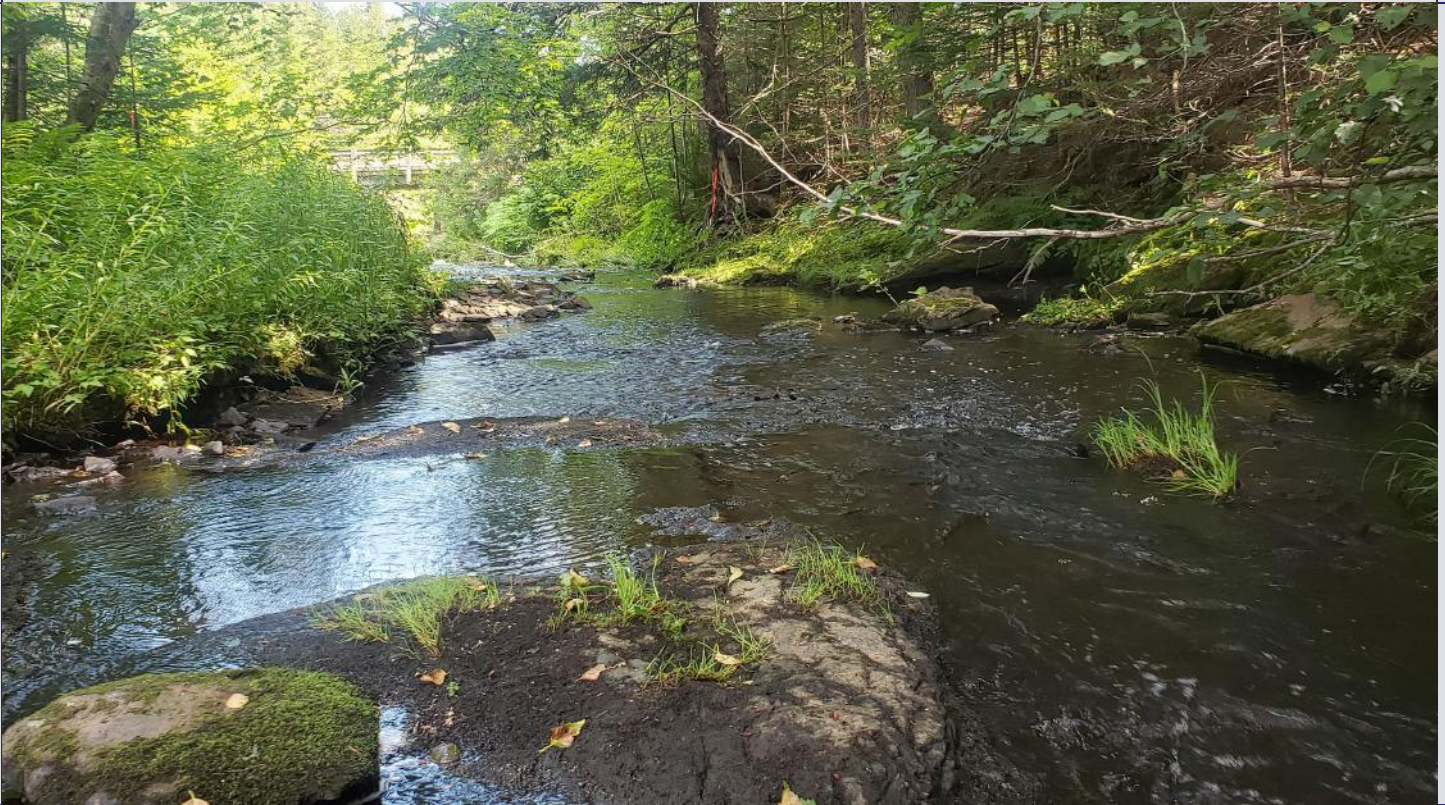
# Fowler Brook

Despite its beautiful crown coverage, flow, dissolved oxygen levels, and excellent substrate (20% bedrock, 30% cobble, and 50% gravel, <25% embedded), Fowler Brook is the third lowest ranking tributary, according to the Water Quality Index. Fowler Brook shares its headwaters with Scodic Brook in a large wetland complex, as well as sharing several exceedances common with Scodic Brook, including failed tests for aluminum, iron, and manganese.

Despite these shortcomings, Fowler Brook contains juvenile Atlantic salmon, brook trout, fallfish, chub, shiners, dace, and slimy sculpin. During the 2022 freshwater mussel survey, HRAA staff found Eastern Pearlshell, indicating salmonid presence, as well as a plethora of fingernail clams- the only site in the watershed to produce this species. Fowler Brook's water is extremely dark- it is very difficult to see the bottom, making surveying this stretch relatively difficult, as one becomes very unsure of footing.

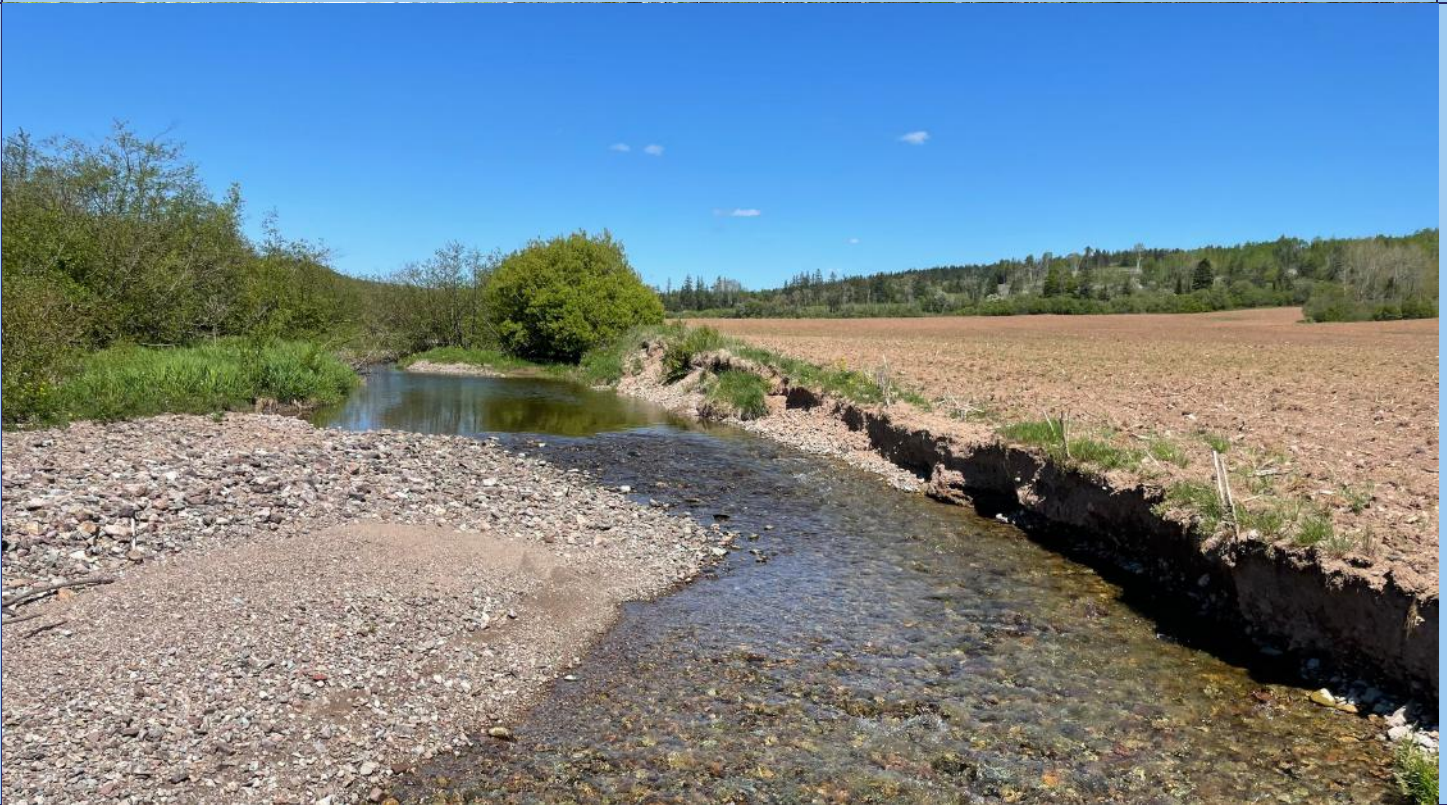
# Hammondvale

It is very difficult discussing Hammondvale- this site is a former HRAA restoration site, in which over 750 willow stakes were planted along its banks in 2020 with landowner approval; however, the landowner leases this land (shown above), and the leasee effectively ploughed under all of the willow stakes, and erosion is continuing in this area at an exponential rate.

What makes this even more frustrating is the fact that Hammondvale consistently produces salmon redds; indeed, salmon redds were documented in 2022 in the area shown above. If land use continues, without immediate restoration, the sediment transport will eventually completely embed the gravel substrate and effectively eliminate this spawning site.

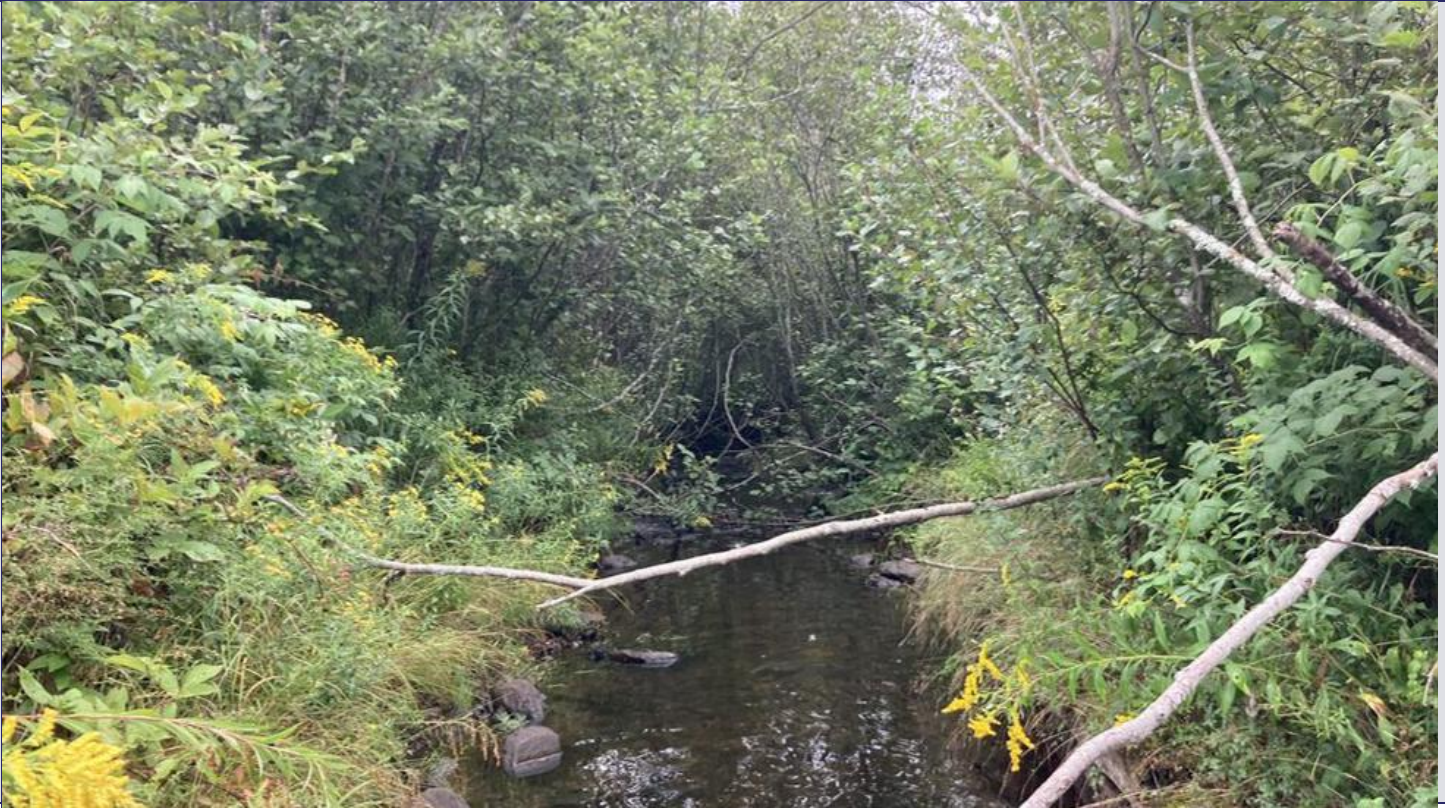
# Snow Brook

Snow Brook is a new addition to HRAA's water quality monitoring program, as a result of 1 grab sample in 2021 yielding exceptionally high levels of iron, aluminum, and e. coli (a whopping 10,180 CFU/100mL). The area surrounding Snow Brook is a historical dump site- it operated in the early 1970's, operated by the Department of Transportation, as 1 of the 11 dumpsites within the Fundy Region. This dumpsite was operable until approximately 1989, when Minister of Environment, Vaughan Blaney, closed the site. According to landowners, the site's closure and remediation were limited to trucking in fill and dumping it on top of the dumpsite, given that there were no regulations regarding what sort of material can be deposited into landfills, and how landfills should effectively be closed after use. DELG staff recommended testing Snow Brook on a regular basis, with a focus on trace metals, BTEX, phenols, cyanide, and hydrocarbons; however, budgeting constraints did not allow for these additional parameters, and this should be revisited in the future.

Turbidity, total dissolved solids, and total suspended solids remained high in comparison to other tributaries throughout the 2022 sampling season, and e. coli and total coliforms exceeded guidelines in July.

It is recommended that HRAA expand the water quality parameters for Snow Brook in 2023, as well as include this site in our fall electrofishing, to determine fish composition within this stressed tributary.

It is recommended that both Snow Brook and Prospect Brook remain on our water quality monitoring program in 2023, to better determine the potential source of these parameters.
