## Hammond River Angling Association

# GETTING HANDS- ON IN THE HAMMOND

PROJECT NUMBER  
220209

PREPARED FOR:  
NB ENVIRONMENTAL TRUST FUND

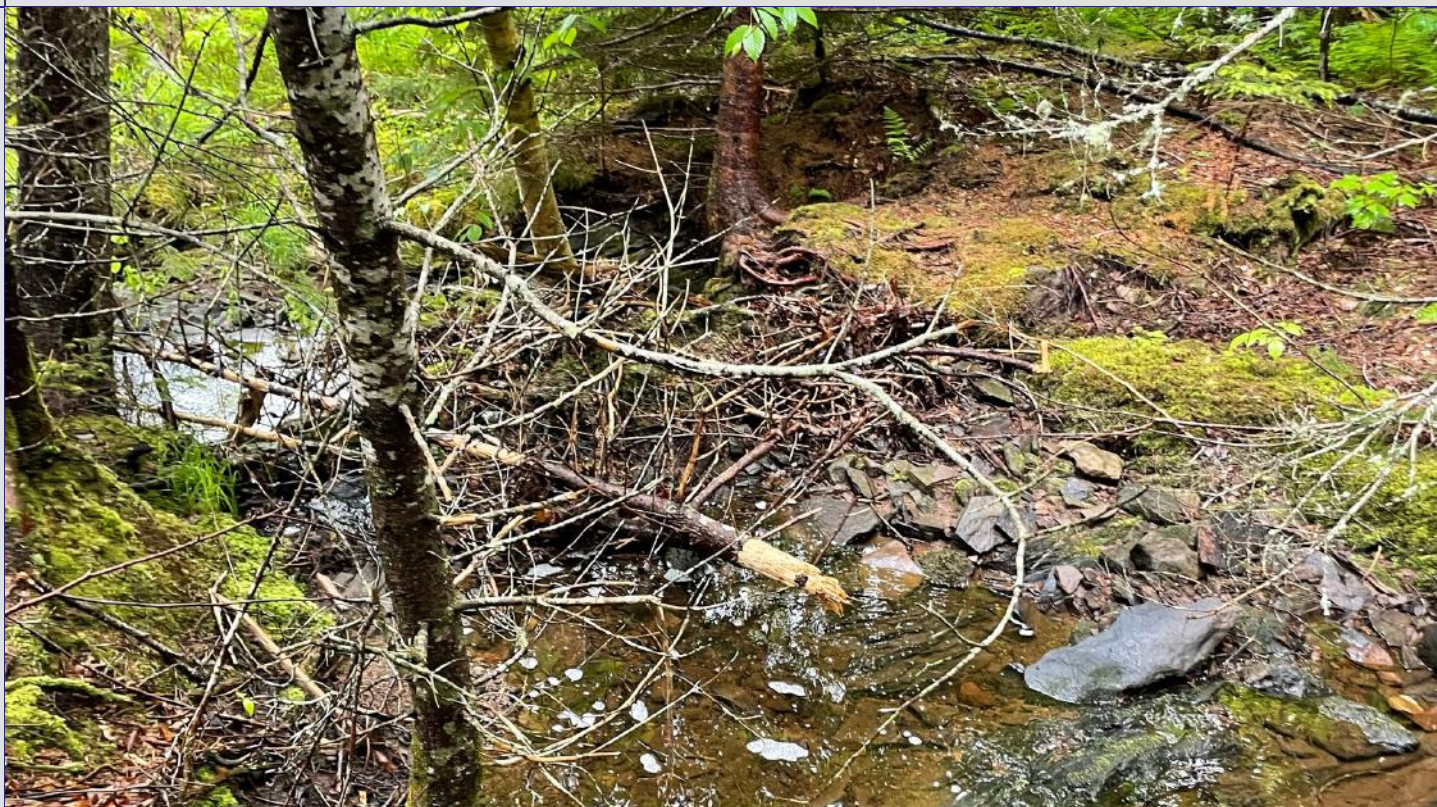
# Prospect Brook

In 2021, HRAA expanded our water quality dataset to include 6 new mountainous tributaries, with great success. These 6 new sites contained excellent water quality and were flowing into the main stem in known salmon spawning areas. In 2022, HRAA wanted to expand this mountainous dataset to include Prospect Brook- originally, we had anticipated that this brook would follow the trend of providing excellent thermal refugia and water quality to sustain salmonid populations; however, we were very surprised by our findings.

Located atop of Prospect Mountain near Smithtown, Prospect Brook ranked the third lowest tributary according to the Water Quality Index. Aluminum concentrations are above guidelines, with a seasonal average of 500 µg/L; iron average of 360 µg/L; and contains elevated levels of potassium and sulfate, and its peak e. coli levels reached 3,600 CFU/100mL. Turbidity levels reached a high of 203 FNU in August, with 202 mg/L of total suspended solids.

It is recommended that both Snow Brook and Prospect Brook remain on our water quality monitoring program in 2023, to better determine the potential source of these parameters.

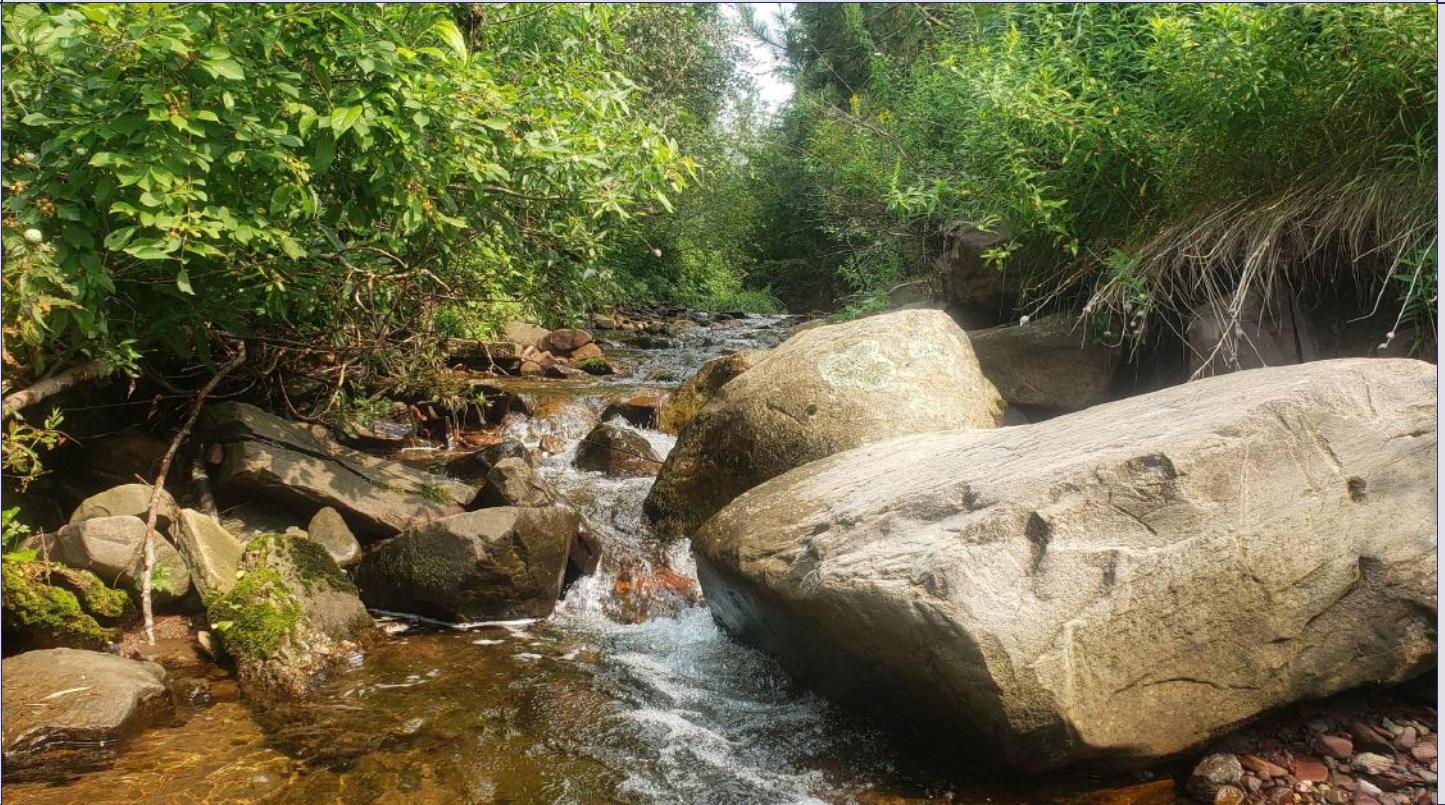
# O'Dell Brook

O'Dell Brook is a new addition to our water quality monitoring program as of 2021 and continuing in 2022. In 2021, O'Dell Brook ranked second highest within the watershed, with a ranking of "Excellent"- it maintains the second highest ranking; however, it has dipped slightly to "Good", as a result of lower dissolved oxygen content.

O'Dell Brook is a historic HRAA restoration site- it once completely lacked riparian buffer zone, and cattle were allowed free access into the brook, drastically increasing its nutrient loading. HRAA planted an abundance of willows and mountain ash, as well as installing fence posts and limiting cattle access- it has become one of the best examples of improved water quality as a result of HRAA's restoration efforts.

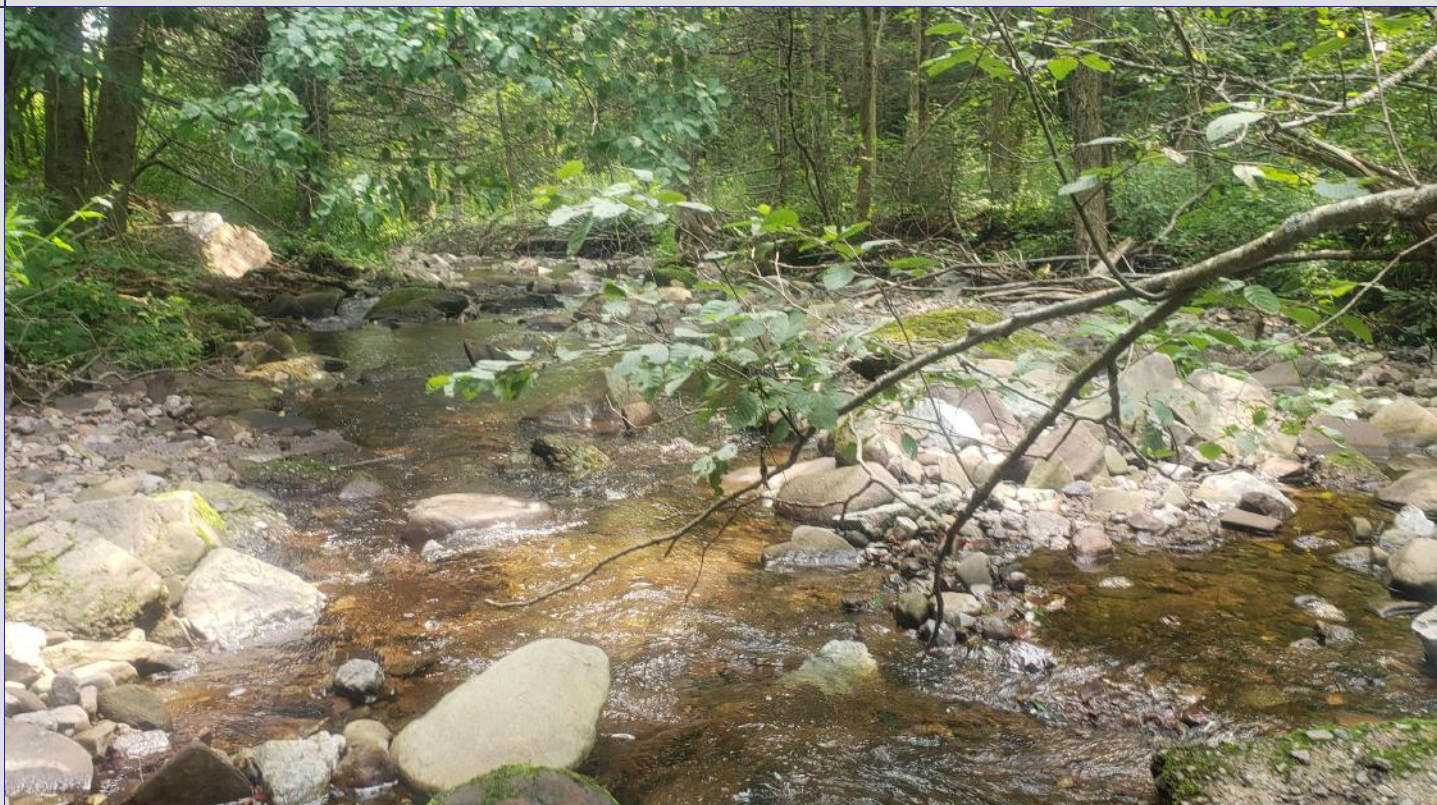
# McGonagle Brook

McGonagle Brook was formerly an index site for water quality monitoring in the late 1990's; however, it dropped off the program until 2021, and was included in the 2022 water sampling program. McGonagle Brook is yet another HRAA riparian restoration success story- in 2000, over 500 willows were planted along the lower reach of McGonagle Brook, and a fjord was installed to allow cattle crossing. These efforts assisted in decreasing the nutrient input into the brook.

In 2022, the McGonagle Brook confluence area was included in a riparian restoration effort, as the main stem and confluence point were experiencing erosion. Over 200 native trees and shrubs were planted along this stretch. McGonagle Brook was also included in the 2022 freshwater mussel survey; however, this brook did not yield any mussels.

Habitat assessments were performed in the upper reach of McGonagle Brook, as this area had been previously undocumented. HRAA staff surveyed approximately 850m of the upper stretch of McGonagle Brook- we noted that the culvert below Route 820 is degrading, and under low flow conditions will not allow fish passage- many brook trout were documented in the outflow pool. The upper portion of McGonagle Brook offers excellent salmonid habitat, and it is recommended to engage in conversations with the Department of Transportation to encourage them to consider an open span culvert or bridge when replacing/remediating the McGonagle Brook culvert in the future.

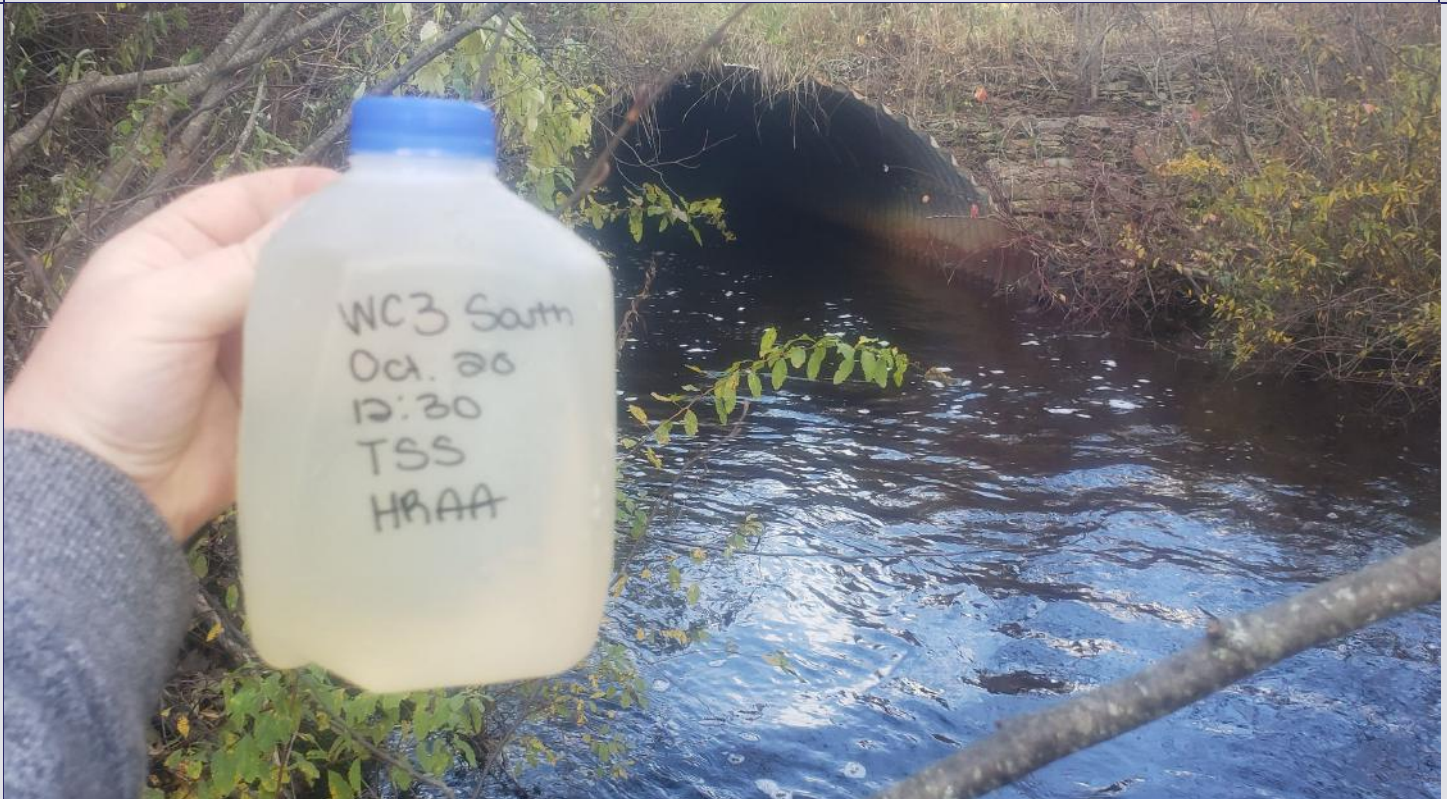
### TSS Site Comparison

As per conditions set out in the Environmental Impact Assessment, total suspended solids (TSS) in WC3S should not exceed 25 mg/L above the monthly average. Throughout the sampling season, the HRAA did not record any exceedances of TSS in WC3S, with the majority of the samples resulting in lower than detection limit. Similar to results in 2020 and 2021, WC3 East maintains the highest input of TSS; however, this is not as a result of project activities.

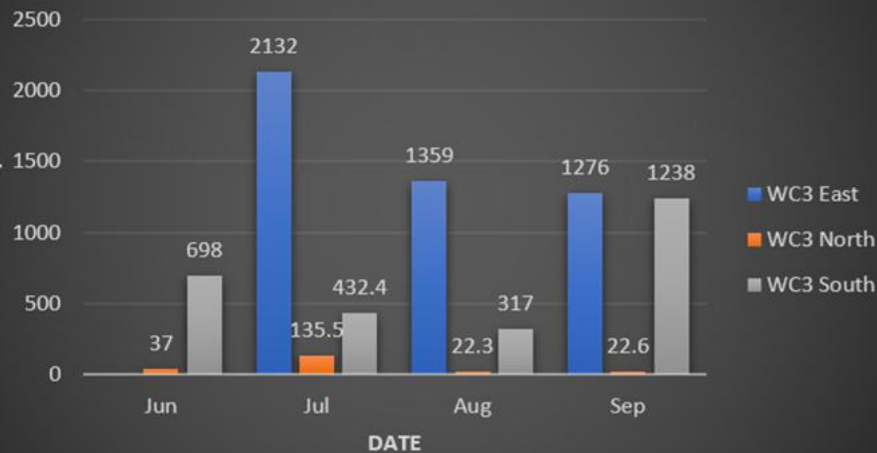
### Total Dissolved Solids Comparison

The types of rock and soil in an area will influence the conductivity of the water- rocks that break down more easily will raise conductivity. Given gypsum's brittle nature and its high mineral content, it is increasing the conductivity levels in comparison to WC3 North and WC3 East. WC3 South maintains a higher level of conductivity than the other 2 sampling sites, and this is due to its proximity (and potential groundwater influence) of the gypsum resource. One conductivity spike occurred in July in WC3 East due to heavy rainfall.

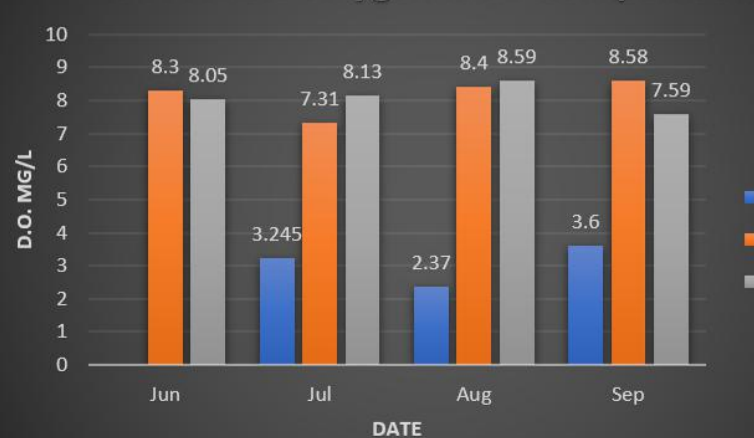
### Dissolved Oxygen Site Comparison

According to the Canadian Council of Ministers of the Environment, dissolved oxygen levels should be  $>9.5\text{mg/L}$  in freshwater to sustain early life stages of aquatic life and should be  $>6.5\text{mg/L}$  to sustain all other life stages of aquatic life. WC3 South was just below levels to support early life stages of aquatic life; however, our electrofishing survey disputes these results, given a high abundance of juvenile trout within the tributary. WC3 South and WC3 North both have excellent dissolved oxygen levels to support all other life stages of aquatic life.

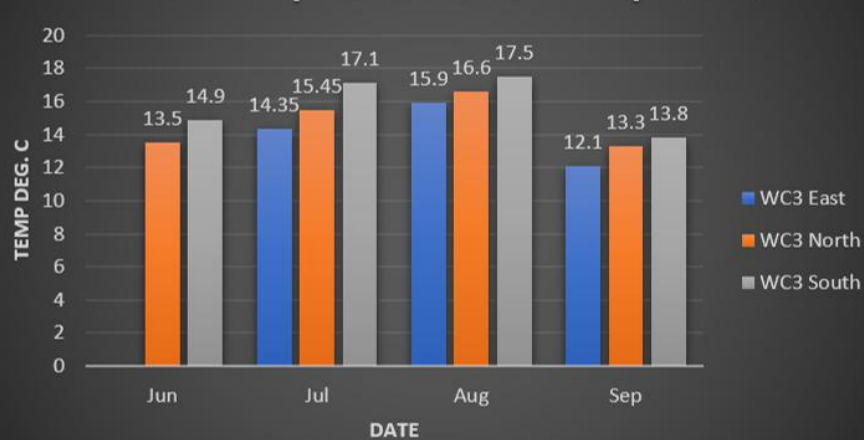
### Water Temperature Site Comparison

Water temperature was not included as a parameter in 2020 or 2021; however, we have determined that this is a critical parameter and will be included for the remainder of project life. WC3 South maintained the warmest water temperature throughout the sampling season in comparison to the 2 other sampling sites; however, the temperatures are low enough to support aquatic life, providing cold water refugia for juvenile trout.

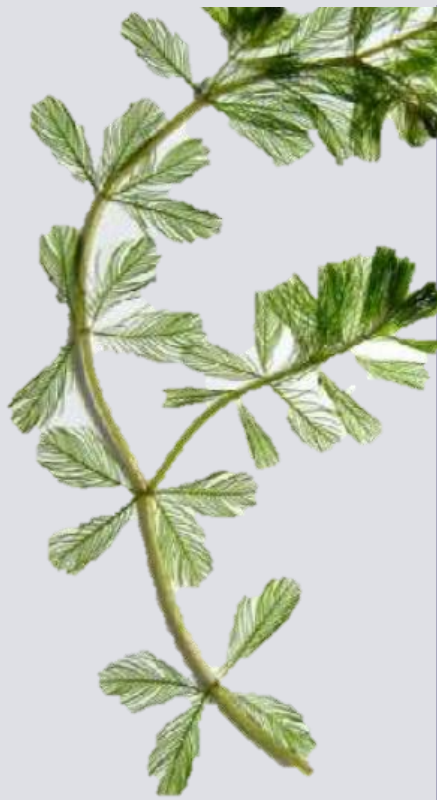
Invasive milfoil detected  
in Darlings Lake
