HAMMOND RIVER ANGLING ASSOCIATION

LAKE ASSESSMENT

FINAL REPORT PRESENTED TO:
THE NEW BRUNSWICK ENVIRONMENTAL TRUST FUND

2021

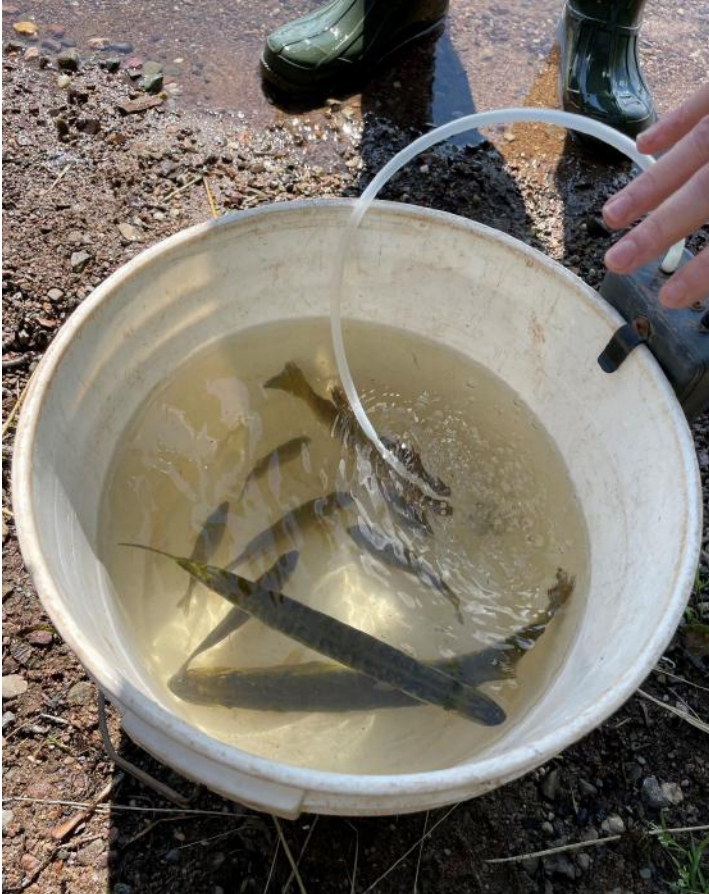
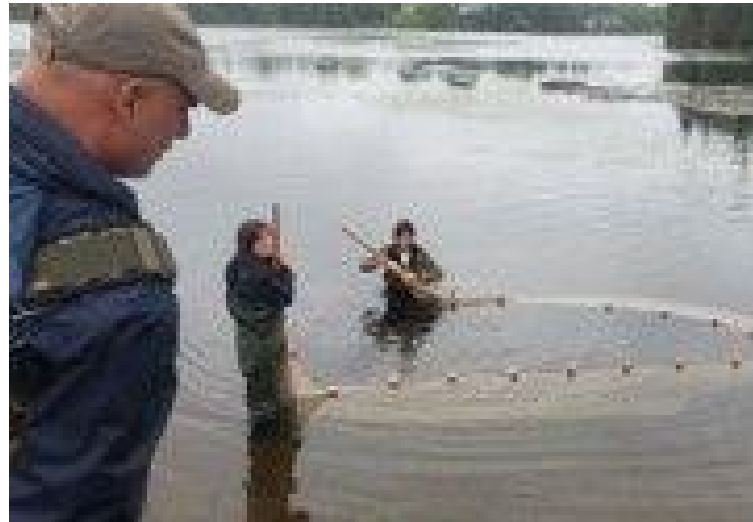
Beach Seining

The net, approximately 10m in length, is suspended between two large, wooden poles. The net hangs horizontally in the water with weights added to the bottom side, and floatation buoys attached to the top side. These buoys will ensure that the top has buoyancy, while the weights will ensure that the bottom part of the net can sufficiently drag along the bottom of the waterway.

One field staff remains in the shallows near the shore, with the pole being pressed into the ground on a slight angle. A second staff member takes the other pole and walks out to the desired depth with the pole. In order to achieve a similar effort between sites, we seined for a total of three minutes, whereby both pole carriers walk together perpendicular to the shore and keeping the poles as close to the bottom of the water as possible. Once the three minutes have passed, the person in the deeper water will swing in to meet the person in the shallows in a semi-circular arch, bringing the poles together in the shallows. Caution is used to ensure that the weights drag slowly across the bottom of the water, ensuring no fish escape while the seine net is being closed.

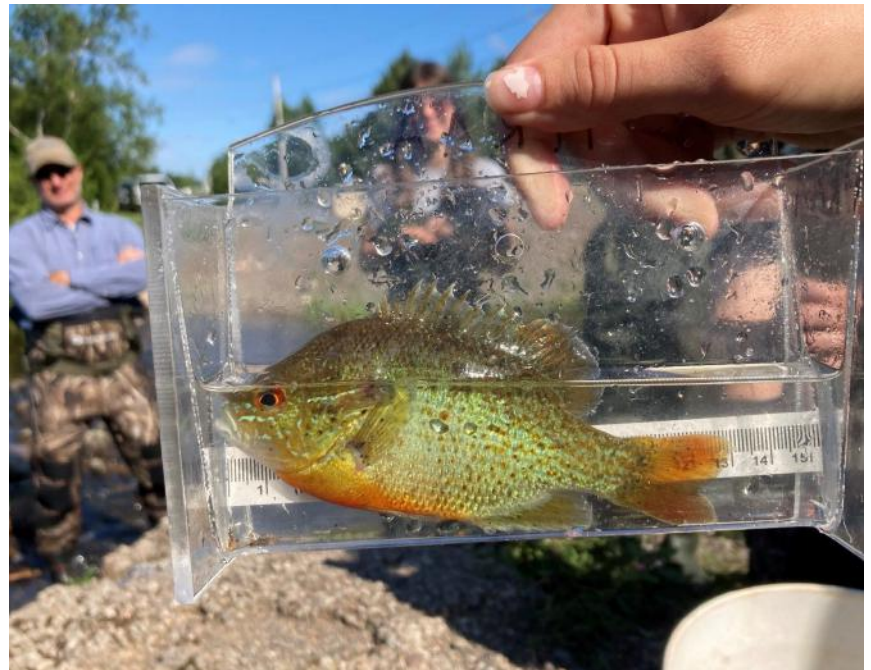
Fyke Netting

A fyke net is comprised of three main parts- the funnel and side wings. The fyke net must have a live box at its downstream termination and tended at least once every 24hrs, and if it does not have live box, it must be checked hourly. The fyke net deployed in the Lake Survey had a live box at the downstream end, and its net length was 3.7m long with two 6m wings. Each wing and the downstream end are secured into the ground with a long piece of rebar, and the fyke net is set perpendicular to the shore.

Staff set up the fyke nets on the first day, and signs were posted along the shore, notifying the public that a net was placed in the water. The fyke nets also had identification tags secured on the shallow wing, to notify any governmental agencies of our permit to be performing this work. Staff returned the following day to check on the fykenets- the rebar is removed from the downstream end, allowing staff to carefully remove any fish that were caught in the live box.

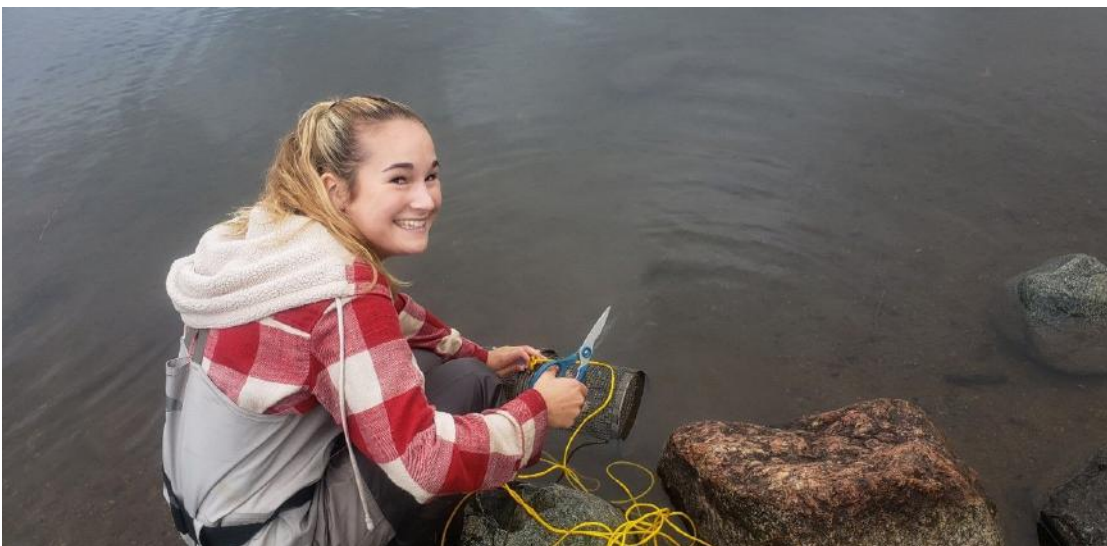
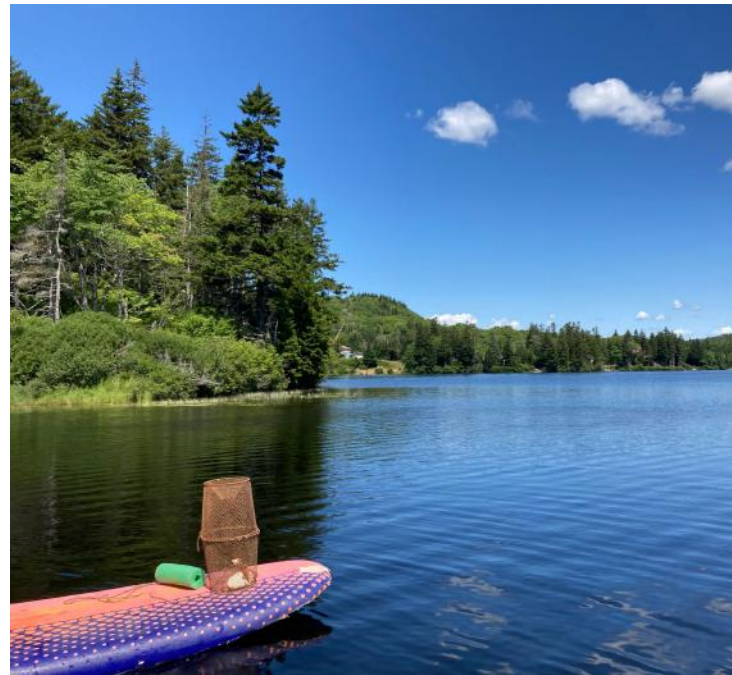
Minnow Traps

In order to ensure that no undue stress is placed on the fish, staff begin by testing the water temperature. Provided that the water temperature is $<22^{\circ}\text{C}$, staff will begin to set up the minnow traps. ACAP Saint John provided the HRAA with several sets of minnow traps. The traps were built out of metal mesh conical wastebaskets, in which a 2" diameter hole is cut into the bottom of each wastebasket, and the metal is pushed inwards, to create a funnel. Each wastebasket is then zip tied to a second wastebasket, creating a trap that has two entrances, but no exits. Before the trap is closed, bait is placed into the trap. Staff then attached a rope with a colorful buoy and tied the rope onto the trap. At the beginning of each lake assessment, some of the minnow traps were thrown into the lake from shore and others were deployed in the middle of the lake via kayak. At the end of each lake assessment (approximately 2-3 hours later), the minnow traps were retrieved. Fish were counted, measured, and then the zip ties that were holding the two wastebaskets were cut to allow the fish to be returned to the water.

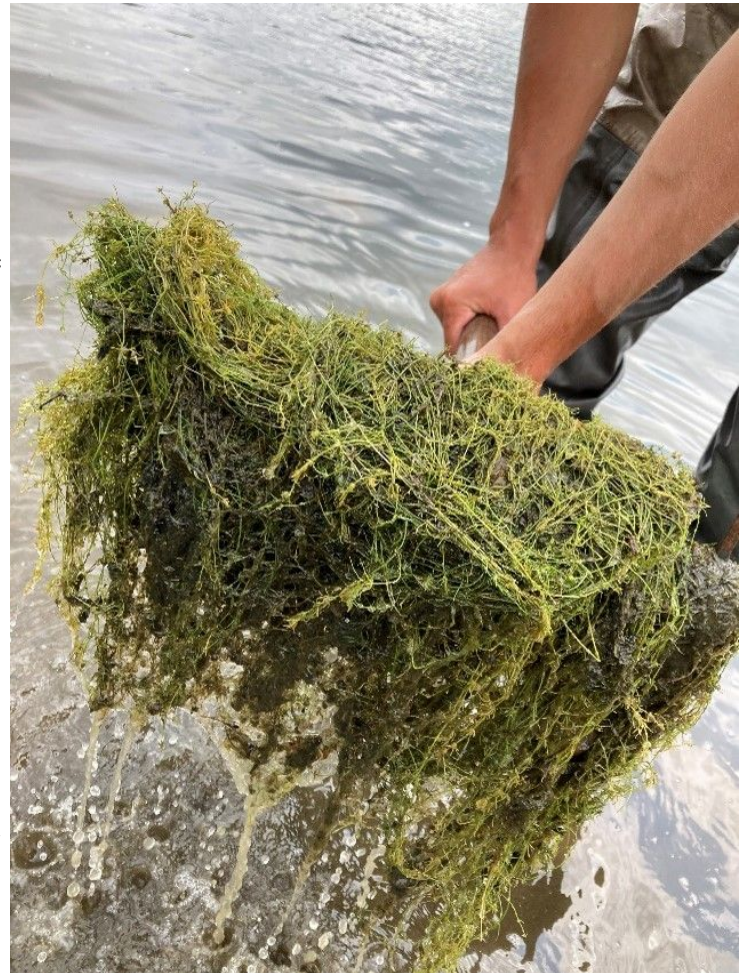
Table 1 Definitions and examples of indices used to measure submersed aquatic vegetation with a rake

Staff then examine the contents of the rake and begin to identify the type of aquatic plants that have been collected. This also provides an excellent opportunity to document any aquatic invasive species.

Once the aquatic plants have been identified, staff then tally up the number of species present in the waterbody. This allows for data collection on presence of species found at a site during raking; frequency of occurrence, and density ranking of each species found. The data collected assists with the overall understanding of the lake health, as macrophytes are important for fish and macroinvertebrate habitat; produce dissolved oxygen; and provide food for aquatic life.

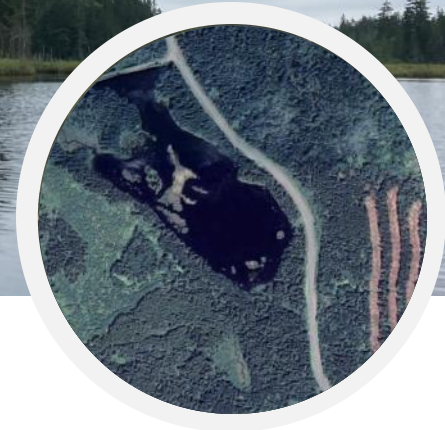
Tracy Lake contains an abundance of aquatic vegetation, woody debris, and high beaver presence. The outflow of Tracy Lake contains a severely degraded culvert which is 100% obstructed due to beaver presence.

In the summer of 2020, HRAA field crews encountered a J.D. Irving Ltd worker who was installing a significantly smaller culvert. It was reported that the access road to a wood lot beyond Tracy Lake is repeatedly washed out due to the beavers and the degraded culvert. It is HRAA's belief that the culvert remediation that occurred on the access road is not sufficient (albeit a temporary solution to redirect water flow under the road). This may impact fish access to and from Tracy Lake into Isaac Brook, and the HRAA ranked this as a high priority for future outreach and landowner engagement during the *2020 Culvert Assessment*.

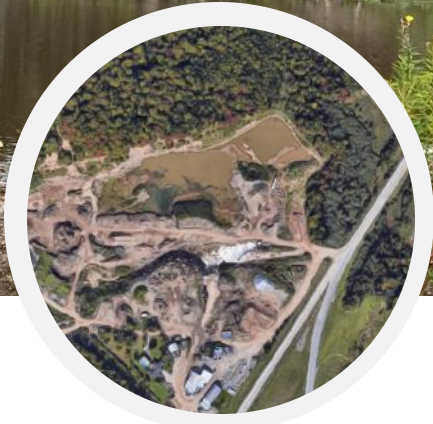
It is unclear if this lake has ever been stocked, but it is doubtful that this lake provides acceptable fish habitat. Given surrounding industrial activity, it is recommended that HRAA include an extremely vigorous water quality sampling program, including organic and inorganic parameters, and expanding to include microplastics, BTEX and hydrocarbons. There is a large amount of lumber (organic) debris in the lake; however, there are multiple long lengths of plastic pipe, roofing shingles, metal, and other sorts of garbage in the lake.

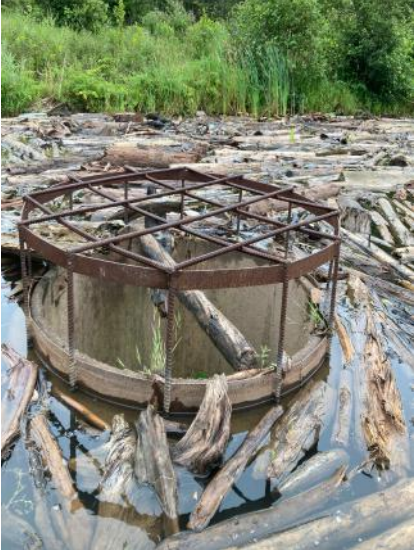
Renforth Pit Lake
45.430417, -65.925145

The steep slope along the northern bank is experiencing a fair degree of erosion, and heavy rain events are depositing high levels of sediment into the lake. There is minimal vegetation surrounding the lake's edges, and summer water temperatures are high due to lack of crown closure and shade.
