***Maintaining
Water Quality Data
While Adapting To
Climate Change***

**Final Report # 210115
Presented to the
New Brunswick Environmental Trust Fund
On Behalf of the Hammond River Angling Association
S. Blenis & J. Kelly**

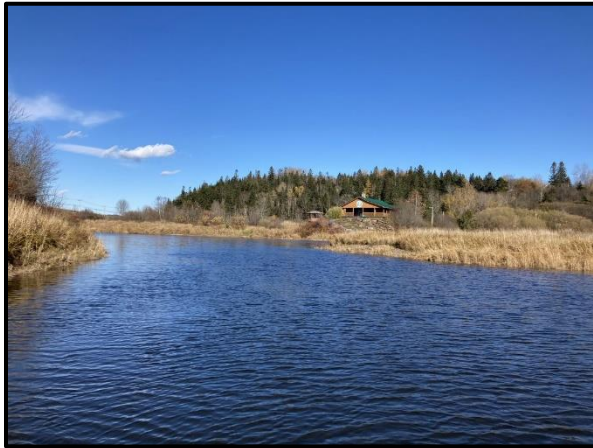
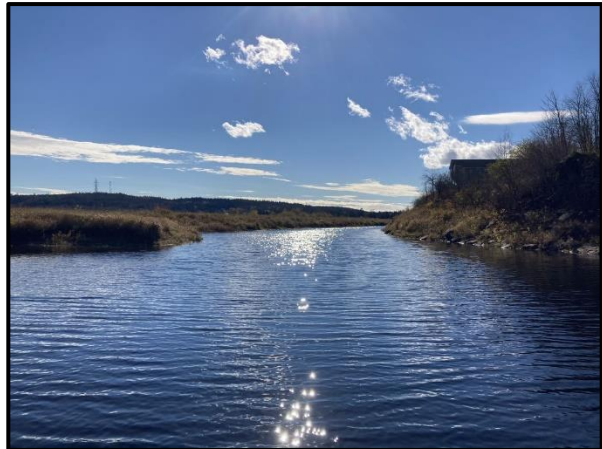
The Palmer Brook sub-catchment is located in the lower reaches of the Hammond River watershed and is 19.5 km² in size. This sub-catchment is the most highly developed in the watershed; land use in this area consists of the Hampton highway (Route 1), the Trans-Canada Highway, commercial and residential development, open gravel pits, a sewage field for the municipality of Quispamsis, some crop land and fallow pasture (Bradford, 2015). Land management issues in this area have typically consisted of eroding banks and heavy sedimentation (Campbell and Prosser, 2008). These issues are still occurring to date and are mostly attributed to the density of development in the area, as the riparian zone appears largely intact (99.9% undeveloped). Tidal influx is known to cause stagnant water in the Palmer Brook confluence zone resulting in a grease-like film on the water surface. It is the widest and deepest confluence zone documented in 2021.

Photo 4 (left): Palmer Brook Confluence, looking downstream to the main stem. **Photo 5** (right): Palmer Brook Confluence, looking upstream from the main stem. *Photos: J. Kelly*

Currently, fallow pasture which is prone to seasonal flooding and is adjacent the lowest 250 m of Palmer Brook is undergoing revegetation efforts, with 1108 native shrubs planted in the riparian zone in 2021. This area is known to contain a spring fed cool water source and holding pools and provides significant habitat for striped bass, American eel, brook trout and nesting salmon. The Palmer Brook confluence zone is the most critical migratory holding pool for Atlantic salmon within the watershed.

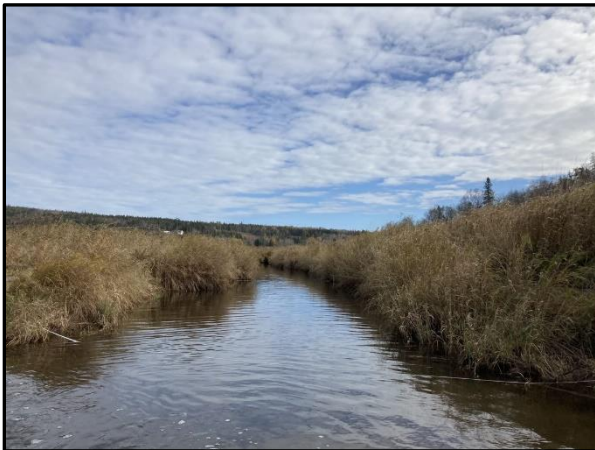
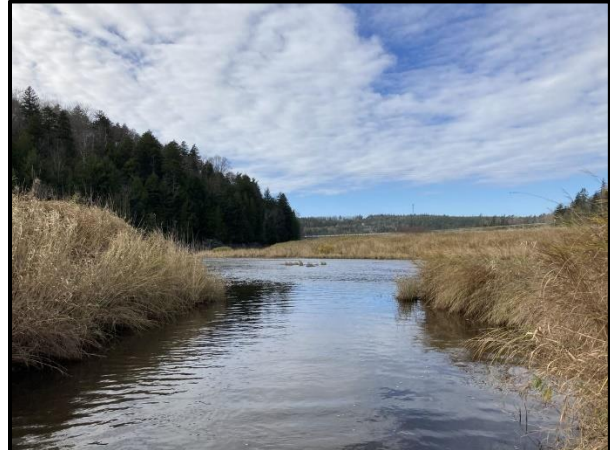
Stream cover at the Bradley Brook confluence zone is minimal, as a result of years of agriculture. This leads to poor shade, and higher water temperatures in the peak summer months. During heavy rainfall events, there is high levels of sedimentation occurring in the confluence zone, and the water color appears very tannin and murky, particularly in comparison with other confluence zone sites. Substrate is significantly embedded (80%) at this site, and mainly compromised of sand and fines, and does not provide ideal fish habitat.

Photo 6 (left): Bradley Brook Confluence looking upstream from the main stem. **Photo 7** (right): Bradley Brook Confluence looking downstream to the main stem. *Photos: J. Kelly.*

While Bradley Brook Confluence contained higher levels of alkalinity and hardness, indicating that the confluence zone may adapt to changes in pH and provide suitable water quality for aquatic species, this site historically contains higher concentrations of iron, copper, and potassium, and this was confirmed again in 2021. 2021 also recorded higher levels of chloride and sulfate, with a spike in August recording 17mg/L of sulfate- the highest level for all confluence zones in 2021.

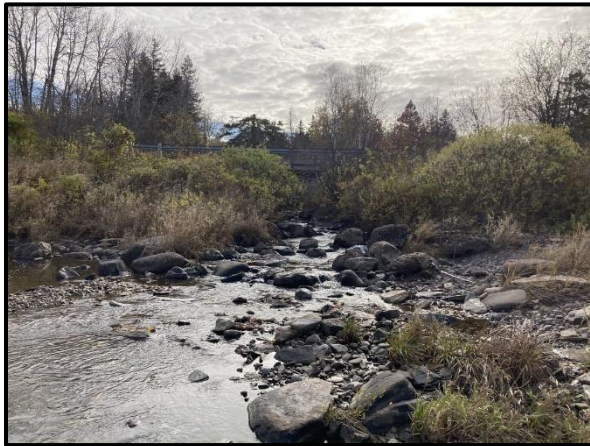
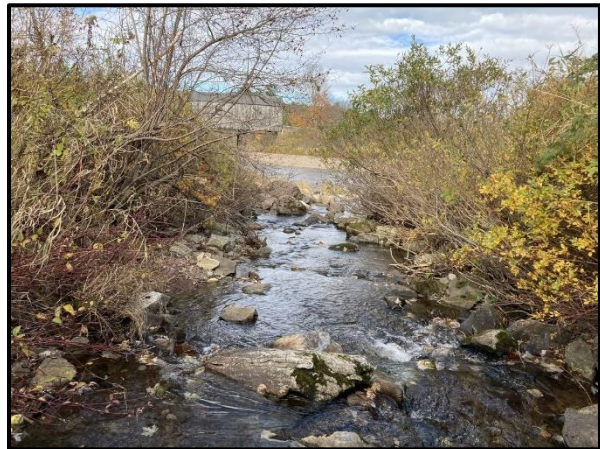
Brawley Brook confluence area contains dense shrub and tree canopy, providing excellent shade to the brook. Its dissolved oxygen contents remained at acceptable levels (9.5 mg/L to maintain early life stages and 6.5 mg/L to maintain other life stages) throughout the sampling period. The confluence area offers a mix of substrate with a low embedded score (<20%), providing excellent fish habitat.

Photo 8 (left): View of Bradley Brook confluence point from the main stem. **Photo 9** (right): View from Bradley Brook looking downstream towards the main stem. *Photos: J. Kelly*

Sodium, sulfate, and chloride were high in comparison to other confluence zones; however, it is anticipated that this is a result from road salts entering the watercourse from the bridge that crosses Brawley Brook at the confluence point. Bacterial levels were consistently below guideline levels throughout the sampling period; however, *E. coli* levels were slightly higher in the confluence zone than in the index site, with a seasonal average of 60 cfu/100mL versus 20 cfu/100mL respectively.

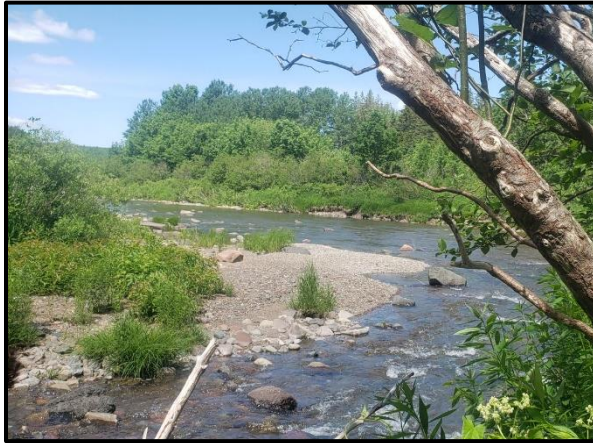
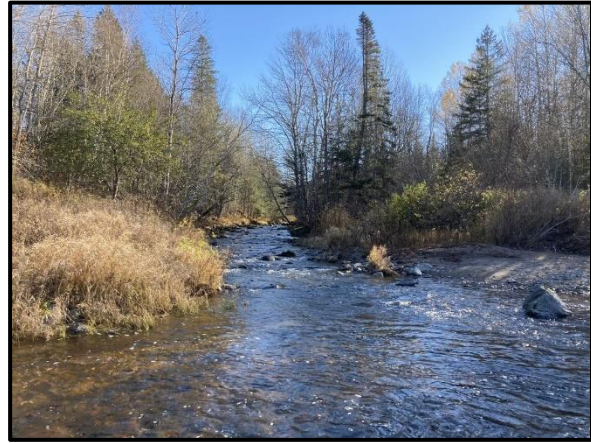
Photo 10 (left): View downstream from South Stream at the confluence, looking at the main stem. **Photo 11** (right): View from the river, looking upstream of South Stream confluence. *Photos: S. Blenis & J. Kelly*

During stream habitat assessments in 2020, HRAA staff documented a high density of livestock having unfettered access to South Stream, below the index sampling site. South Stream, in part, was the original inspiration for creating *Maintaining Water Quality Data While Adapting to Climate Change*- we recognized that we did not have up to date data (and, in some cases such as South Stream, almost no data) on confluence points.

Our suspicions of potential bacterial excess in the watercourse were confirmed with water quality sampling in 2021- *E. coli* spiked in June, with levels reaching 1340 cfu/100mL, over three times higher than guideline limits. Dissolved oxygen and phosphorus levels failed 75% of the tests run through the water quality index calculator, and the South Stream confluence area could be classified as eutrophic, with high levels of macrophyte coverage and substrate embeddedness.

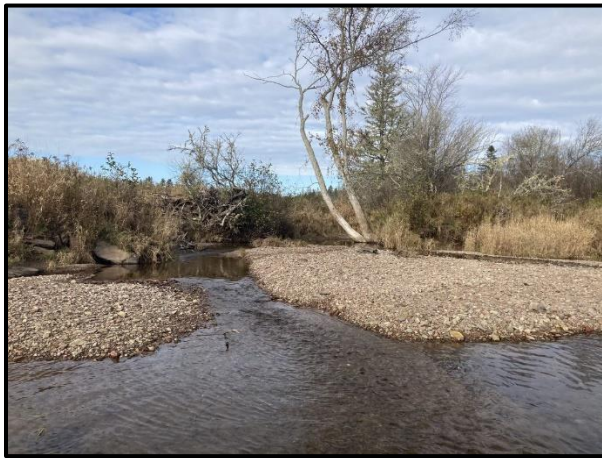
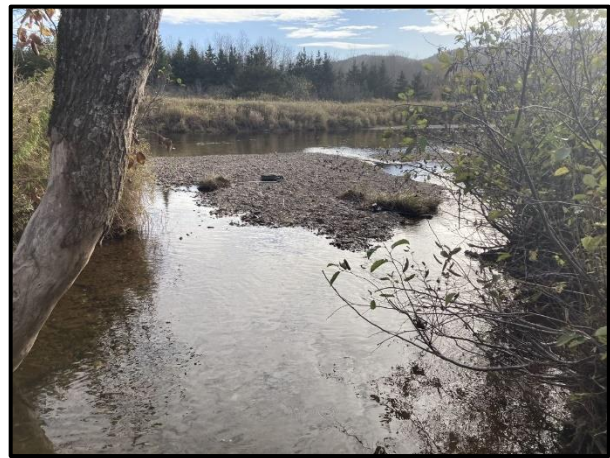
Photo 12 (left): View from the Hammond River, looking upstream of the Scoodic Brook confluence. **Photo 13** (right): View from Scoodic Brook, looking downstream to the Hammond River. *Photos: S. Blenis & J. Kelly*

The flow type changes drastically throughout the sampling period, from riffle (50%) and run (50%) to include many stagnant pools caused by low water levels and exposed substrate in the peak summer months. Aluminum levels, as well as phosphate, nitrogen, and turbidity, are above acceptable levels for the protection of aquatic life. The site transitions from oligotrophic to mesotrophic during the July and September measurements and this periodic transition most likely causes the prevalent algal film on the substrate. This site has been the focal point for 2 consecutive years for sampling for the presence of potentially toxic cyanobacterial benthic mats; however, we are still awaiting results from the samples collected.

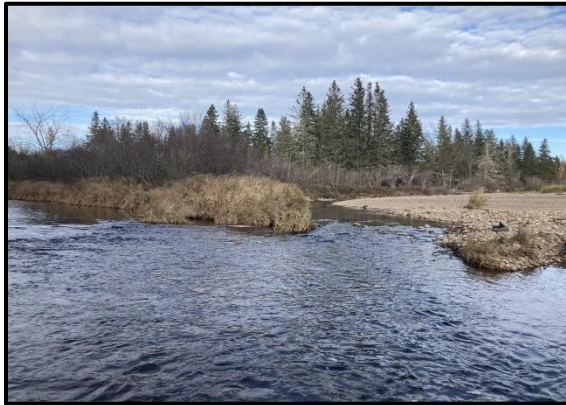
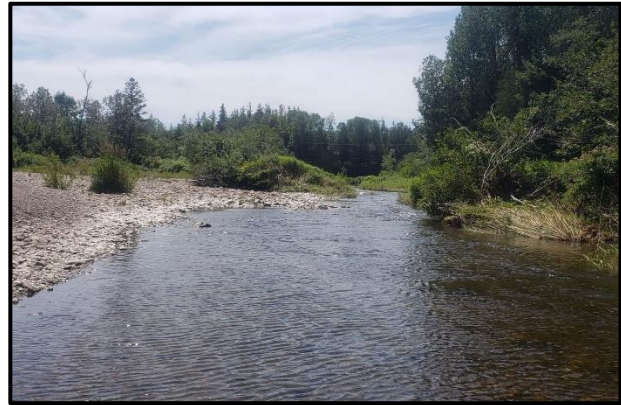
The confluence sampling site is located approximately 600m downstream of the confluence point of Porter Brook- in 2008, it was determined that the habitat within Porter Brook was insufficient to maintain aquatic life given its exceptionally high concentrations of cadmium, iron, and aluminum. Porter Brook could potentially have a negative impact on the Hanford Brook confluence area; however, the Hanford Brook confluence site was the highest-ranking confluence site on the water quality index in 2021.

Photo 14 (left): View of Hanford Brook confluence, looking upstream from the main stem river. **Photo 15** (right): From Hanford Brook confluence, looking downstream towards the river. *Photos: S. Blenis & J. Kelly.*

While the majority of the water quality samples were within acceptable limits (or below detection limits) for the protection of aquatic life, a major spike occurred in September's results. Copper, which has a guideline limit of 2-4 $\mu\text{g/L}$ (depending on hardness), spiked to 37 $\mu\text{g/L}$ or 9x the acceptable limit. Fluoride, which has a guideline limit of 120 $\mu\text{g/L}$ spiked to 60,000 $\mu\text{g/L}$ in September, or 500x the acceptable limit. Lead, which has a guideline limit of 1-7 $\mu\text{g/L}$ (based on hardness), spiked to 132 $\mu\text{g/L}$ or 18x the acceptable limit. While this decreased the overall water quality index score, these higher levels were not sustained throughout the sampling season and would not have resulted in long term exposure on aquatic life.

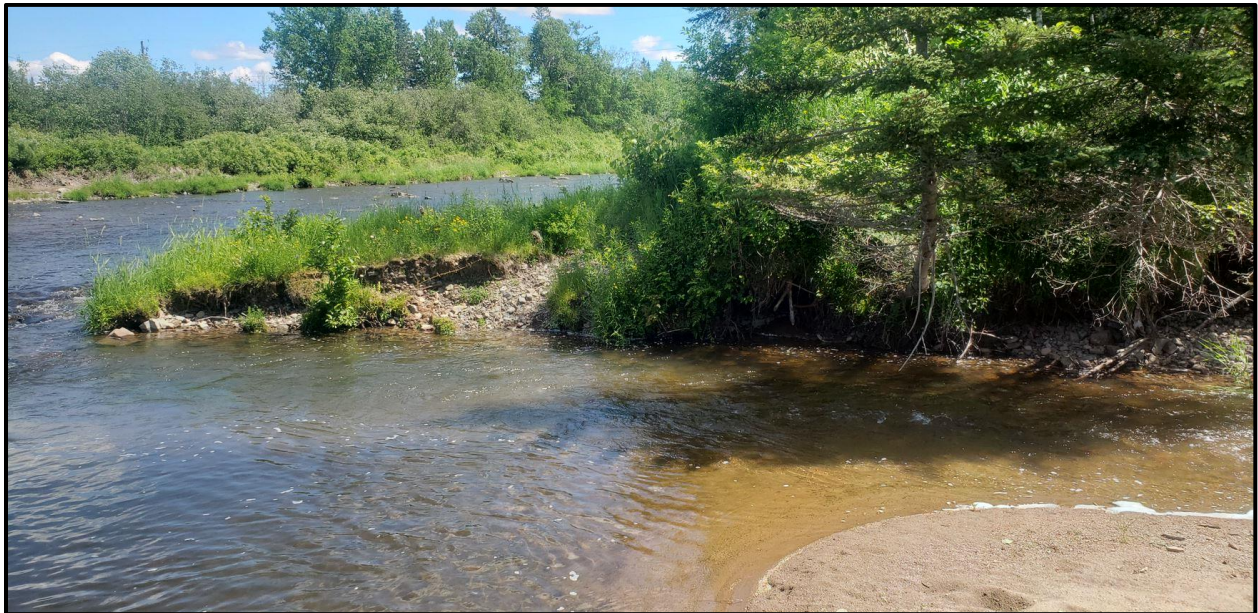
Photo 16: Germaine Brook confluence, with the main stem river in the background. Note the sand bar and fines deposited in the mouth of the confluence point. *Photo: S. Blenis.*

Germaine Brook confluence experienced similar spikes of copper, fluoride, iron, and lead in September, similar to Hanford Brook. Given the close proximity of these tributaries, it is probable that they share similar geologic makeup. Germaine Brook confluence received a decent water quality index score of 83.3, or “Good”, erosion is having an impact on turbidity and total suspended solids, and the degrading riparian zone has been having a negative impact on fish habitat. This site needs to be given top priority for future riparian restoration initiatives in order to (hopefully) restore its salmon spawning and juvenile habitat.

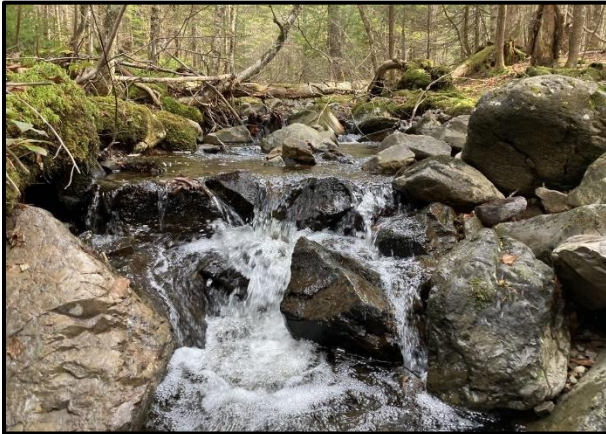
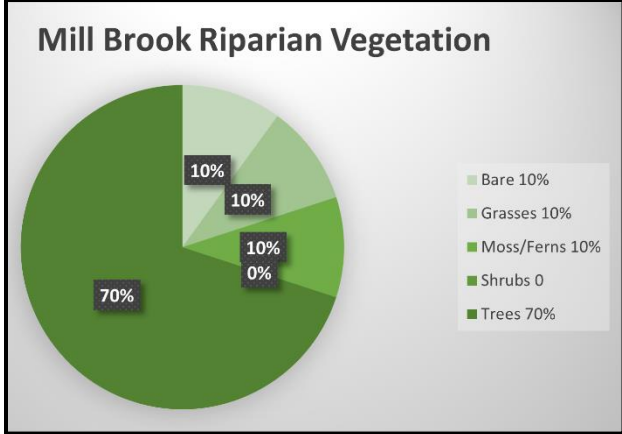
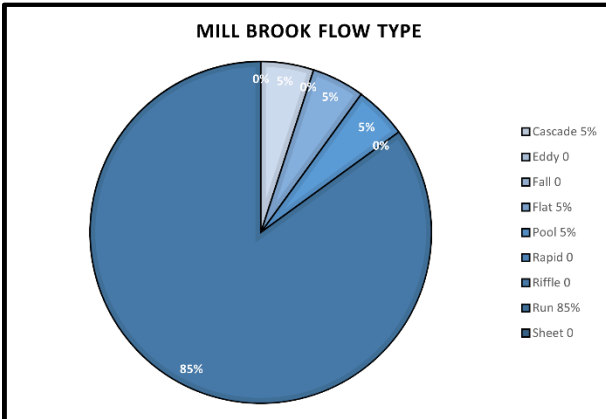
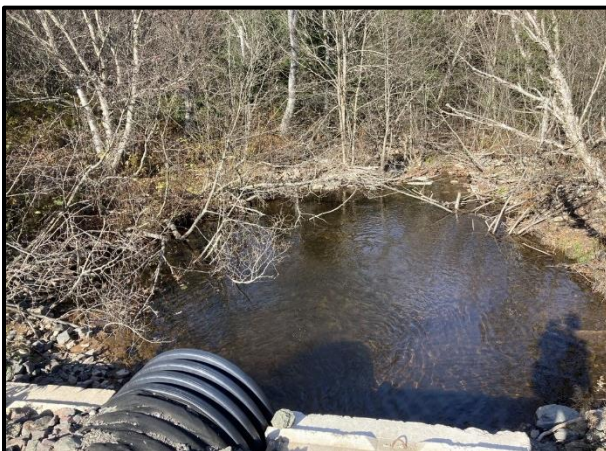
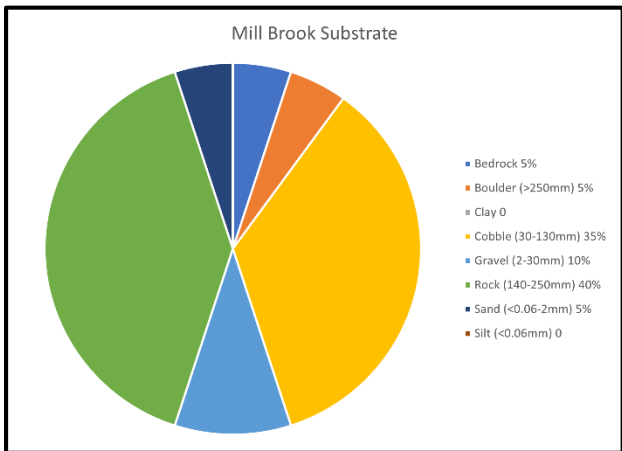
Photo 17 (top left): Upper reach of Mill Brook survey. **Figure 8** (top right): Riparian vegetation. **Figure 9** (middle left): Flow Type. **Photo 18** (middle right): Middle of Mill Brook. **Photo 19** (bottom left): Sampling site for Mill Brook. **Figure 10** (bottom right): Substrate Types. Brook trout and bait fish (minnows, dace, sculpin) were observed in the culvert outflow pool throughout the 2021 season- culvert provides fish passage, with some angling occurring at the outflow pool. *Photos: J. Kelly. Figures: S. Blenis.*

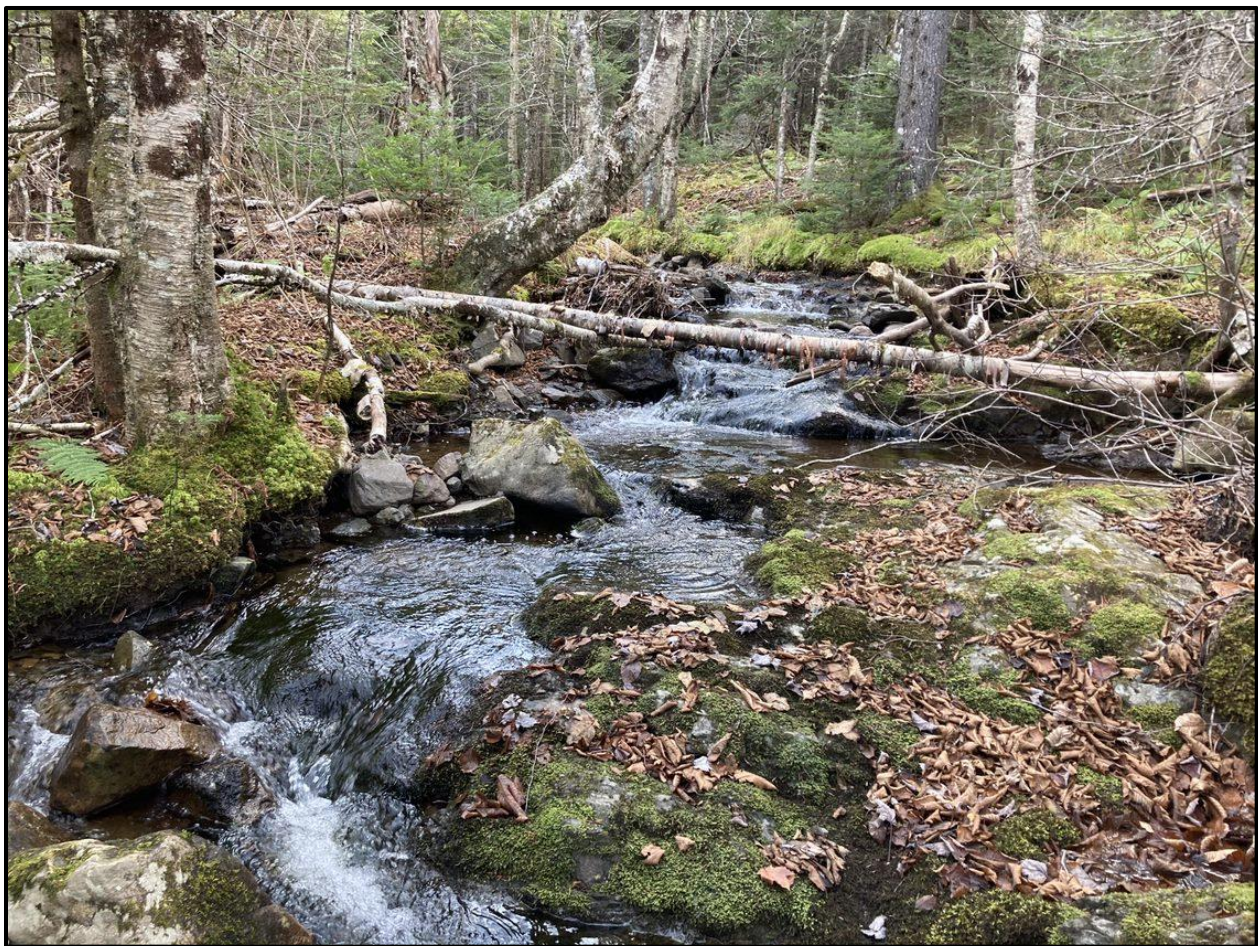
Bank Characteristic	Left Bank	Right Bank
Forest Maturity	Mature	Mature
Slope	High	High
Overhanging Vegetation	50%	50%
Undercutting	5%	5%
Shade	45%	45%
Stable	40%	40%
Bare Stable	5%	5%
Eroding	5%	5%

Map 3 (top left): LiDAR imaging, demonstrating the valley that Mill Brook passes through before reaching the main stem. **Figure 11** (top right): Bank Characteristics. **Photo 20** (bottom center): Mill Brook below the sampling site. Substrate embeddedness was <20% embedded.

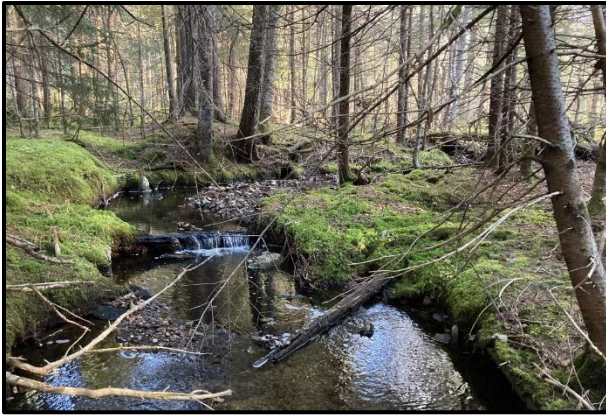
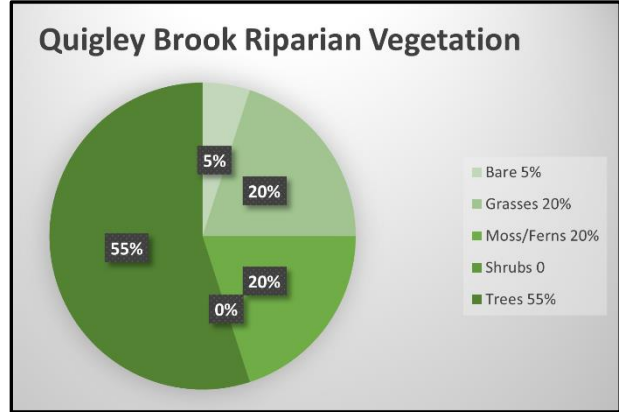
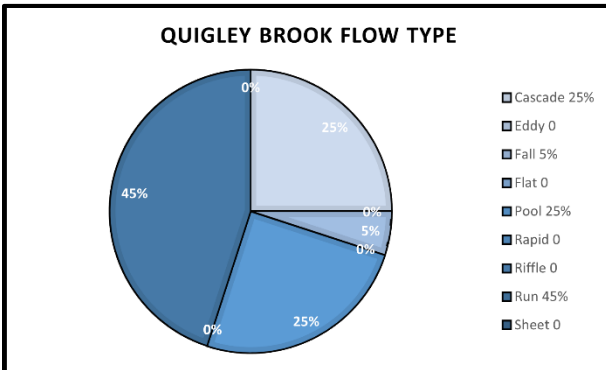
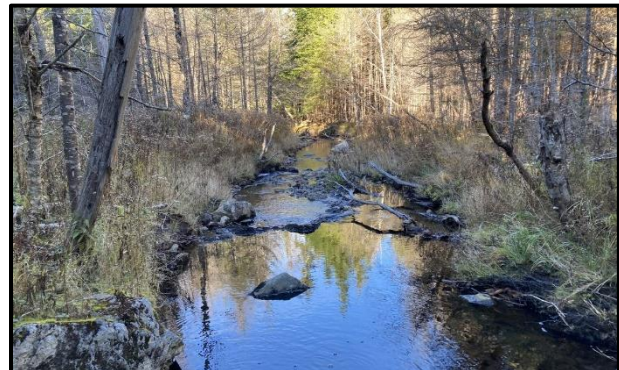
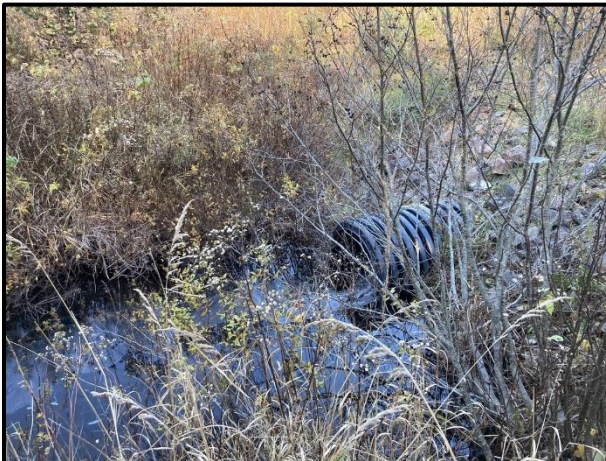
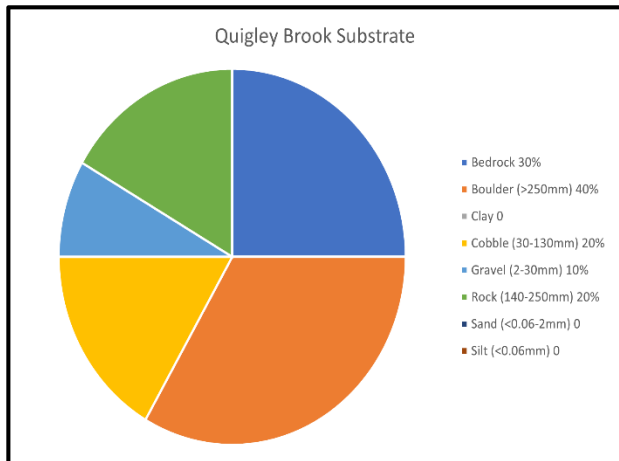
Photo 21 (top left): Upstream of the sampling site. **Figure 12** (top right): Riparian vegetation. **Figure 13** (middle left): Flow type. **Photo 22** (middle right): Downstream of the sampling site. **Photo 23** (bottom left): The sampling site at the culvert outflow. **Figure 14** (bottom right): Substrate. Brook trout were observed in the culvert outflow pool throughout the 2021 sampling season. Culvert allows fish passage. *Photos: J. Kelly, S. Blenis. Figures: S. Blenis.*

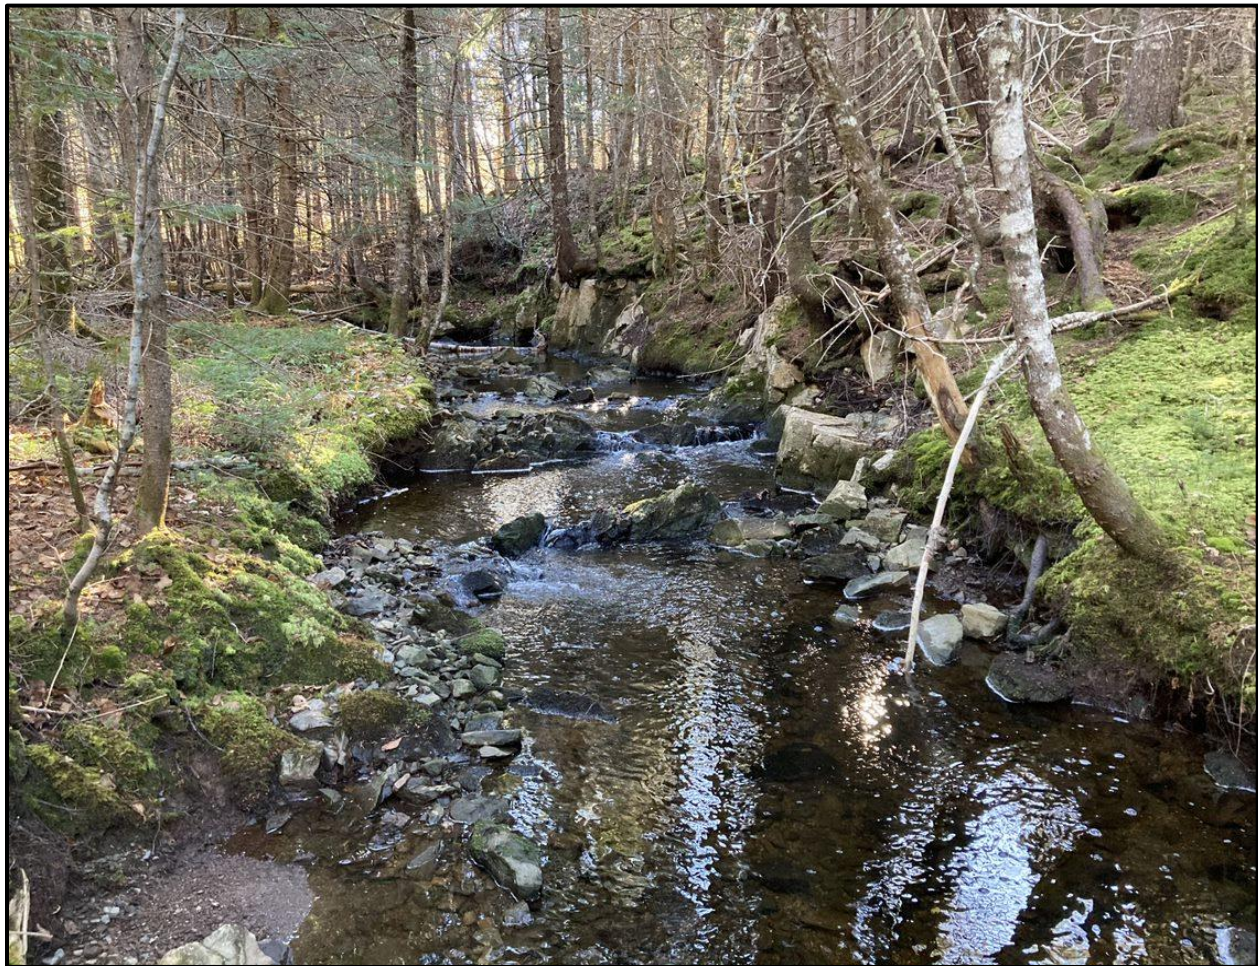
Map 4 (top left): LiDAR imaging of Quigley Brook. **Figure 15** (top right): Bank characteristics. **Photo 24** (bottom center): Quigley Brook below the sampling site. Steep slopes, excellent riparian coverage, and substrate is <20% embedded. Undercut banks make for excellent fish habitat, while the cascades allow for excellent dissolved oxygen.

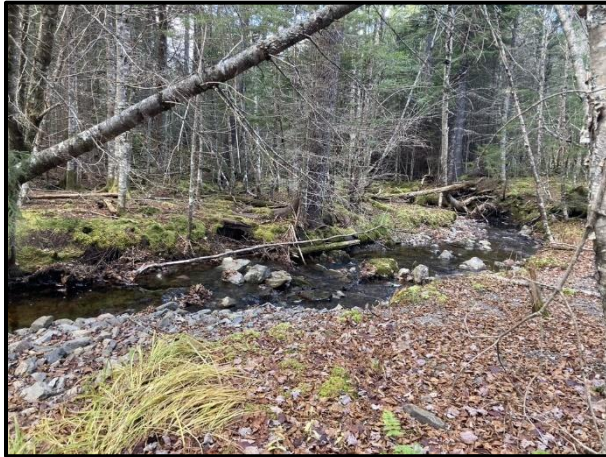
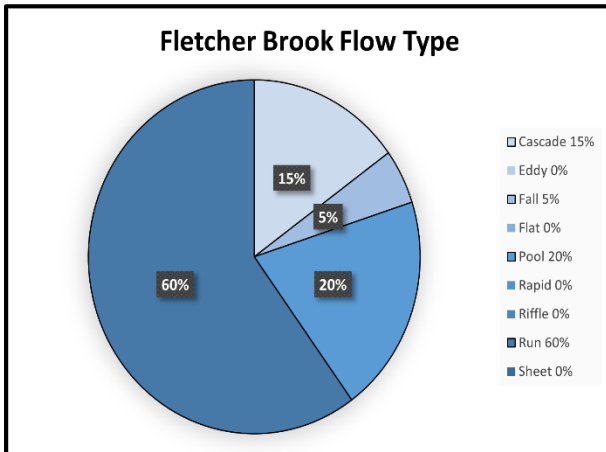
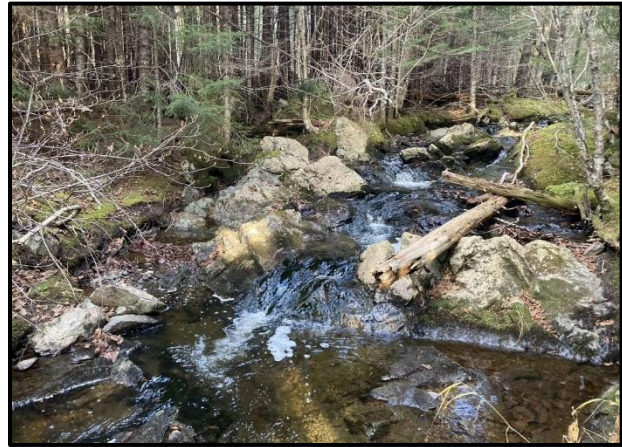
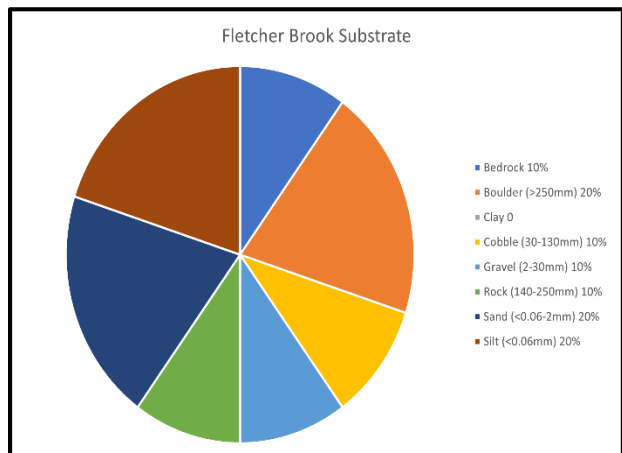
Photo 25 (top left): Upstream of the sampling site. **Figure 16** (top right): Riparian vegetation. **Figure 17** (middle left): Flow type. **Photo 26** (middle right): Downstream of the sampling site. **Photo 27** (bottom left): The sampling site at culvert outflow. **Figure 18** (bottom right): Substrate type. Brook trout were observed throughout the sampling season at the culvert outflow pool. Culvert allows fish passage.

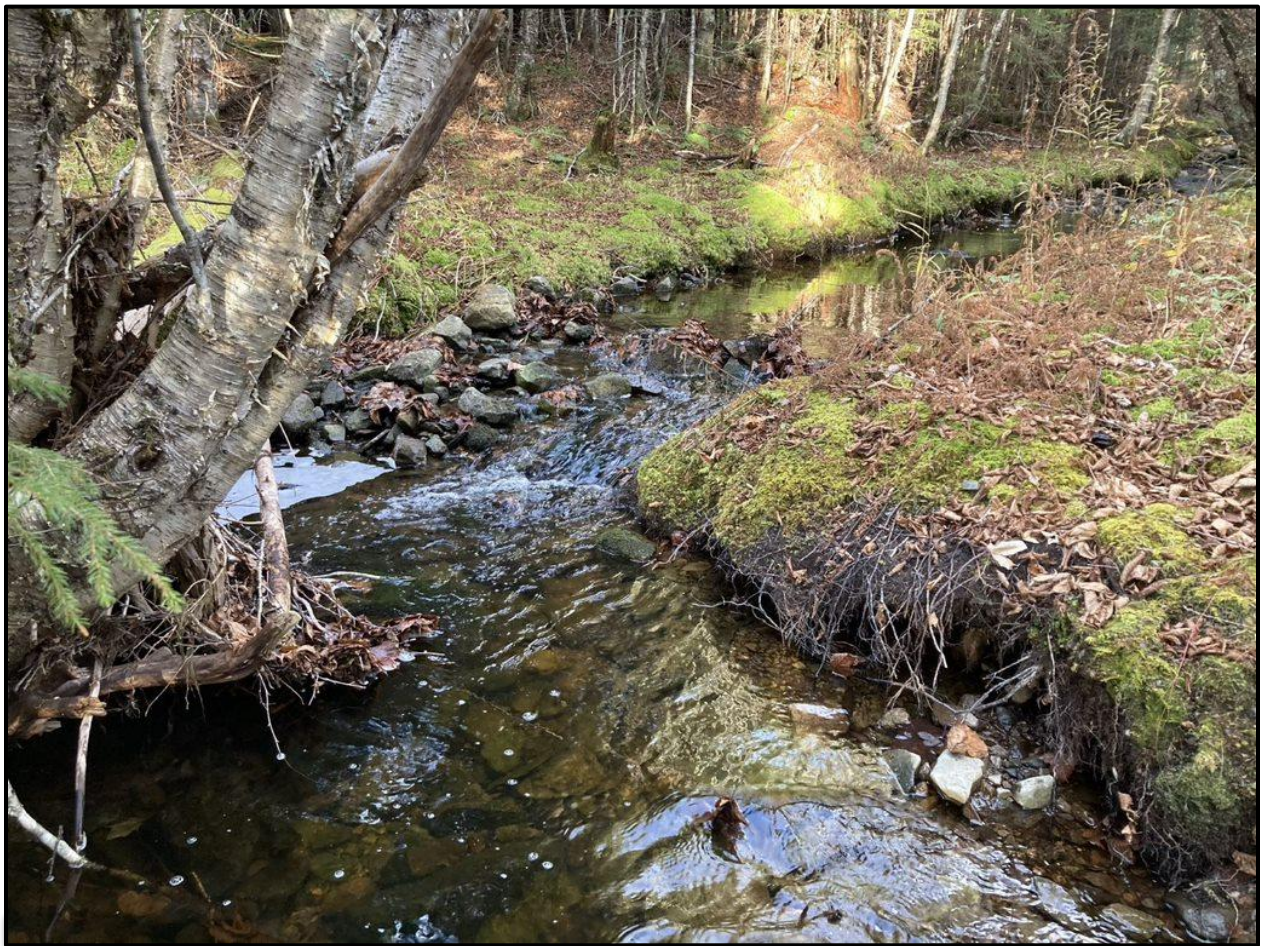
Bank Characteristic	Left Bank	Right Bank
Forest Maturity	Mature	Mature
Slope	High	High
Overhanging Vegetation	30%	30%
Undercutting	0%	5%
Shade	50%	50%
Stable	25%	25%
Bare Stable	5%	5%
Eroding	20%	20%

Map 4 (top left): LiDAR imaging of Fletcher Brook. **Figure 19** (top right): Bank characteristics. **Photo 28** (bottom center): Fletcher Brook below the sampling site- this picture was taken at noon on a bright sunny day, demonstrating the high level of shade that is cast over the brook. Fletcher Brook offers an excellent matrix of flow types, as well as undercut banks and woody debris in the brook, providing excellent fish habitat.

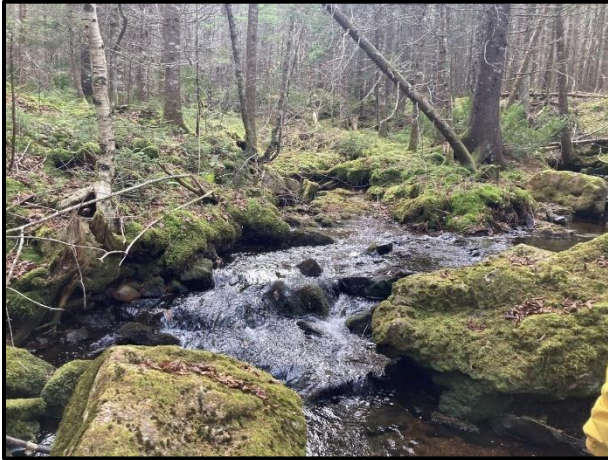
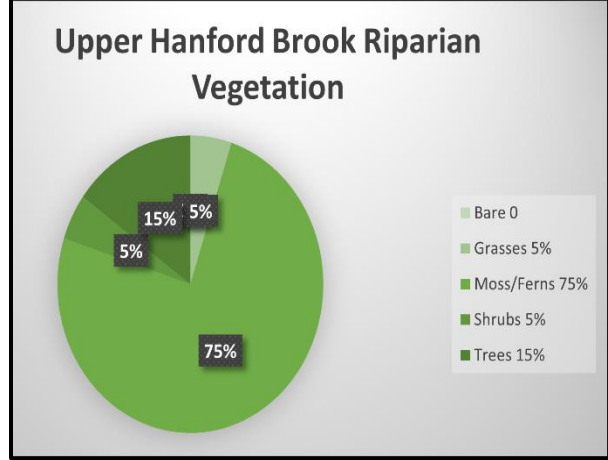
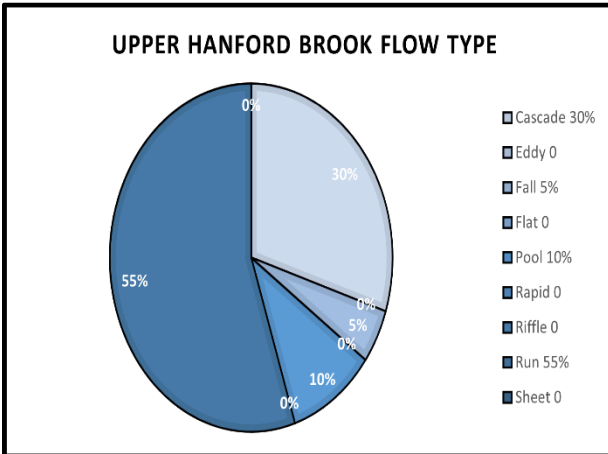
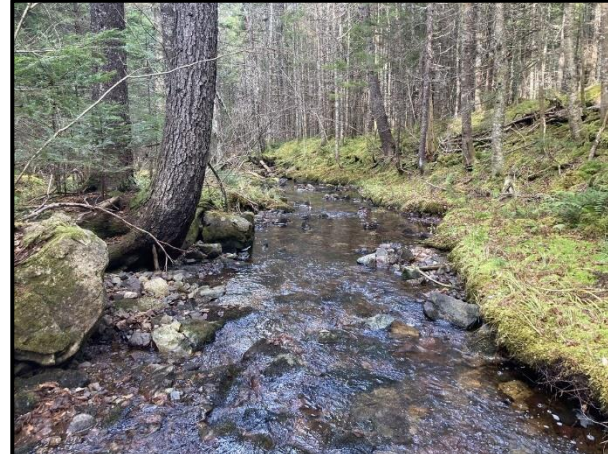
Photo 29 (top left): Upstream of the sampling site. **Figure 20** (top right): Riparian vegetation. **Figure 21** (middle left): Flow Type. **Photo 30** (middle left): Downstream of the sampling site. **Photo 31** (bottom left) The sampling site. **Figure 22** (bottom right): Substrate. Brook trout and minnows were observed in this stretch in the 2021 sampling season. *Photos: J. Kelly. Figures: S. Blenis.*

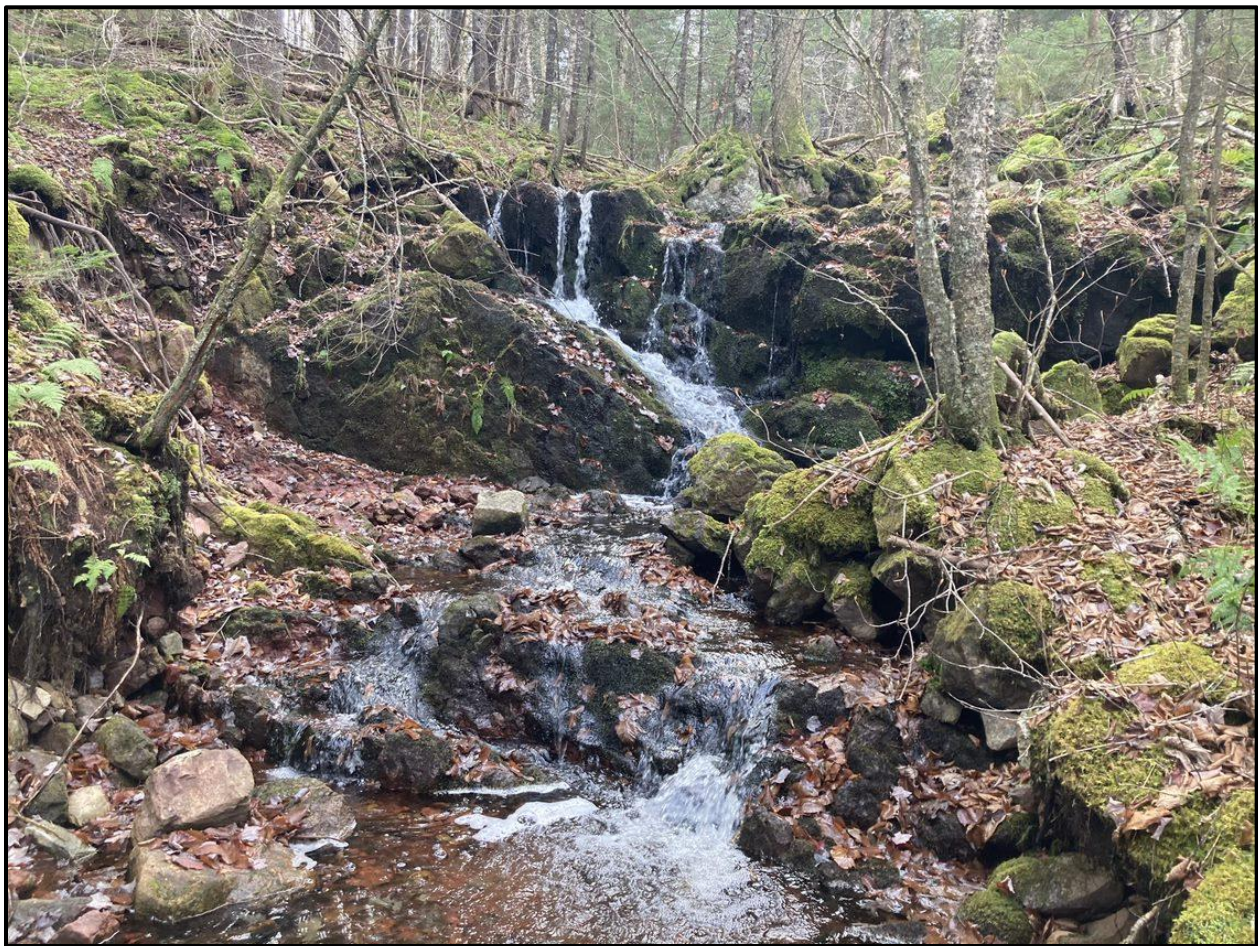
Bank Characteristic	Left Bank	Right Bank
Forest Maturity	Mature	Mature
Slope	High	High
Overhanging Vegetation	40%	40%
Undercutting	0%	5%
Shade	50%	50%
Stable	45%	50%
Bare Stable	0%	0%
Eroding	5%	0%

Map 5 (top left): LiDAR imaging of Hanford Brook. **Figure 23** (top right): Bank characteristics. **Photo 32** (bottom center): Upstream of the sampling site, representing the upper reach for fish passage. Above this area, Hanford Brook is fed by a large wetland, and above the wetland is Porcupine Lake. HRAA has proposed a new project for the 2022 season that will further investigate Porcupine Lake, Hanford Brook and the tributaries that feed into it. *Figures: S. Blenis. Photo: J. Kelly.*

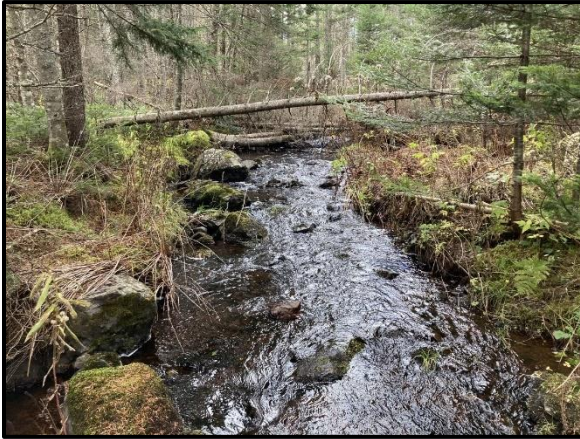
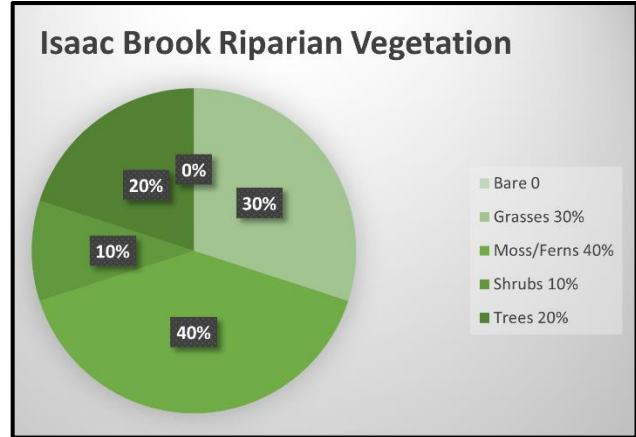
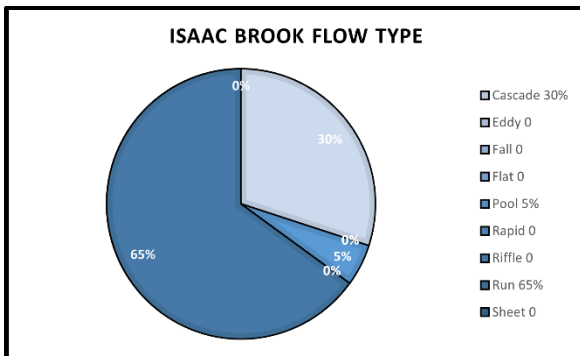
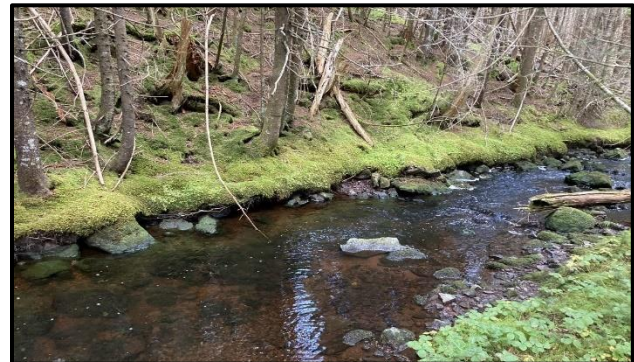
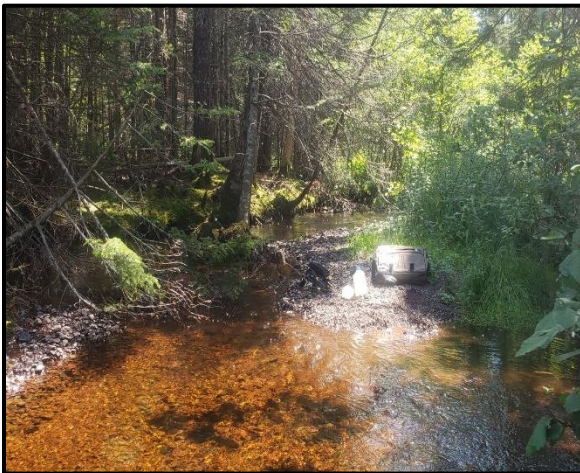
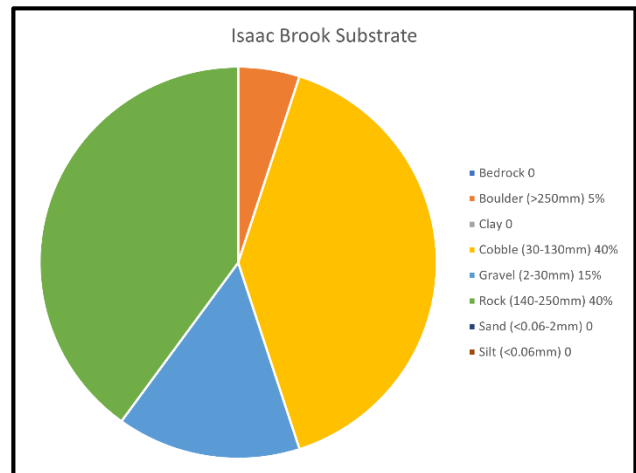
Photo 33 (top left): Upstream of the sampling site. **Figure 24** (top right): Riparian vegetation. **Figure 25** (middle left): Flow type. **Photo 34** (middle right) Downstream of the sampling site. **Photo 35** (bottom left) The sampling site with HRAA's YSI kit and sampling bottles. **Figure 26** (bottom right) Substrate type. Brook trout and minnows were observed in this stretch throughout the 2021 sampling period. *Photos: J. Kelly. Figures: S. Blenis.*

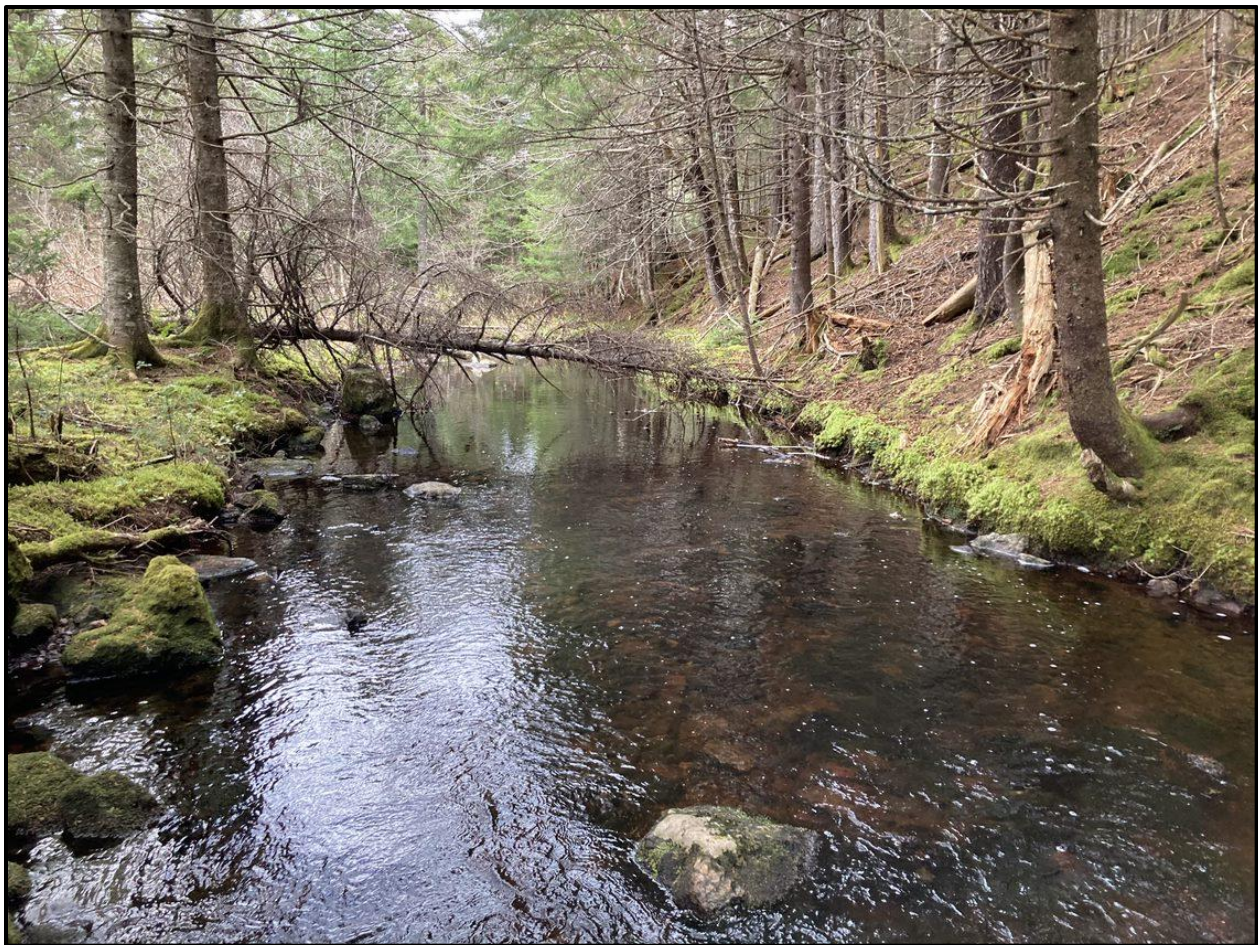
Map 6 (top left): LiDAR imaging of Isaac Brook. **Figure 27** (top right): Bank characteristics.

Photo 36 (bottom center): downstream of the sampling site. The headwaters of the Isaac Brook is Tracy Lake. Tracy Lake received a “Marginal” water quality index score in HRAA’s 2021 Lake Assessment due to its trace metal exceedances, which can also be found within Isaac Brook. Despite exceedances, both the lake and brook are teeming with aquatic life. *Figures: S. Blenis. Photo: J. Kelly.*

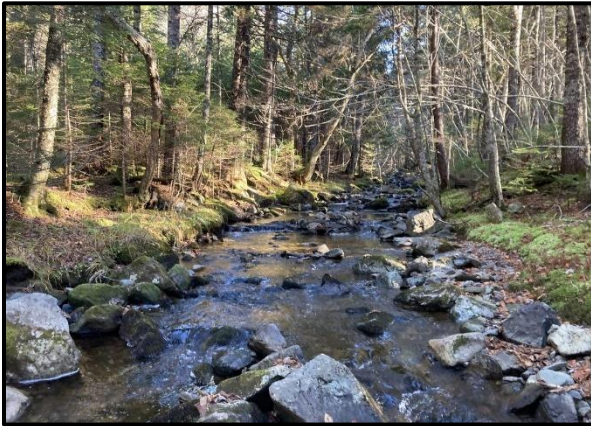
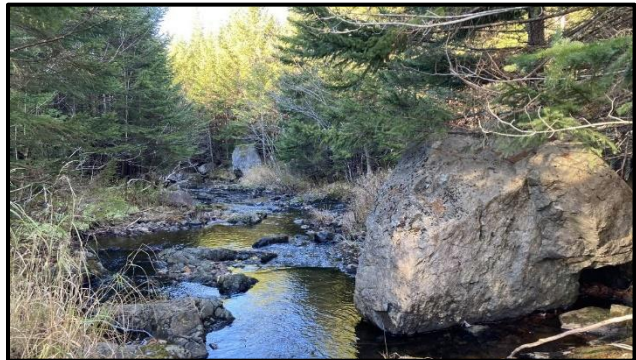
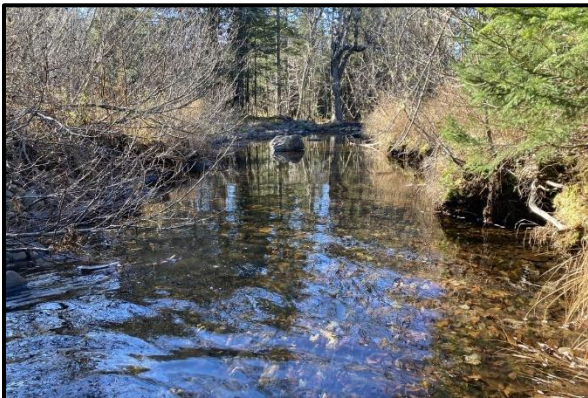
Photo 37 (top left): Upstream of the sampling site. **Figure 28** (top right): Riparian vegetation. **Figure 29** (middle left): Flow type. **Photo 38** (middle right): Downstream of the sampling site. **Photo 39** (bottom left): The sampling site. **Figure 30** (bottom right): Substrate type. In 2020, the HRAA submitted the Jenny Lind Brook, Theobald Lake, and upper Irish River to the province of New Brunswick as a Candidate Protected Natural Area, and this candidacy was approved in 2021 through the Nature Legacy Program. The Jenny Lind Brook received a perfect water quality index score and is indeed worthy of conservation and protection!

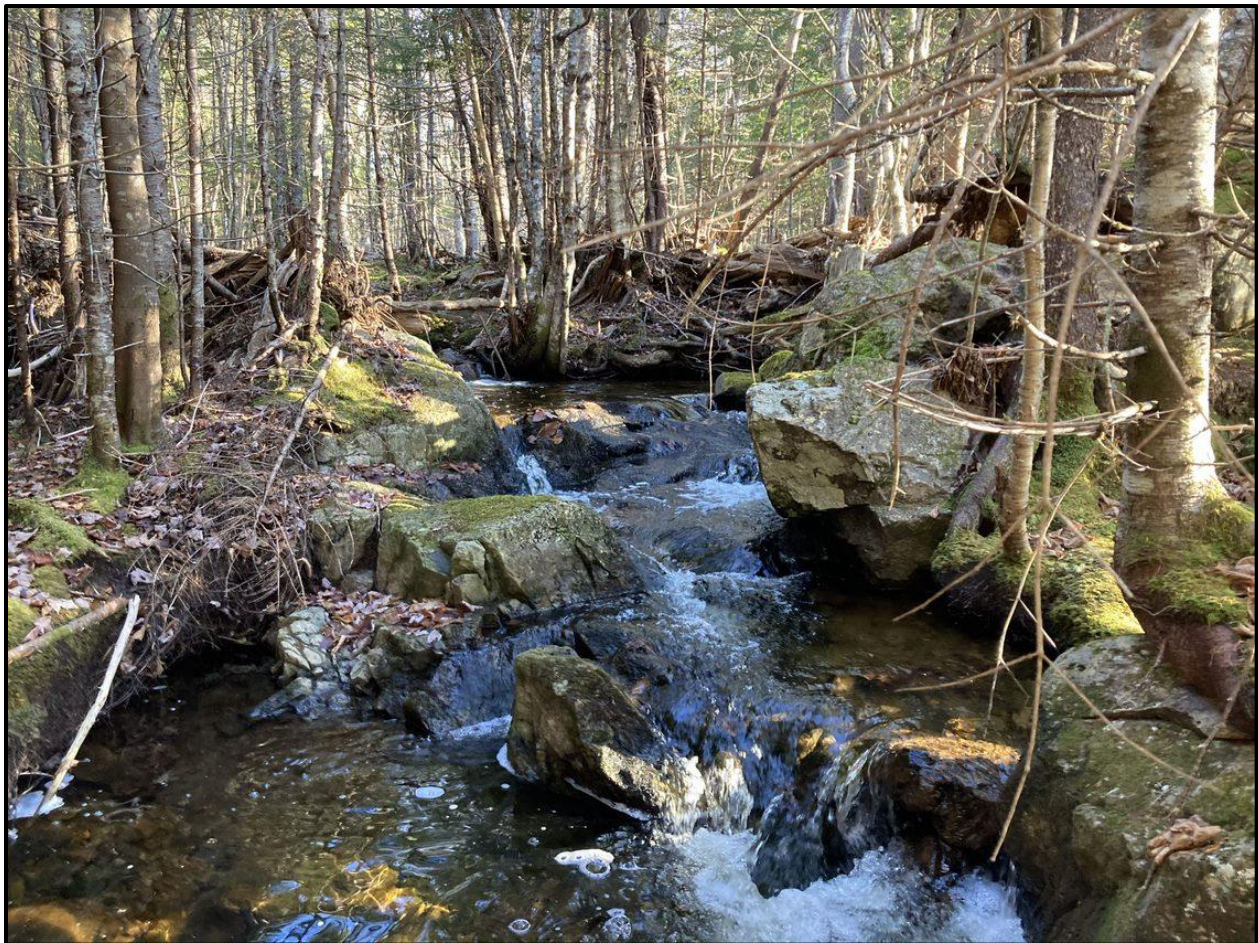
Bank Characteristic	Left Bank	Right Bank
Forest Maturity	Mature	Mature
Slope	High	High
Overhanging Vegetation	40%	45%
Undercutting	10%	5%
Shade	40%	40%
Stable	50%	50%
Bare Stable	0%	0%
Eroding	0%	0%

Map 7 (top left): LiDAR imaging of Jenny Lind Brook. **Figure 31** (top right): Bank characteristics. **Photo 40** (bottom center): Below the sampling site. The Jenny Lind Brook is an absolute gem of the Hammond River watershed, and the HRAA field staff felt extremely grateful to the NB Environmental Trust Fund for allowing us the opportunity to investigate these upper mountainous tributaries! *Figures: S. Blenis. Photo: J. Kelly.*
