***Maintaining
Water Quality Data
While Adapting To
Climate Change***

**Final Report # 210115
Presented to the
New Brunswick Environmental Trust Fund
On Behalf of the Hammond River Angling Association
S. Blenis & J. Kelly**

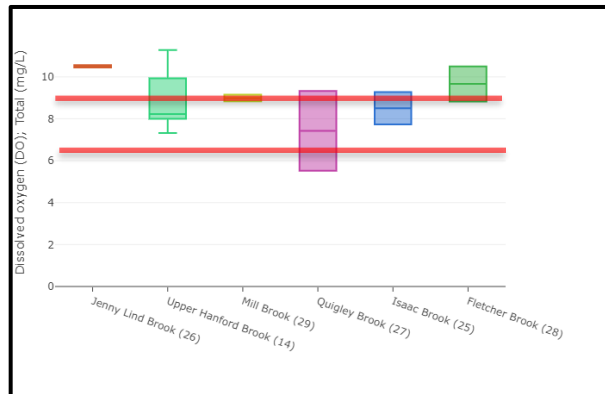
Figure 36. Dissolved oxygen levels in the 6 mountainous tributaries. All tributaries demonstrated acceptable dissolved oxygen levels to sustain other life stages of aquatic life, while the Jenny Lind Brook, Upper Hanford Brook, and Fletcher Brook consistently demonstrated acceptable dissolved oxygen levels to sustain early life stages of aquatic life. Quigley Brook's dissolved oxygen levels were slightly lower than the other 6 tributaries; however, this is a result from poor site selection for sampling (i.e.: in hindsight, the sampling site was not representative of the overall tributary). *Figure: S. Blenis.*

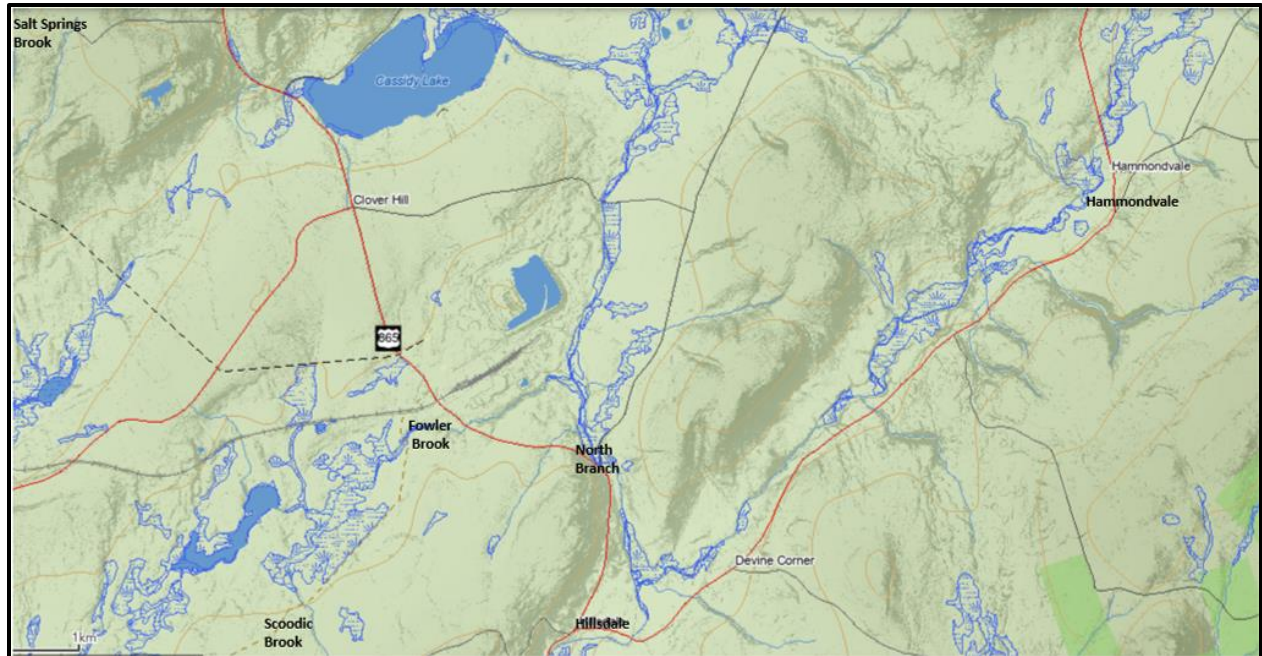
Map 8: Demonstrating the headwaters of the Hammond River, including index sampling sites Hammondvale, Hillsdale, North Branch and Fowler Brook. Included in this map is the upper reach of Salt Springs Brook and the upper reach of Scoodic Brook. *Map: DNR & S. Blenis.*

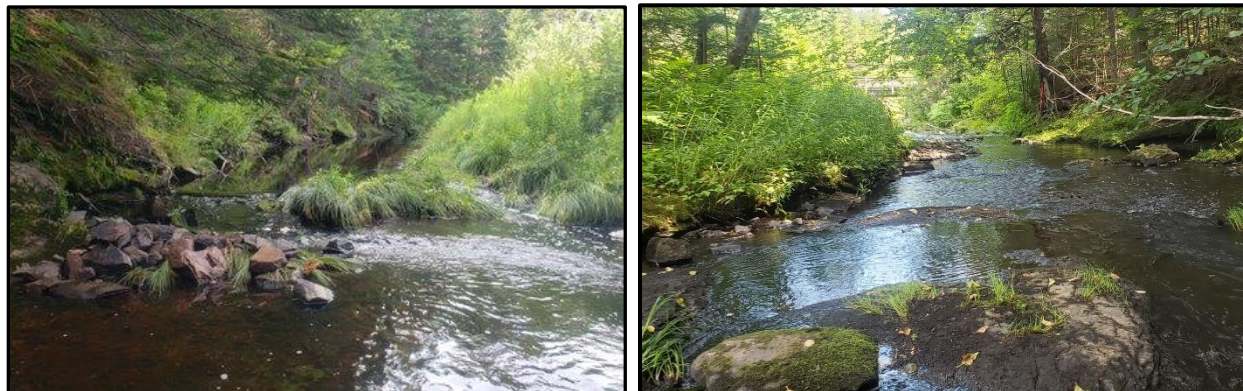
One of the most surprising results from water quality sampling in 2021 was the overall ranking of Fowler Brook. Fowler Brook, a tributary of the North Branch, appears to be in pristine condition, with beautiful riparian coverage, substrate, fish habitat and species abundance (including juvenile salmon) and relatively low anthropogenic stressors; however, it ranked the 5th lowest scoring tributary in the watershed according to the CCME Water Quality Index score.

Photo 42 (left): Upstream view of Fowler Brook. **Photo 43** (right): Downstream view of Fowler Brook. *Photos: S. Blenis.*

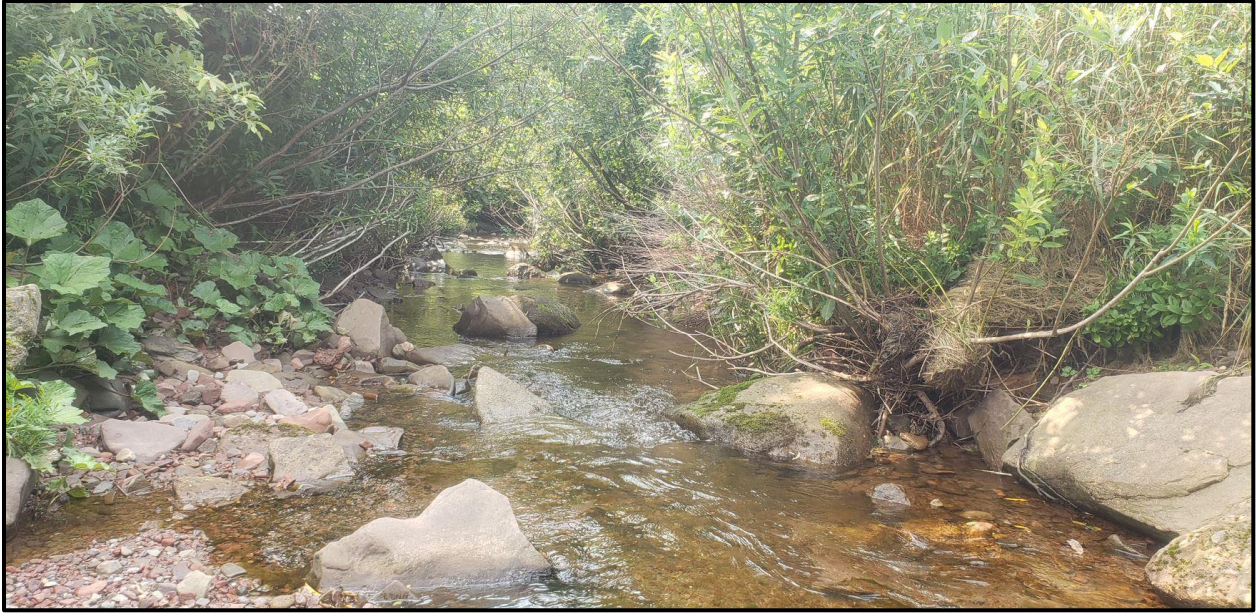
Photo 44: Upstream of the sampling site. Willows pictured on the right and left bank are from the restoration project in 2000. *Photo: S. Blenis.*

Both McGonagle Brook and O'Dell Brook represent historic HRAA restoration sites from 2000. These sites were severely degraded and lacked a vegetated riparian buffer and were allowing full livestock access to both brooks. In 2000, HRAA staff installed fence posts and limited livestock access to the brooks, as well as planting approximately 2,500 willows, mountain ash, and dogwood. Both sites are considered to be two of the top restoration efforts in HRAA's history, as these sites now appear almost fully naturalized, with less erosion and turbidity, and exceptional crown coverage.

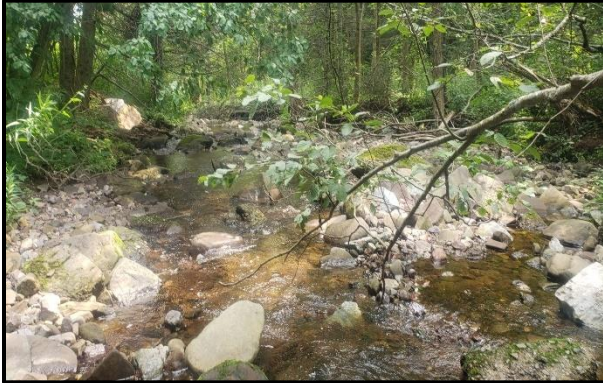
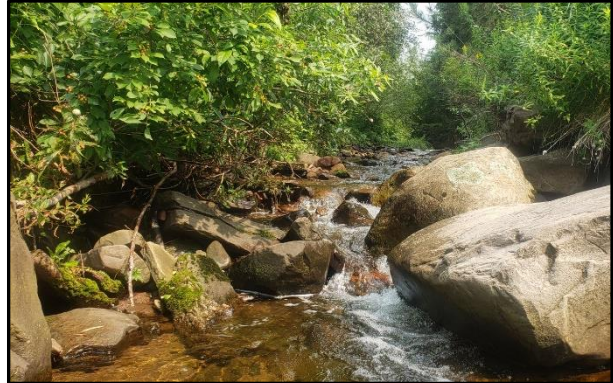
Photo 45 (left): McGonagle Brook. **Photo 10** (right): O'Dell Brook. *Photos: S. Blenis.*

In 2021, O'Dell Brook received a perfect score on the Water Quality Index, and McGonagle Brook ranked fairly high out of all sites surveyed, ranking at 9th place overall, with a score of 94.1, or “Good”. McGonagle Brook came very close to receiving a perfect score, like O'Dell Brook, except two of the dissolved oxygen results came in at a conservative 9 mg/L, just shy of the 9.5 mg/L required for early life stages of aquatic life. In both cases, bacterial levels, particularly *E. coli*, decreased dramatically.

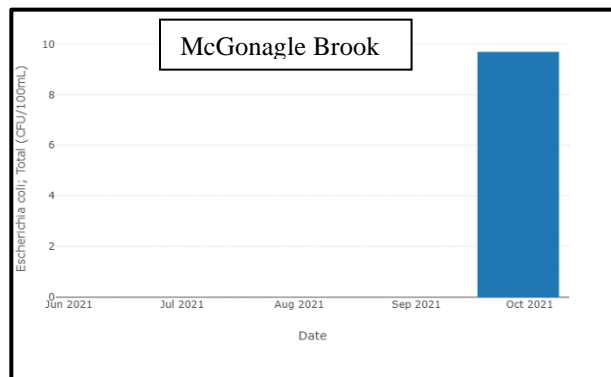
Figure 51 (left): *E. coli* levels in O'Dell Brook. **Figure 52** (right): *E. coli* levels in McGonagle Brook. *Figures: S. Blenis.*

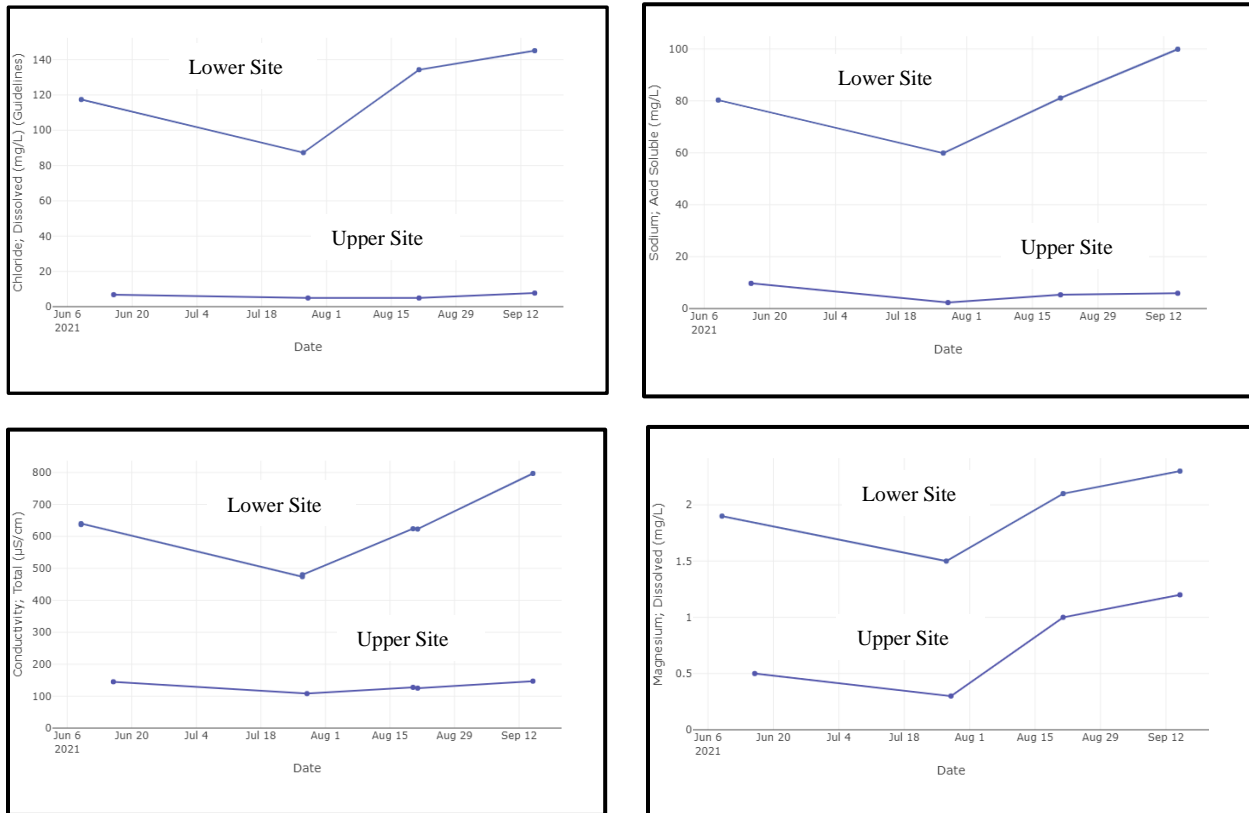
Figure 53 (top left): Chloride in upper and lower sites. **Figure 54** (top right): Sodium in upper and lower sites. **Figure 55** (bottom left): Conductivity levels in upper and lower sites. **Figure 56** (bottom right): Magnesium in upper and lower sites. *Figures: S. Blenis.*

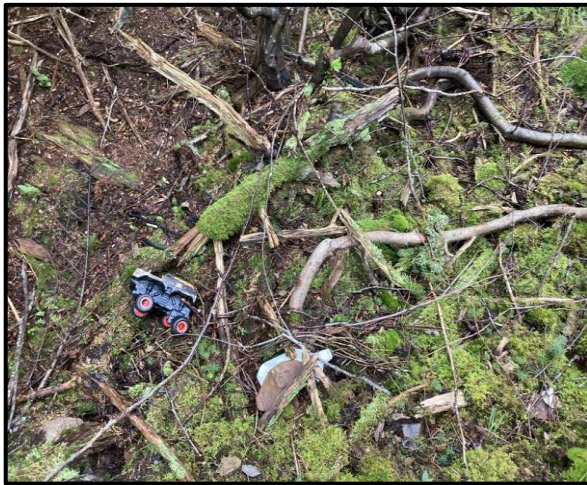
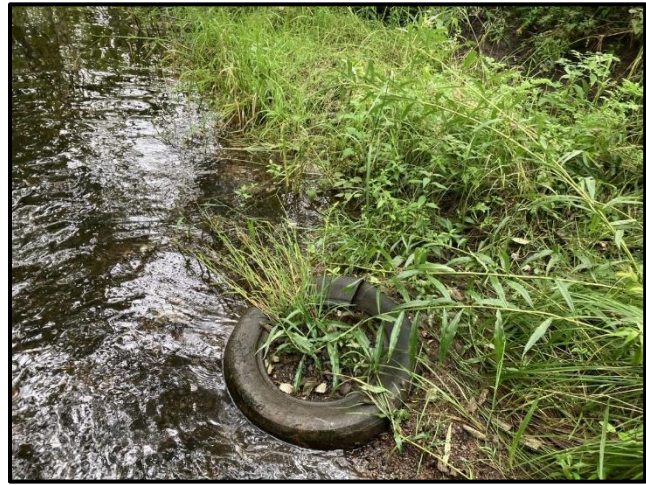
In the summer of 2021, HRAA staff received an email from a local resident, with concerns on the water quality in a tributary, Snow Brook, that was adjacent to a former dump site. To the best of our knowledge, Snow Brook has never been included in any water quality monitoring program since the inception of HRAA; however, our field staff determined that this was a worthwhile concern and performed a preliminary investigation.

Photo 46 (left): some of the debris that was located adjacent to Snow Brook. **Photo 47** (right): a tire that was located (and subsequently removed) from Snow Brook. Metal and glass debris could be spotted sticking out of the ground in various areas along Snow Brook, and this site would be a good candidate as a future clean up initiative. *Photos: J. Kelly.*

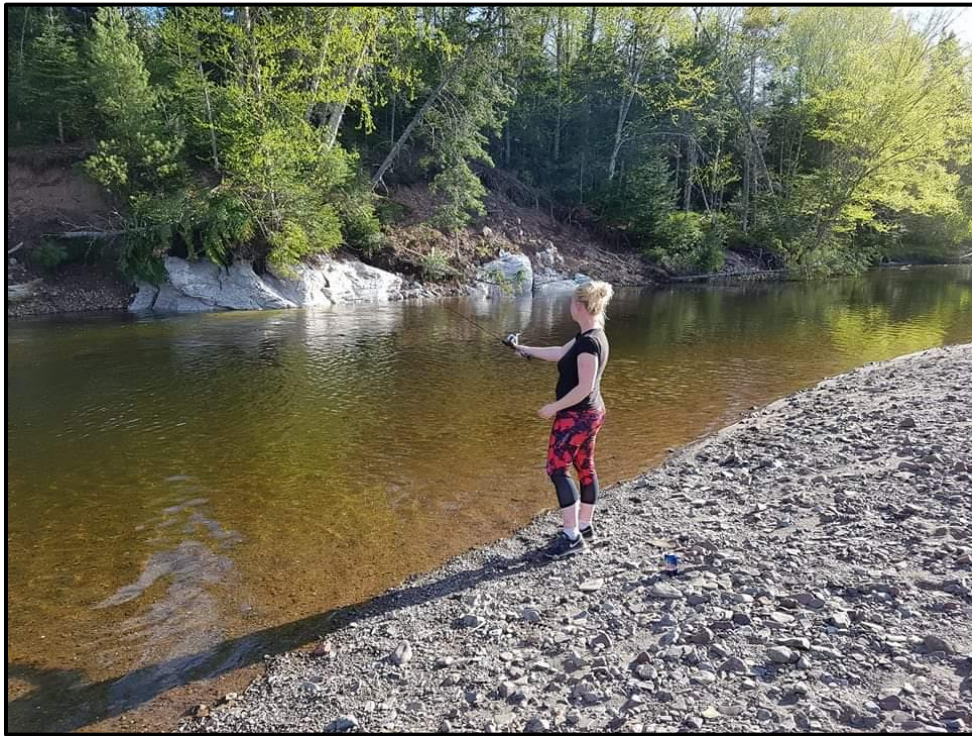
Photo 48. S. Blenis angling on the Hammond River, with a visible gypsum outcropping in the background, with substantial erosion occurring. *Photo: P. Walsworth.*

The Hammond River is peppered with calcareous and karstic outcroppings of gypsum and limestone, which weather the most rapidly of all rock types under moist conditions, as they react chemically with the carbonic acid often found in precipitation and ground water (Ecosystem Classification Working Group). As climate change continues to increase, we must become more aware on how changes in precipitation will affect the state of the watershed. Geology is known to strongly influence many of the constituents of water chemistry. This finding implies that as climates become warmer in the future, stream chemistries will change (Olson, 2012). The geology of an area is a significant factor in the overall quality of its water resources. The dissolution of numerous minerals from geological formations results in spatial and temporal variations in water quality- we may then begin to anticipate changes in water chemistry as a direct response to climate change. As a result of this project, it is recommended that HRAA undertake geological mapping

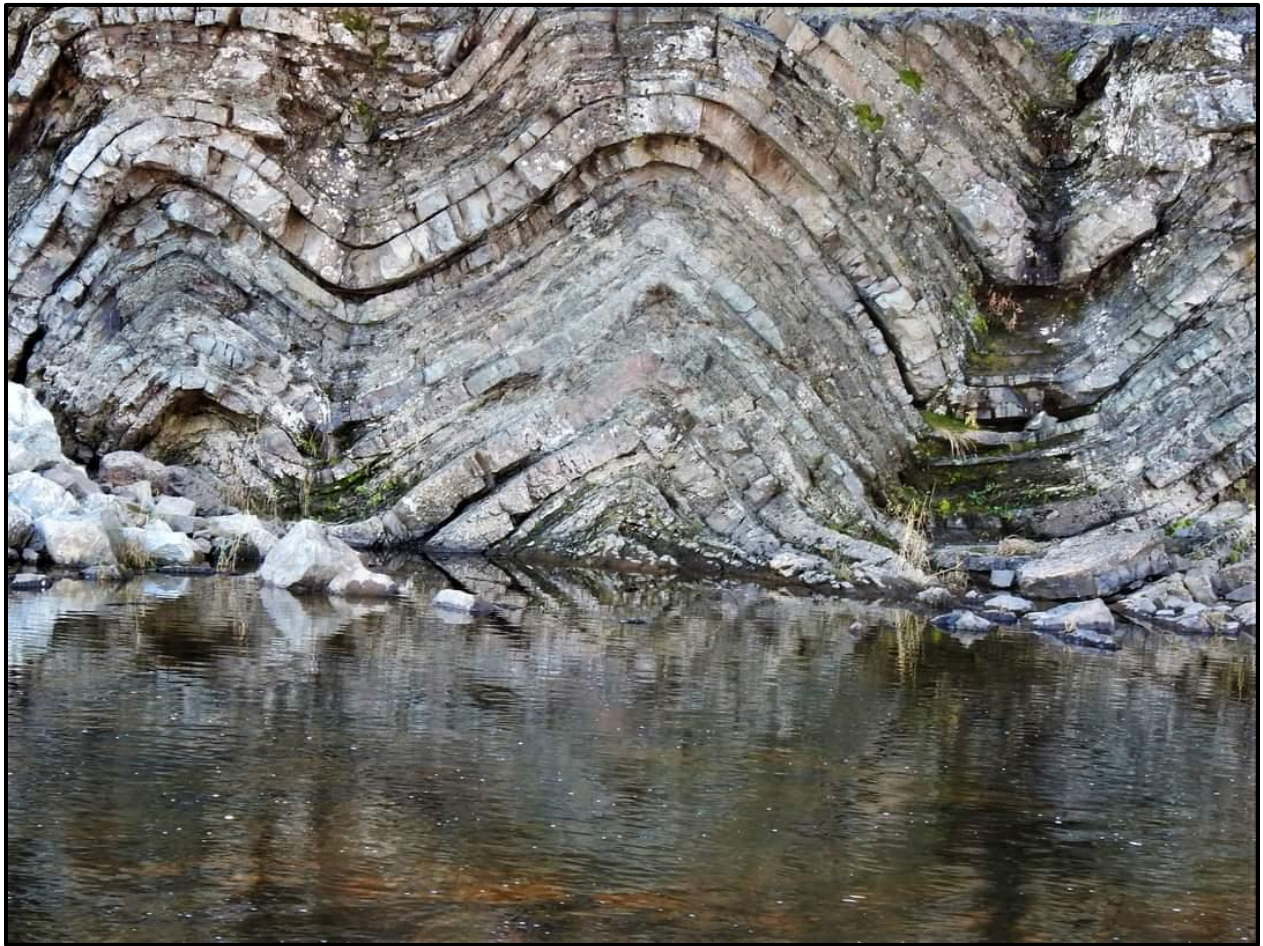
Photo 49: Geologic folding pattern- one of the most captivating geologic sights within the watershed at Tabor Bridge Pool. *Photo: J. Blenis.*
