**Hammond River Angling Association
New Brunswick Environmental Trust Fund**

Hammond River Water Quality Monitoring Project
Project No: #150094
Final Report

March 1, 2016

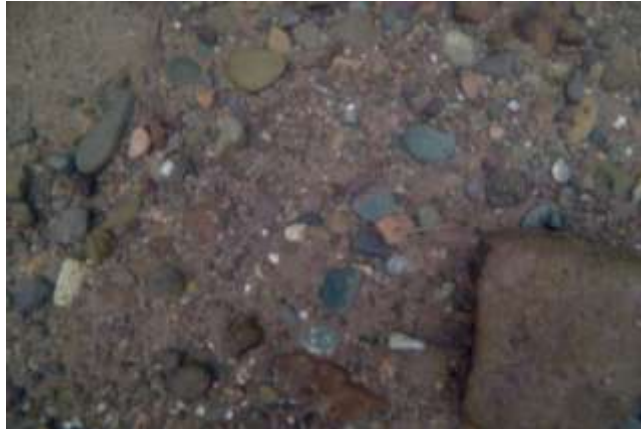
The HRCC site was sampled 4 times in 2015. Located on the main stem of the Hammond River, this site is classified as a stream order 5. **Embeddedness** at the HRCC site had increased 40% (to 80%) since observations were last made by the HRAA in 2008 (Campbell and Prosser, 2008). The stream color was consistently characterized as **tannin**. The dominant flow was **run** and there was **0% forest cover**. Assessing all parameters, the HRCC site was documented to have an **impacted** riparian health and the stream habitat was **stressed**. One major contributor to this area's impacted riparian health was the density of agriculture land, which was the highest in the watershed. Late summer measurements (Aug. 17th) indicated this area does not provide cool water habitat (> 21°C) and dissolved oxygen levels were too low (< 7.5 mg/L) to support a healthy aquatic community (Figure 13).

Figure 14 (top left): The substrate composition by percentile at the HRCC site. *Chart by H. Bradford.* Figure 15: Substrate at the HRCC site. *Photo by H. Bradford July 20 2015.* Figure 16: The left and right banks, facing upstream, at the HRCC site. *Photo by H. Bradford June 17 2015.*

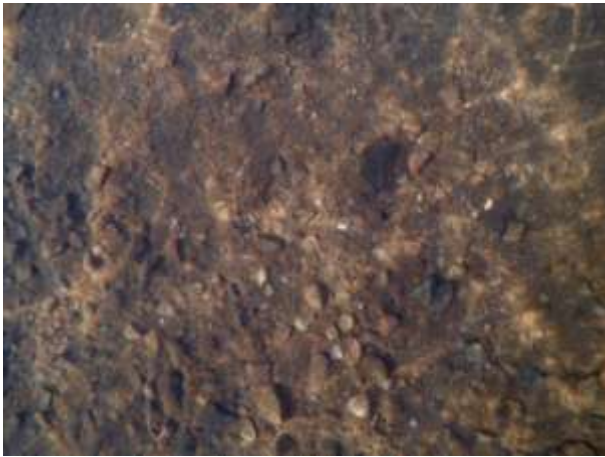
Bradley Brook (stream order 4) is a tributary of the Hammond River and was sampled 3 times during 2015 (July 20th, August 17th and September 23rd, 2015). Sedimentation is a regular occurrence with rainfall events at this site, and substrate was (80%) **embedded** (Figure 5). The stream was characterized by **tannin** coloration with murky visibility and defined by two different flow types 90% run and 10% rapid. The stream cover from grasses was minimal (20%) although this site is identified as a **cool water habitat** (<21°C). *E. coli* (Appendix 4) and dissolved oxygen (Figure 25) were measured above the acceptable limits for healthy aquatic life in August (480 MPN/ 100 ml). Water quality measurements indicated turbid water with above average concentrations of iron, copper and potassium (Appendix 4). The proportion of midges and fly larvae found within the BMI community collected indicate that water quality is poor and may not support a healthy community.

Figure 24 (top right): Substrate at Bradley Brook. *Photo by H. Bradford Aug 17 2015.* Figure 25 (top left): Substrate by percentile at Bradley Brook. *Chart by H. Bradford.* Figure 26: Right and left bank of Bradley Brook facing downstream (toward the conflux). *Photo by H. Bradford Aug 17 2015.*

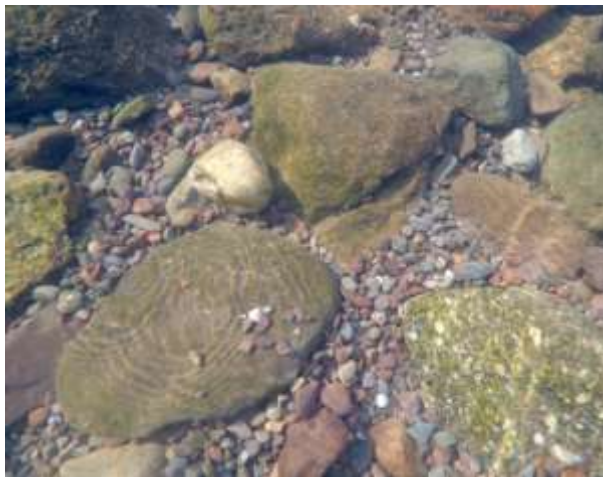
Figure 28 (top left): Flow type by percentile for the Damascus bridge site. *Chart by H. Bradford.* Figure 29 (top right): Right banks, facing downstream of the Damascus bridge. *Photo by H. Bradford June 17 2015.* Figure 30 (bottom left): Substrate at Damascus bridge site. *Photo by H. Bradford Aug 17 2015.* Figure 31: Substrate by percentile at Damascus bridge site. *Chart by H. Bradford.*

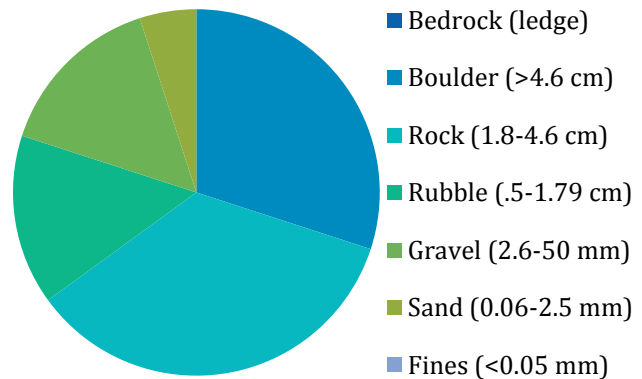
Damascus Bridge crosses the Hammond River (stream order 5) and the sampling station is downstream of a known local fishing and swimming hole. The substrate was 5% **embedded**. The stream had a **clear** coloration with great visibility and was defined by several different flow types (Figure 28). The river had 0% **crown cover** at this location. Assessing all parameters, Damascus was documented to have a **stressed** riparian health, while the in-stream habitat was found to be **healthy**. Pools at this site are known to provide salmon habitat as well as habitat for other fish. However, late summer measurements of dissolved oxygen and temperature identify unacceptable limits for a healthy community. E. coli levels at this site increased (190 MPN/ 100 mL) during the rainfall event in July (Appendix 4). The BMI community had a large proportion of fly larvae and insects indicating this site cannot support a variety of organisms and has potentially impaired water quality (Appendix 5). Overall the benthic community was **unimpaired**.

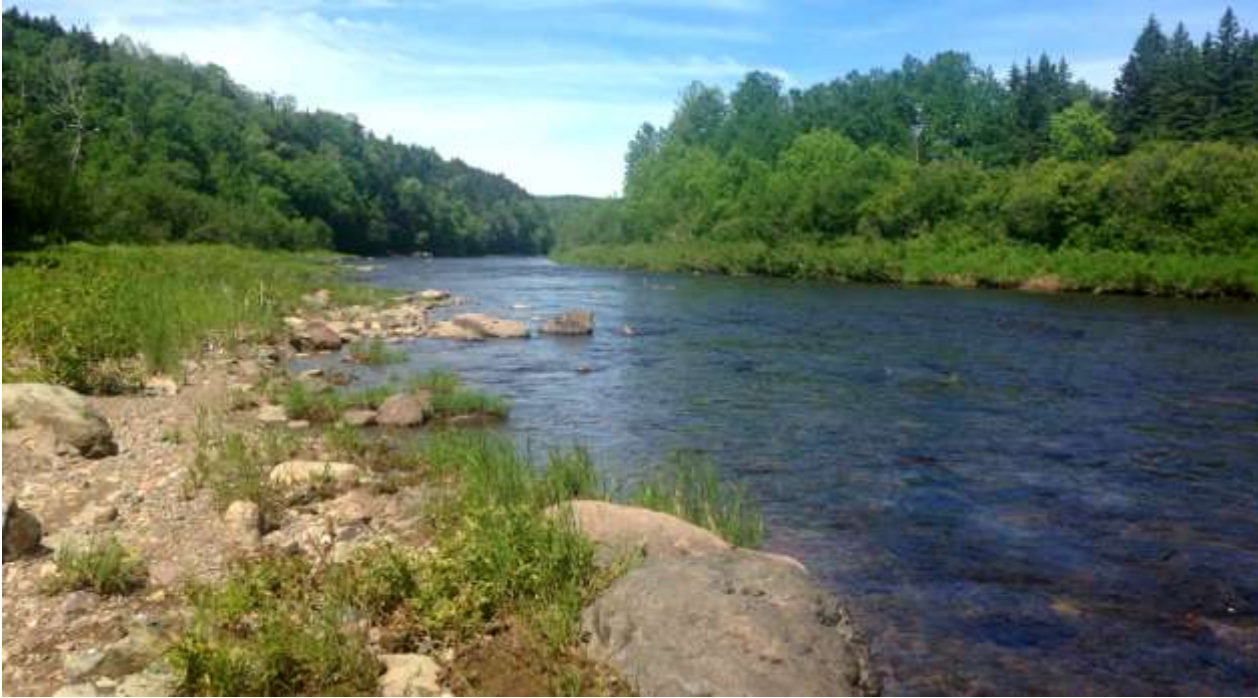
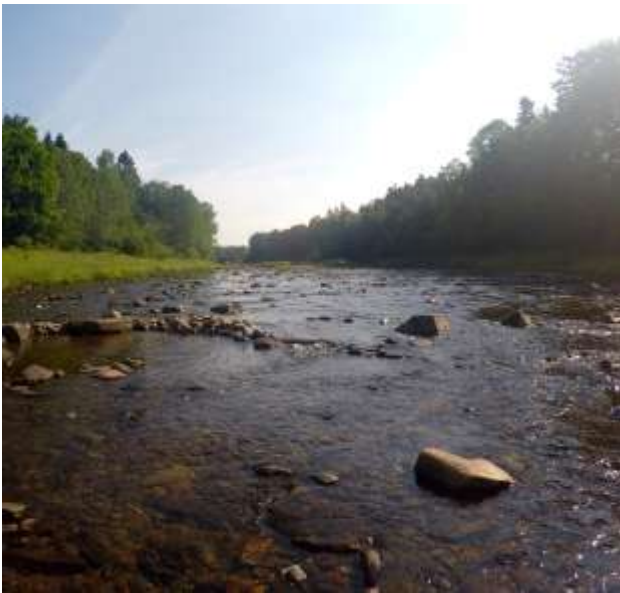
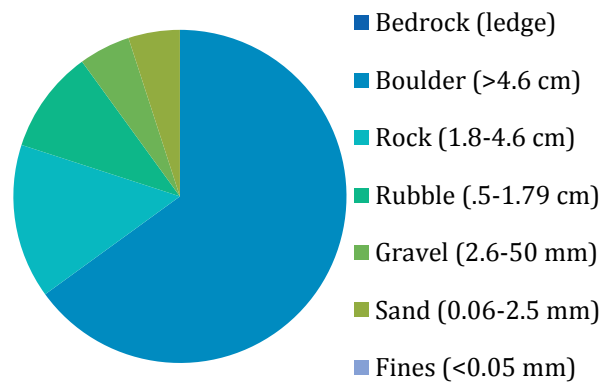
Figure 52: A cross section of the Hammond river at the Route 820 site facing downstream (of the convex with South Stream) at the normal water level. *Photo by H. Bradford June 17 2015.* Figure 53 (bottom left): A cross section of the Hammond River at the Route 820 site facing upstream (of the confluence with South Stream) at low water levels in late summer. *Photo by H. Bradford Aug 17, 2015.* Figure 54 (bottom right): Substrate by percentile. *Chart by H. Bradford.*

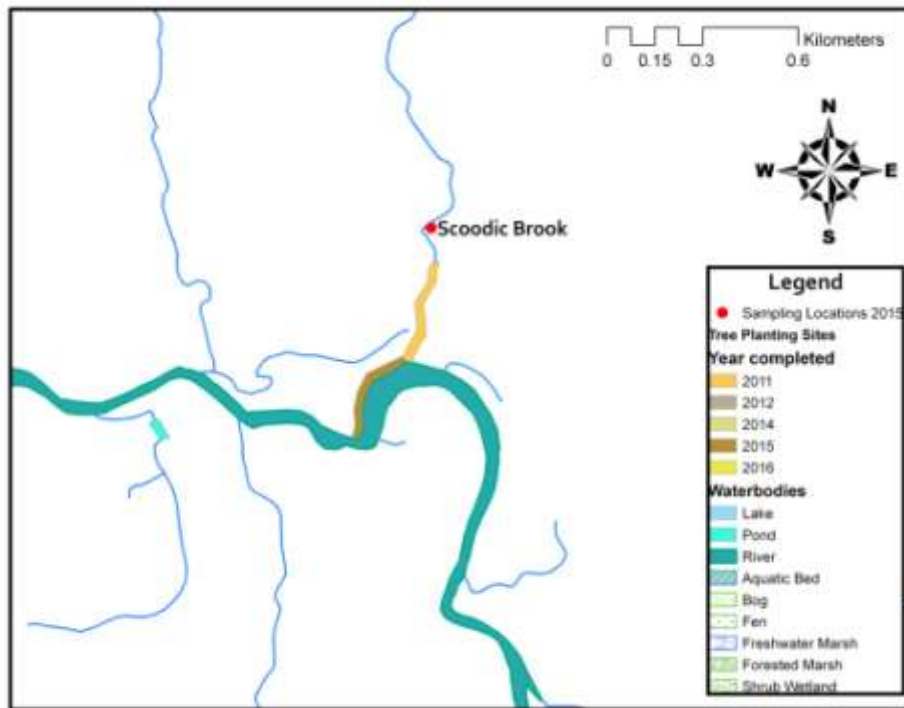
fish habitat occurred downstream of the Scoodic Brook - Hammond River confluence. Due to low survival among trees planted beneath the confluence point, the (left) riverbank was planted again in 2015 (Figure 56).

Figure 56: Recent planting sites at Scoodic Brook by year completed. *Map created by H. Bradford using DNR data layers (2009).*

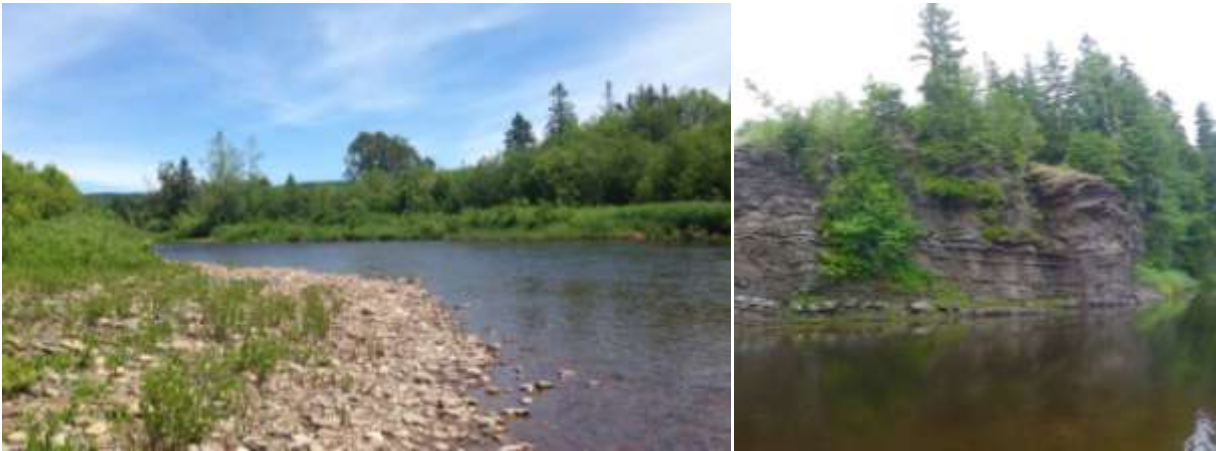
Figure 65 (left): Cross-section of the Hammond River (St. Martins Road) facing upstream. *Photo by H. Bradford June 17, 2015.* Figure 66 (right): Unique geological formation on exposed bedrock downstream of the St. Martins Road bridge. *Photo by H. Bradford July 17 2015.*

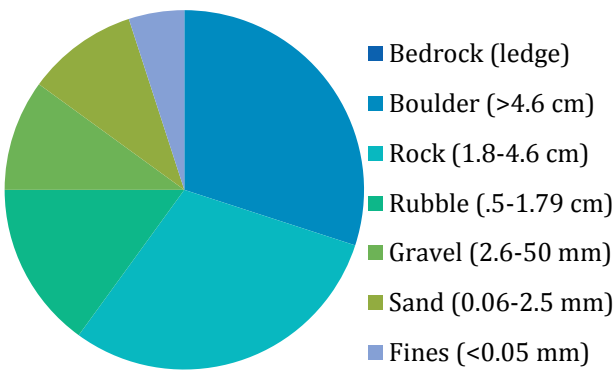
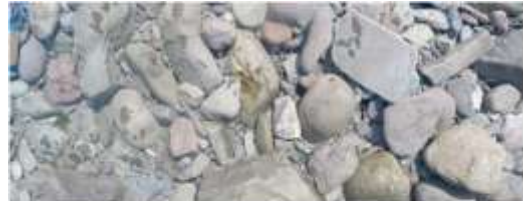
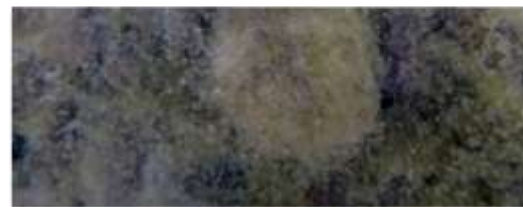
Table 20: Bank characteristics at the Hanford Brook site. *Figure by H. Bradford.*

Figure 69 (top left): Cross section of the Hanford Brook site facing upstream, slanting trees indicate left banks instability and the right bank is sustained by its predominately boulder substrate. Figure 70 (top right): Severe undercutting is visible on the left bank, along with slanting trees. Figure 71 (bottom left): Substrate by percentile. *Chart by H. Bradford.* Figure 72 (bottom right): Comparison of exposed substrate and summered substrate in late summer. *All photos by H. Bradford Aug 20 2015.*

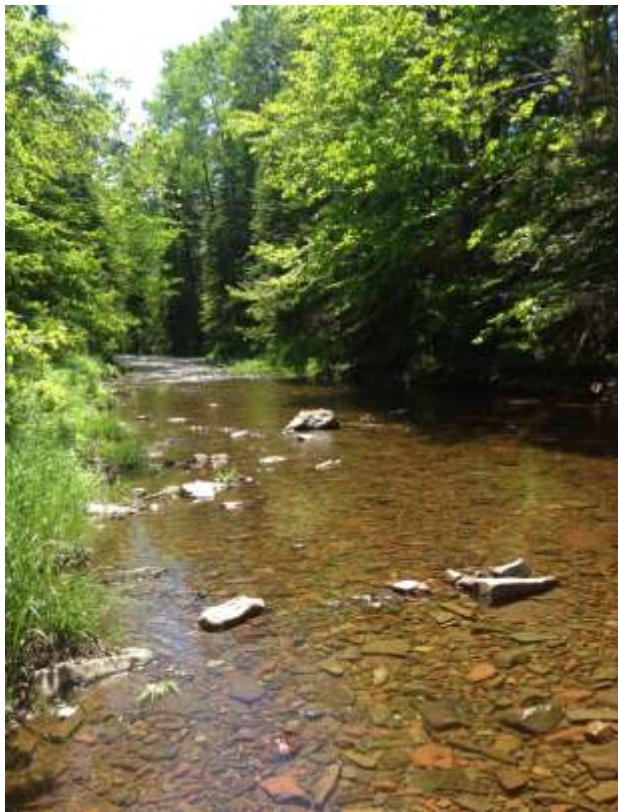
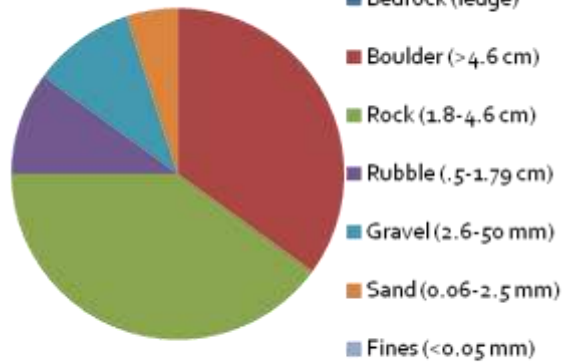
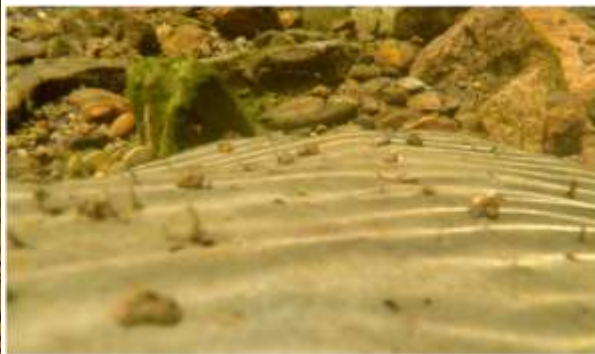
Figure 77 (left): A cross-section of Germaine Brook facing upstream. *Photo by H. Bradford June 17 2015.* Figure 78 (top right): Substrate by percentile at Germaine Brook. *Chart by H. Bradford.* Figure 79: During the late summer, Caddisfly shells appeared to be coating every rock in the Brook. *Photo by H. Bradford Aug 20 2015.*

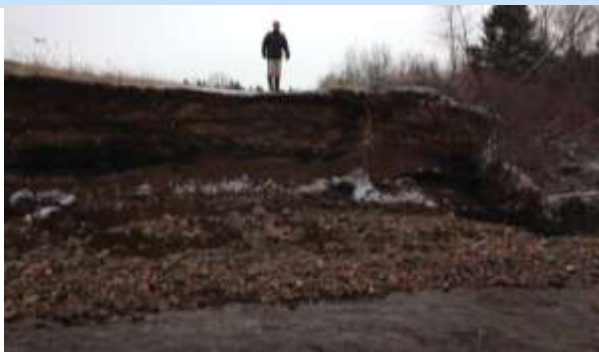
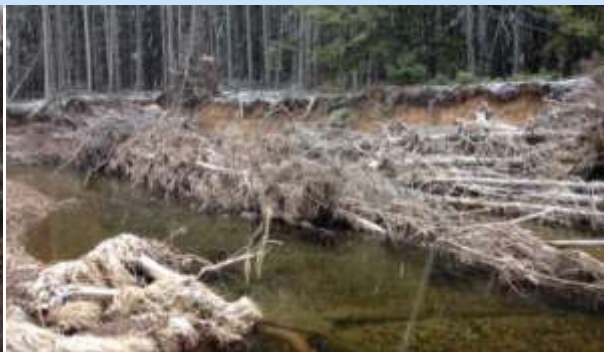
The lower portion of Germaine Brook was planted in 2007, however, this rehabilitation work was regarded as unsuccessful. In 2010, a second attempt at riparian restoration efforts was successful at removing blockages created by bottlenecked debris and creating a 10 meter buffer zone along the bank of the brook. Subsequently, this work has eroded away and the lower Germaine Brook is experiencing major changes to the channel pathway causing significant bank erosion, damage to adjacent farmland and the loss of important salmon spawning habitat (Figure 75). The HRAA hopes to restore this area in the near future.

Figure 75: (left) Recent bank erosion along lower Germaine Brook. Figure 76: (right) Bank erosion has led to trees being uprooted. *All photos by H. Bradford Dec 14, 2015.*

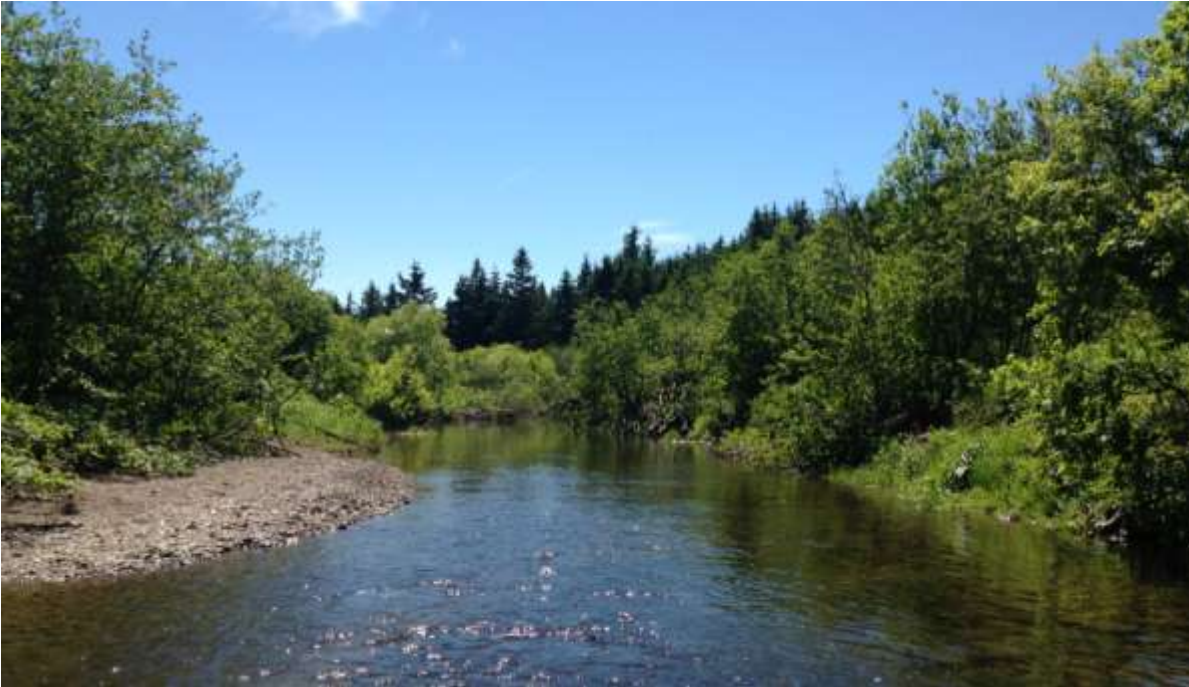
The Highway 111 (St. Martins Road) site is located in Hammondvale and is classified as stream order 4. This site was visited 4 times during 2015. With regards to the substrate, there was no visible **embedding**. The stream is characterized by **clear** coloration and high visibility. The **stream cover** was 35%. Assessing all parameters, Highway 111 Bridge site was documented to have a **stressed** riparian health, which is consistent with previous findings (Campbell and Prosser, 2008). The in-stream habitat was found to be **healthy**. Dissolved oxygen dipped below the acceptable limit (<6 mg/L) for a healthy aquatic community by mid-summer and water temperatures reached a high of 20.5 °C (Figure 87). Despite being considered a reference location, the BMI community indicated the site was **potentially impaired**. A high proportion of midges and insects indicate that the site has potentially poor water quality and may not support a healthy community.

Figure 86: Cross section (facing downstream) at the Hammondvale site. *Photo by H. Bradford Aug 17 2015.*

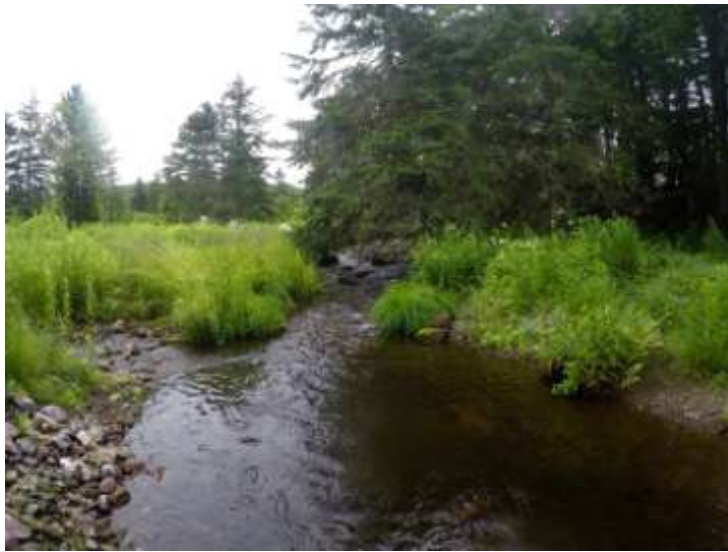
Located in Markhamville, this tributary is classified as stream order 4 and is downstream of the Markhamville Road stream crossing. This area contains cropland, fallow pasture and blueberry fields as well as shrub wetland. The site was visited four times during 2015. The substrate was not visibly **embedded** at this site. The stream was characterized by **clear** coloration during early summer; however, it began to develop an algal film and the appearance of turbid waters later in the season. **Stream cover** was 90%. Assessing all parameters, Markhamville was documented to have a **stressed** riparian health, while the in stream habitat was found to be **healthy**. Water temperature was equal or less than 18°C throughout the summer and this site was identified as **cool water habitat** for fish refuge (Figure 93). The site retained relatively acceptable levels of dissolved oxygen until the September samples, when D.O. dropped below the threshold to 5.11 mg/L.

Figure 94: (top left) A cross-section of the Markhamville site facing upstream. *Photo by H. Bradford July 20, 2015.* Figure 95: (top right) Flow type by percentile. *Chart by H. Bradford.* Figure 96: (bottom left) Substrate by percentile. *Chart by H. Bradford.* Figure 97: (bottom right) Substrate at Markhamville. *Photo by H. Bradford Aug. 20, 2015.*
