The Hammond River Watershed Management Plan

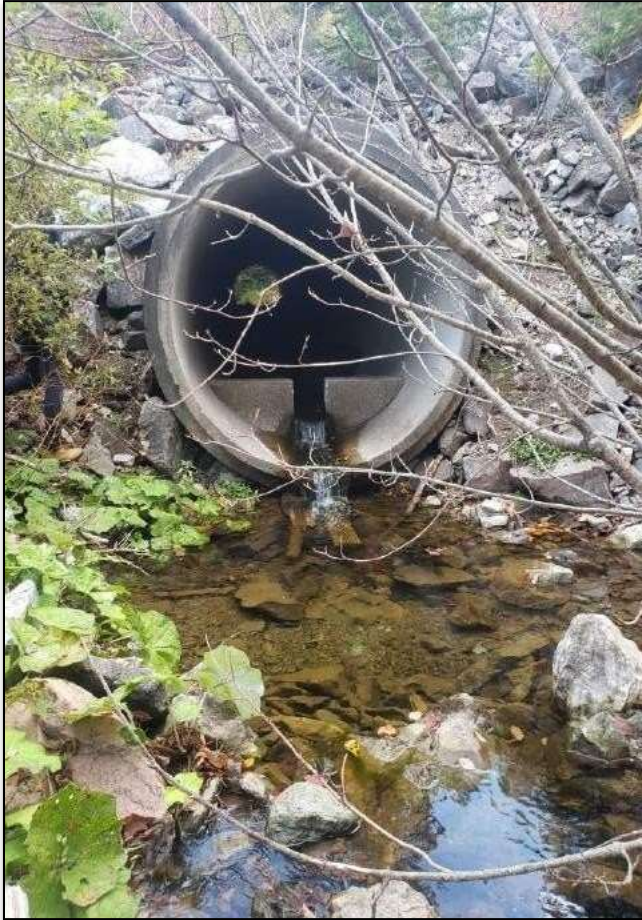
Figure 29. Baffled culvert in Markhamville, that baffled HRAA staff. *Photo: S. Blenis*

Observations: Electro-fishing was not carried out in this site in 2020; however, this site should be included in the 2021 electro-fishing season. During the habitat assessment, HRAA staff came across a fairly new culvert that included baffles. These baffles can provide an adequate depth of flow and reduce the water velocity in the culvert in order to facilitate fish passage. HRAA staff attempted to find additional information on this particular culvert and stretch of river, to no avail. Unfortunately, this culvert was not set at a proper slope, and in the hotter summer months, it becomes hung and does not allow great fish passage, despite its baffles.

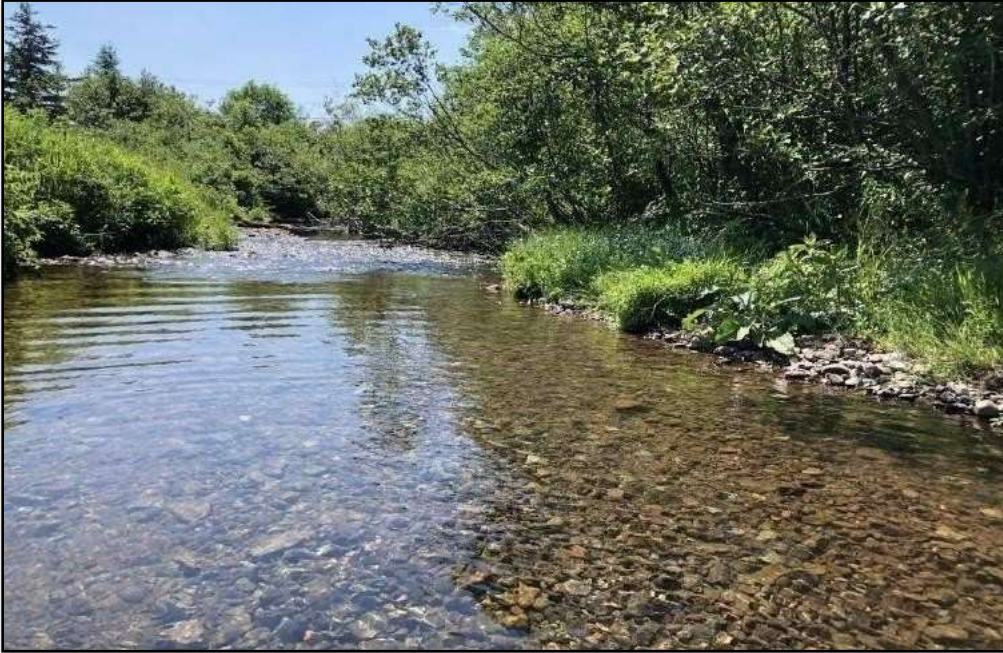
Figure 30. Looking downriver towards the Hammondvale Bridge in October. Site of electrofishing and riparian restoration. *Photo: S. Blenis*

Riparian Rating: At Risk. The current condition of the riparian zone falls within the good to fair rating; however, increased degradation may rapidly reduce the riparian rating. These sites are typically found in agricultural land, and areas under high developmental stress. In 2008, this site had received a riparian rating of “Good”; however, this site has degraded significantly. Riparian restoration must become a focus of this stretch.

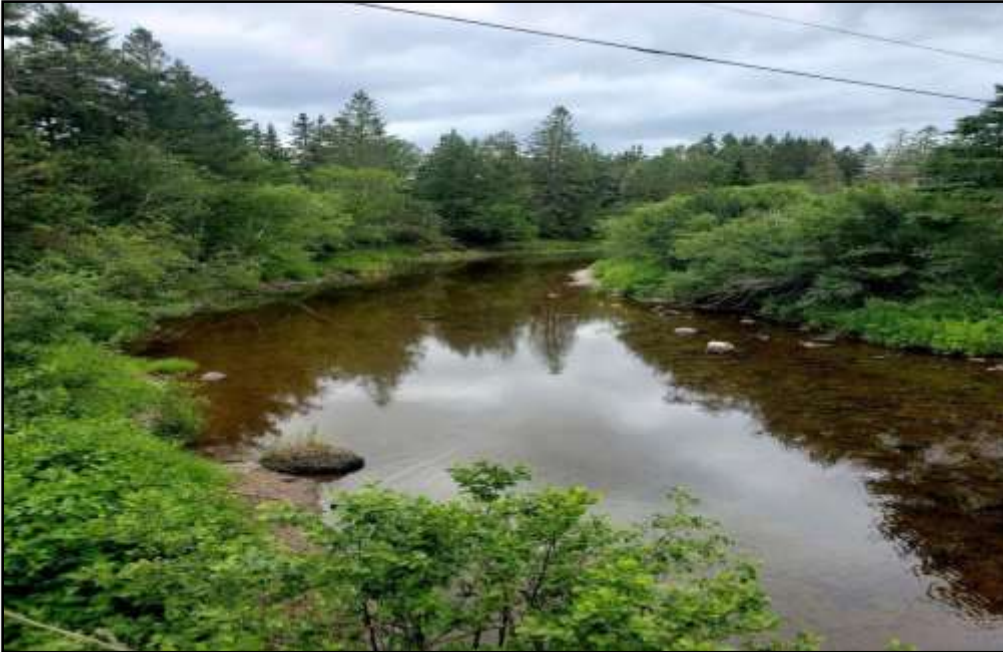
Figure 35. Looking downstream from the Hillsdale Bridge.
Photo: S. Blenis

Riparian Rating: Good to Fair. The riparian zone is well vegetated with the majority of the banks comprised of trees and shrubs; however, there has been some scouring from ice that has led to erosion along the right bank. This site should be closely monitored in the future, as planting may be required, should the undercut banks erode completely. Some woody debris was noted, as some of the trees have fallen into the water.

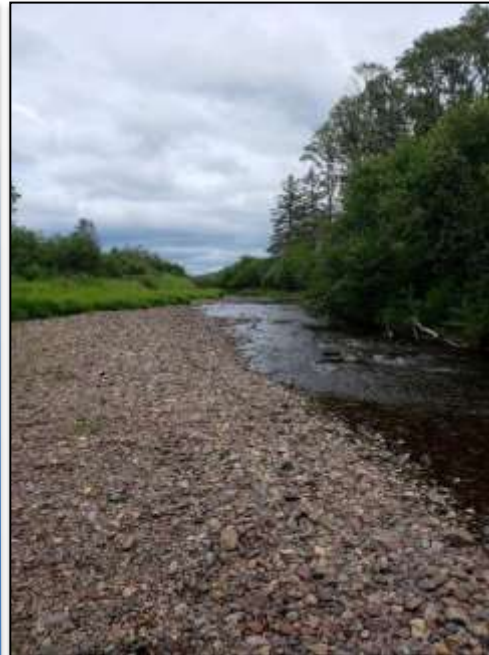
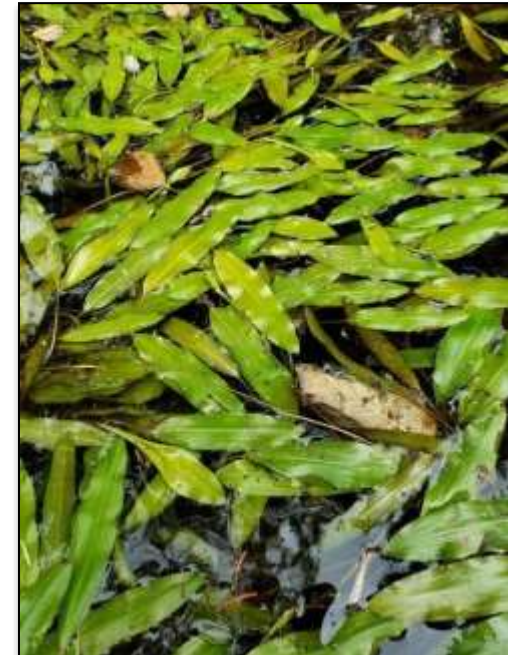
Incidental Observations: Throughout the summer, this site seemed to be prone to buildup of algae, especially surrounding the bridge. This may be a future site for cyanobacteria monitoring, given that it, and Hammondvale above, have elevated levels of nutrients.

Figure 36. Upstream view from the Hillsdale Bridge.

Figure 37. Abundance of aquatic plants throughout. *Photos: S. Blenis*

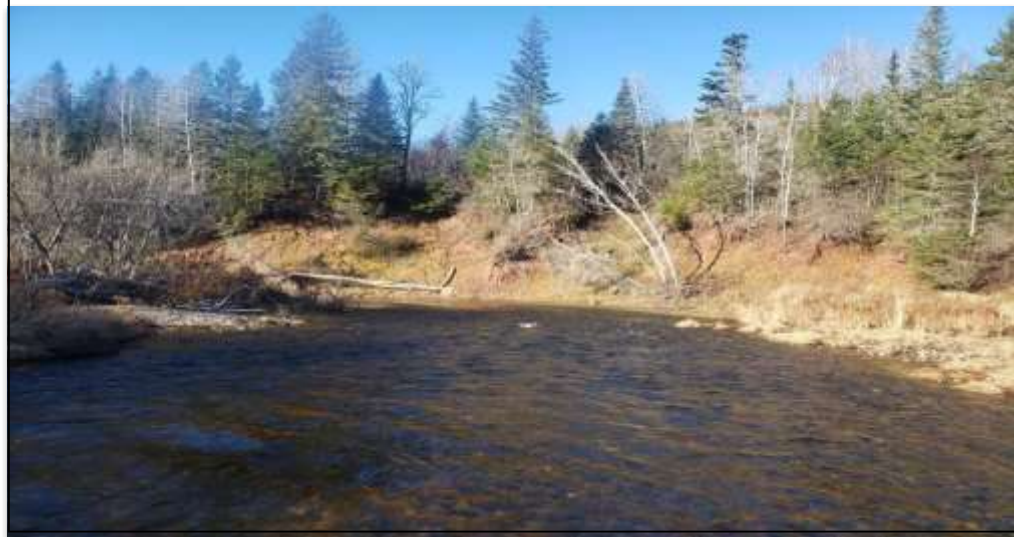
Figure 38. Hayfield with no riparian buffer and degrading banks.

Figure 39. Eroding hillside. Remediation needed at both sites.

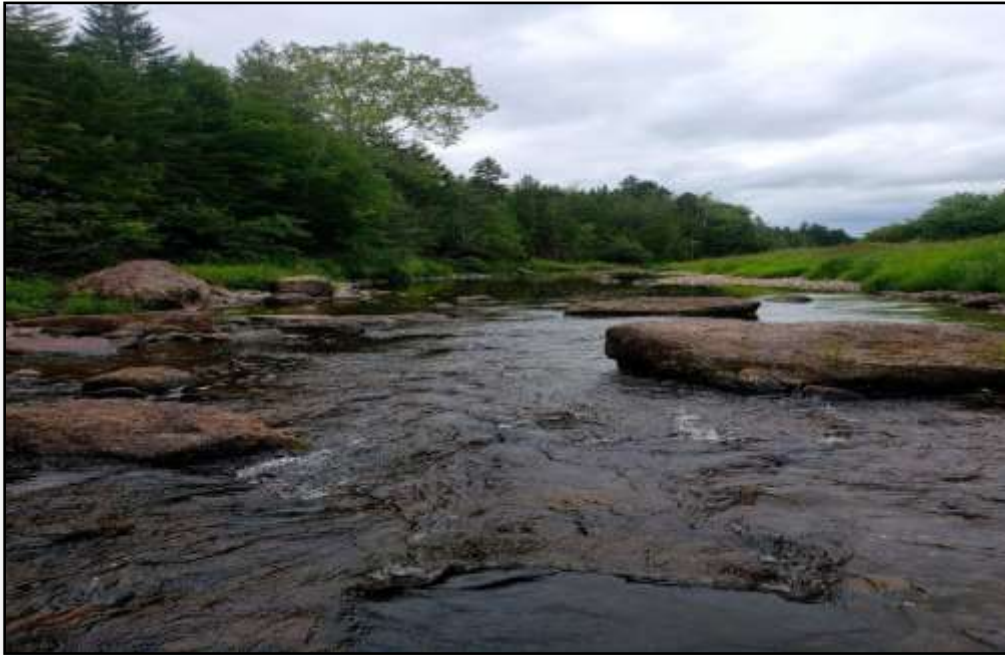
Figure 40. Looking downriver from the confluence of McGonagle Brook.
Photo: S. Blenis

Site Characteristics: Main stem river at the confluence of McGonagle Brook. High priority area for riparian restoration on the right bank.

Riparian Rating: Fair. The riparian zone is vegetated with 59%-40% of the banks comprised of shrubs and few trees, casting less than 60% shade on the reach during mid-day sun. Erosion is occurring during peak water flow times (26%-49%). These areas should be monitored closely to ensure they do not deteriorate further.

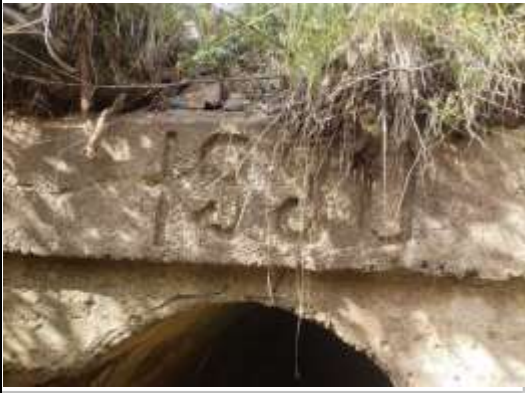
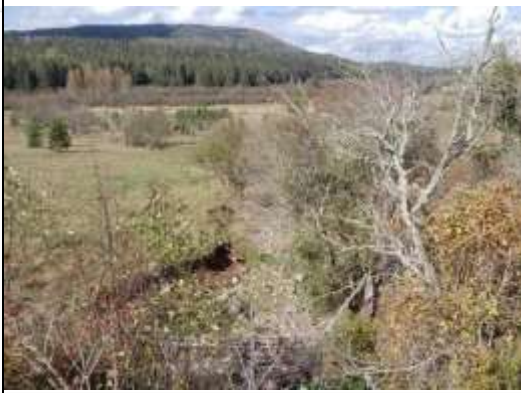
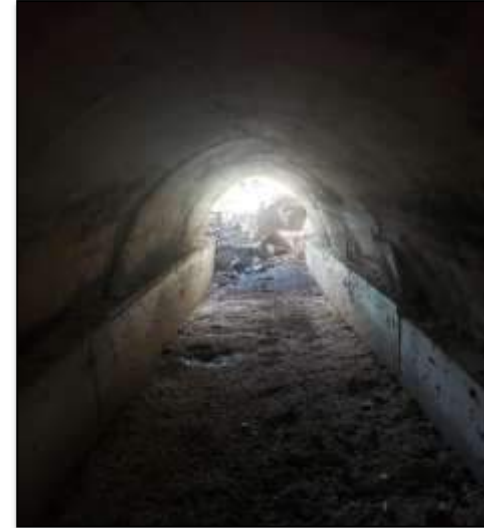
Figure 48 (a,b,c)- Arched culvert that is 91 years old! This culvert only has water flow during heavy rain events. There is a significant blockage at the outflow that could not be removed by staff. Riparian area towards river needs revegetated.

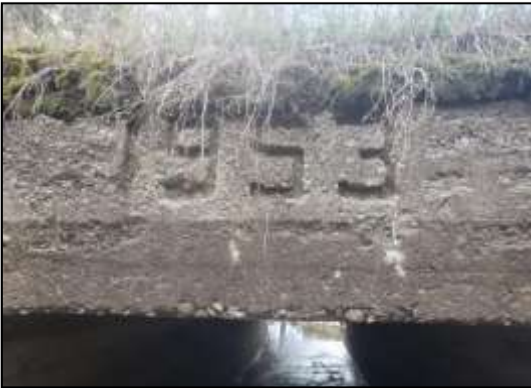
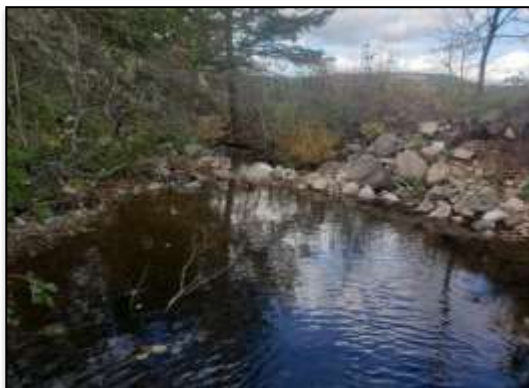
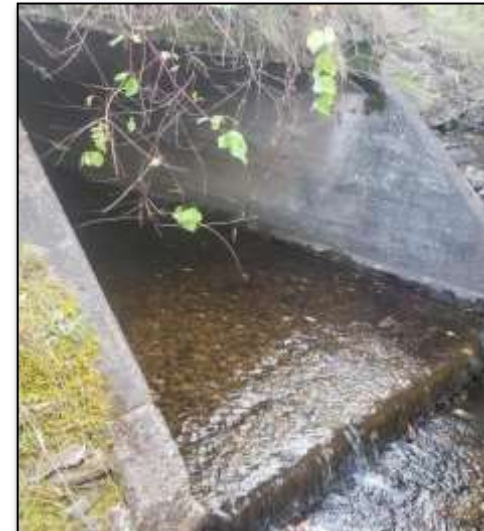
Figure 49 (d,e,f)- Box culvert that is 68 years old! This culvert has a steady flow, and a beautiful outflow pool, with vegetation surrounding the tributary as it flows to the river. Excellent future site for fish population assessment!

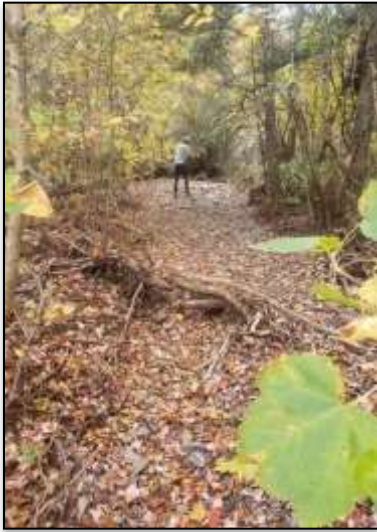
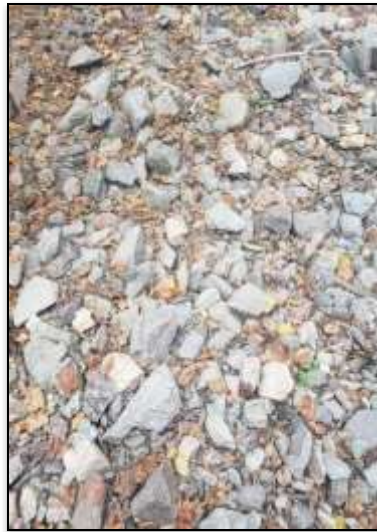
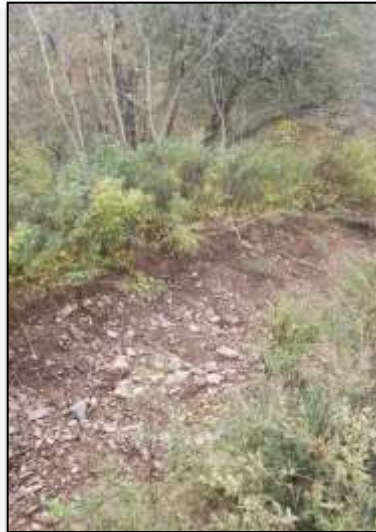
Figure 50 (a,b,c)- Surrounding landowners have many concerns for this culvert, tributary, and safety concerns for route 111. The brook only has flow during heavy rain events. Substrate is sharp, indicating that there is not a regular flow. Staff investigated this stretch for approximately 200m- in 2021, the goal should be to follow the entire streambed, to see if the headwaters is a wetland or small lake. The ditch near road does not have adequate slope to accommodate flow towards culvert. *Photos: S. Blenis*

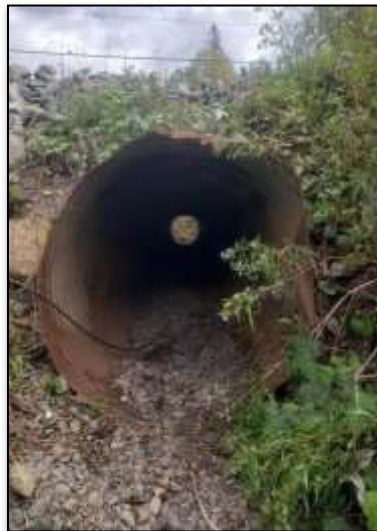
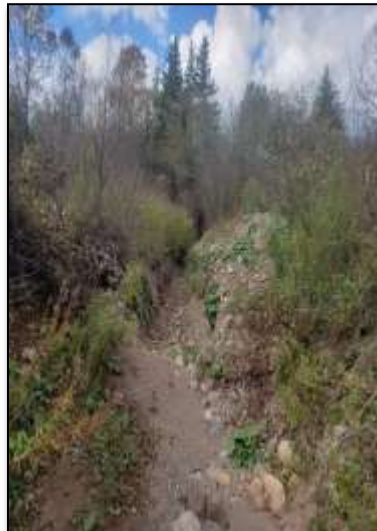
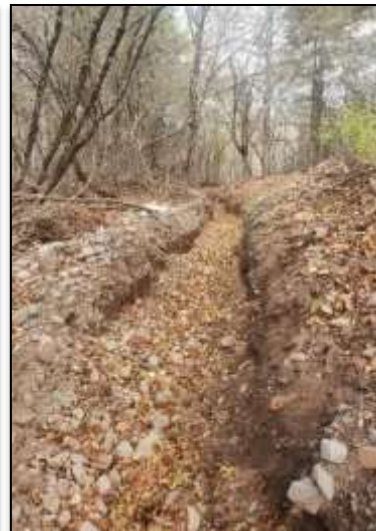
Figure 51 (a,b,c) -Due to improper slope, fast moving water floods the road and landowner property. The culvert is in a poor state, almost entirely rusted. The outflow pool is completely full of sediment and needs to be dredged. There is a small, man-made outflow brook; however, it needs bank stabilization. During heavy rains, it carries huge quantities of sediment into the river. This culvert, brook, and outflow should be addressed in the future as a climate adaptation project. *Photos: S. Blenis*

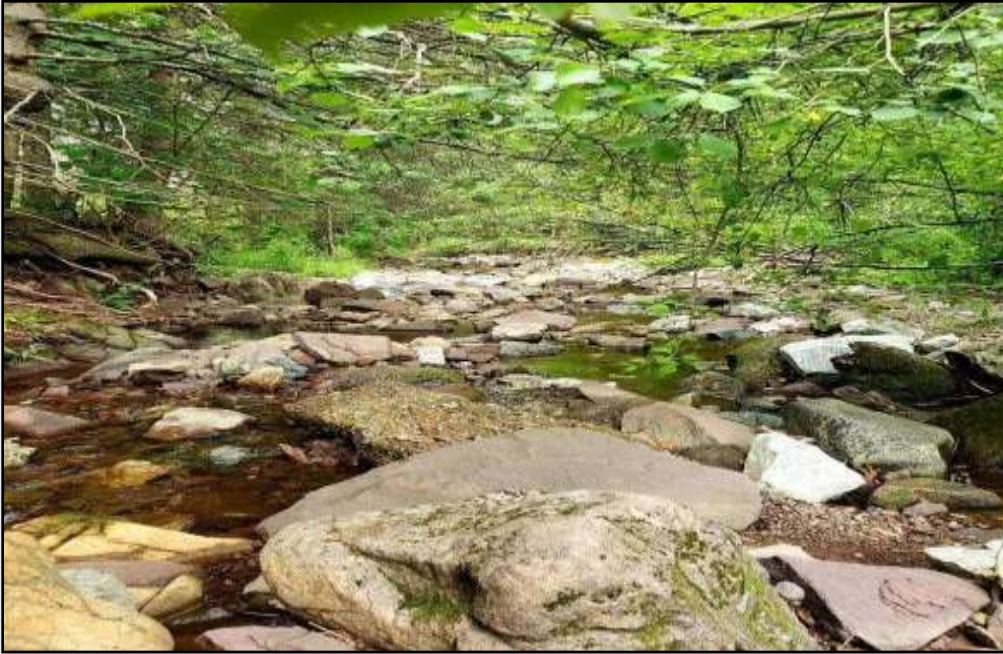
Figure 52. Looking downstream towards the Hammond River in McGonagle Brook. *Photo: S. Blenis*

Riparian Rating: At Risk. The current condition of the riparian zone falls within the good to fair rating; however, increased degradation may rapidly reduce the riparian rating. These sites are typically found in agricultural land, and areas under high developmental stress. In 2008, this site had received a riparian rating of “Fair”; however, this site has degraded significantly. Riparian restoration must become a focus of this stretch.

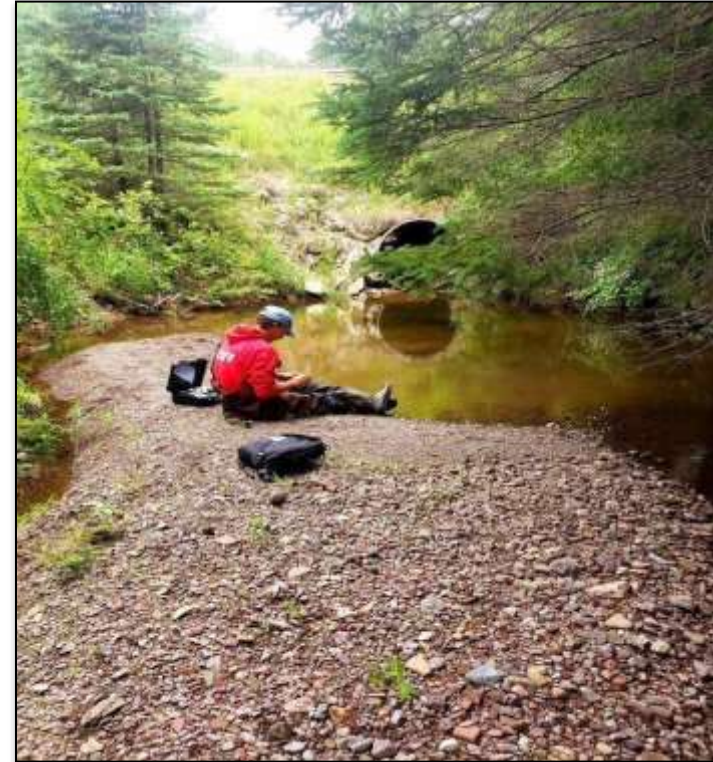
Figure 53. Josh taking a turbidity sample at the culvert pool in McGonagle Brook. *Photo: S. Blenis*

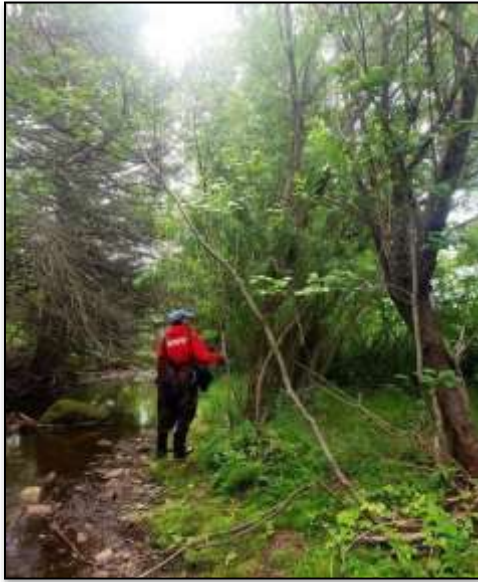
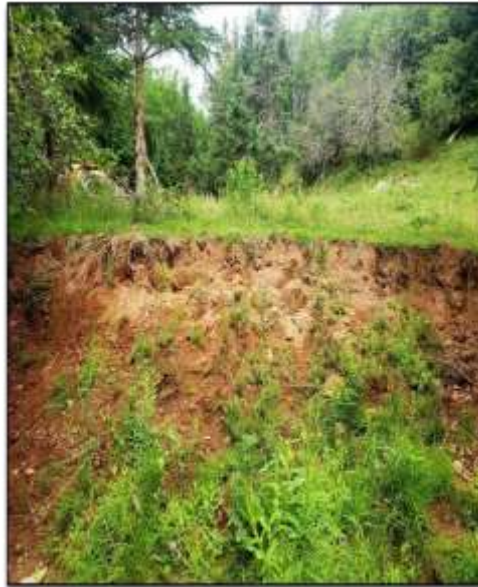
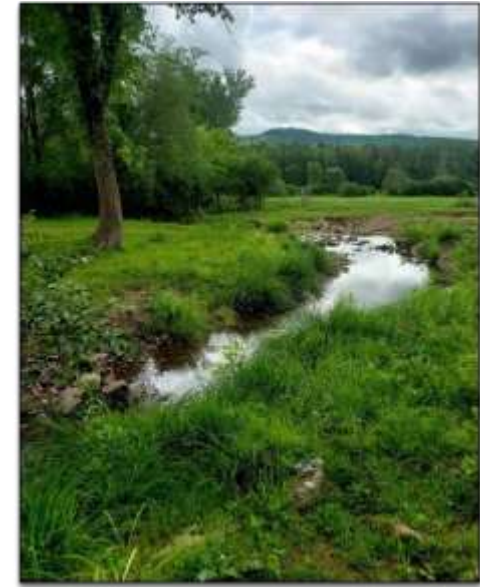
Between 1997-1998, HRAA staff took on a large restoration project along McGonagle Brook. Willows were planted along a 500m stretch of the brook, and their survival rate has been exceptional, as seen in Figure 10, with Josh as a height reference. These willows have helped to restabilize the banks in the upper portion of McGonagle Brook. In 1997-1998, HRAA staff also placed fencing along the field, restricting cattle access. In the 2020 site visit, many of these fences were in disrepair, and cattle once again have unfettered access to the brook. Working with the local landowners to repair these fences should be done in the near future. In 1997-1998, HRAA staff also created a ford by re-sloping part of the property and placing large cobble stones. This area has become severely compacted, and requires new cobble stones. At the confluence point where McGonagle enters the main stem Hammond River, a section of approximately 800m of riverbank has become severely eroded and needs riparian restoration work. Addressing this issue is paramount, because it may be increasing sediment in critical salmon habitat in the pools below (Silver Hill, Robichaud and Tabor Bridge Pools). Overall, McGonagle should be an upcoming focal point for riparian restoration activities- it already offers a solid base from the work performed 23 years ago, and with a little fixing and planting, this site could be a great demonstration site to showcase HRAA's riparian work. Incidental observations of common milkweed throughout the tributary and at the confluence point were also noted. *Photos: S. Blenis*

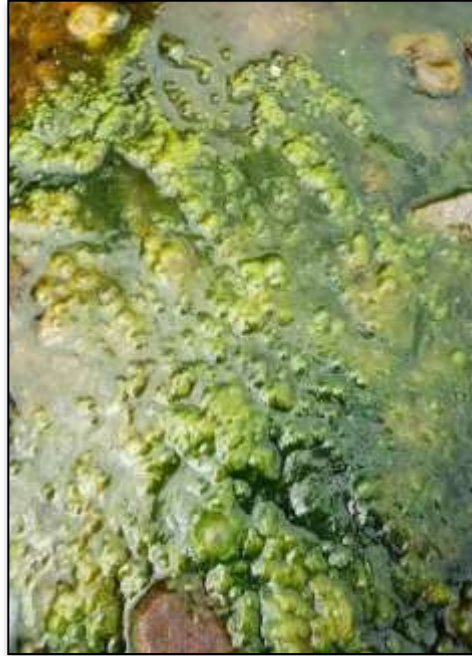
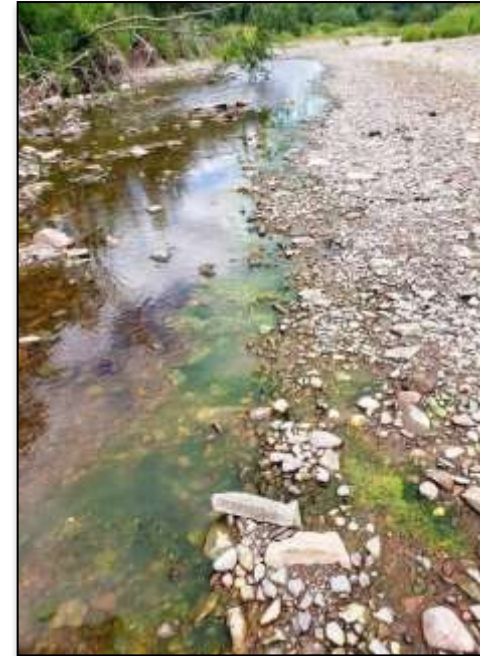
Figures 61 (a & b) Evidence of nutrient loading & erosion in Robichaud Pool. *Photos: S. Blenis*

Action Plan: Additional organic chemistry samples are required at this location. It is highly likely that there are higher levels of phosphate, nitrate, *E. coli* and total coliforms at this location.

HRAA should also reach out to surrounding landowners to discuss riparian restoration projects and the importance of limiting livestock access to the river.

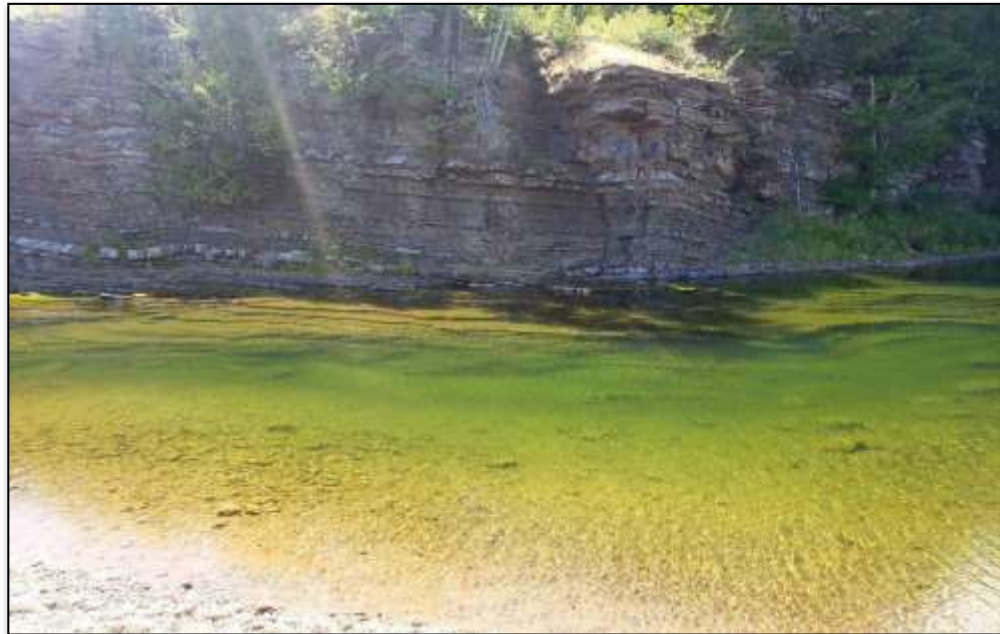
Figure 65. Color shifted in August to bright green. *Photo: S. Blenis*

Water Classification: Class A. No point source pollution discharges within this reach; however, the effluent from the Upham East Gypsum mine is being pumped into the river approximately 200 meters upriver from Tabor Bridge Pool. Dissolved Oxygen levels are above recommended limits (9.5mg/L) and *E. coli* levels are under the upper-level limits (50/100mL). A more robust water quality monitoring plan should be instated in this pool, to help determine the cause of the color shift in late summer, and to ensure that the HRAA is properly monitoring the discharge from the mining project.

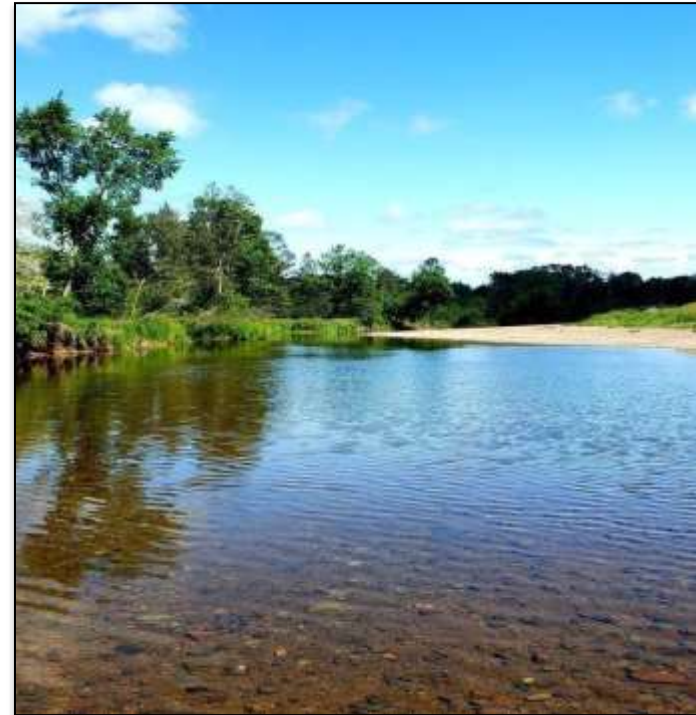
Figure 67. Upriver view of Firehall Pool. Photo was taken early June before the water temperatures reached their peak level. Substrate was clear with minimal benthic mats or algae buildup- a stark contrast to what this pool looked like at the end of July to mid-August- the rocks were covered in benthic mats, and large clumps of algae had formed throughout this pool. Firehall Pool is one of the nicest swimming and fishing holes in the watershed, with minimal littering or garbage. *Photo: S. Blenis*

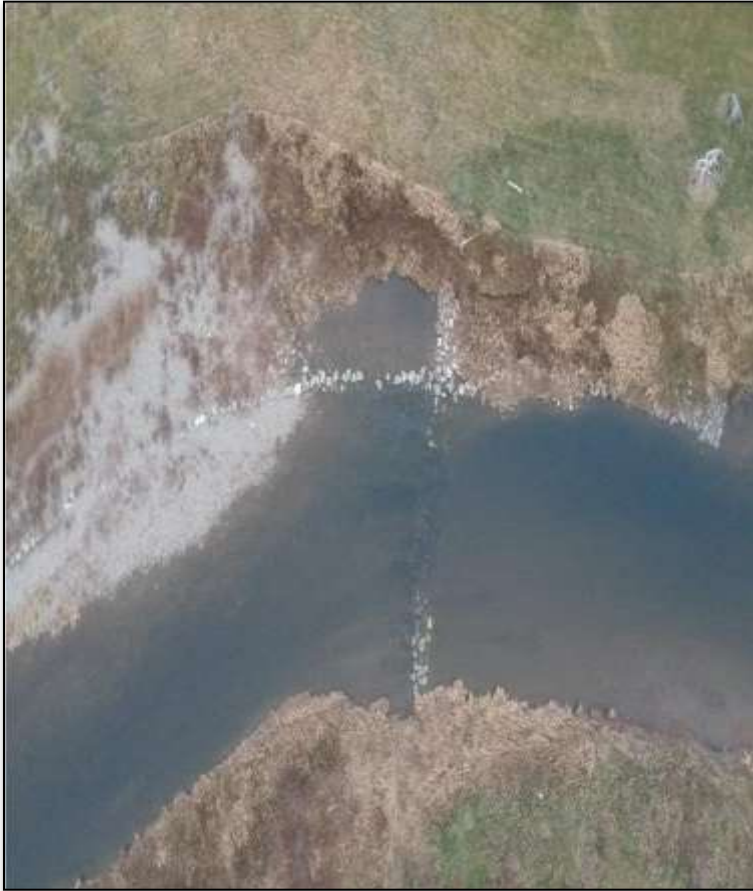
Figure 69. Drone footage from 2020, showing remnants of the 2005 structure, and continued erosion.
Photo: M. Adams.

The 2005 solution to the ongoing erosion issue was to build 'groynes'- approximately 15 rock structures were built instream to deflect the main current of the river away from the unstable outer bank towards the center of the stream. These structures were to protect the bank, allowing it to be stabilized by the addition of riprap and large-scale vegetation. These structures were generally wedge-shaped and were abled upstream at approximately 5 degrees, forcing current towards the center of the stream. This project was designed to ensure long term stabilization, specifically in the groyne portion. The geotextile placed beneath the riprap was to keep the material supporting the rip rap from washing out under precipitation events until further natural stabilization occurs. Staff planted 500 willows along the bank and removed rebar that was in the river.

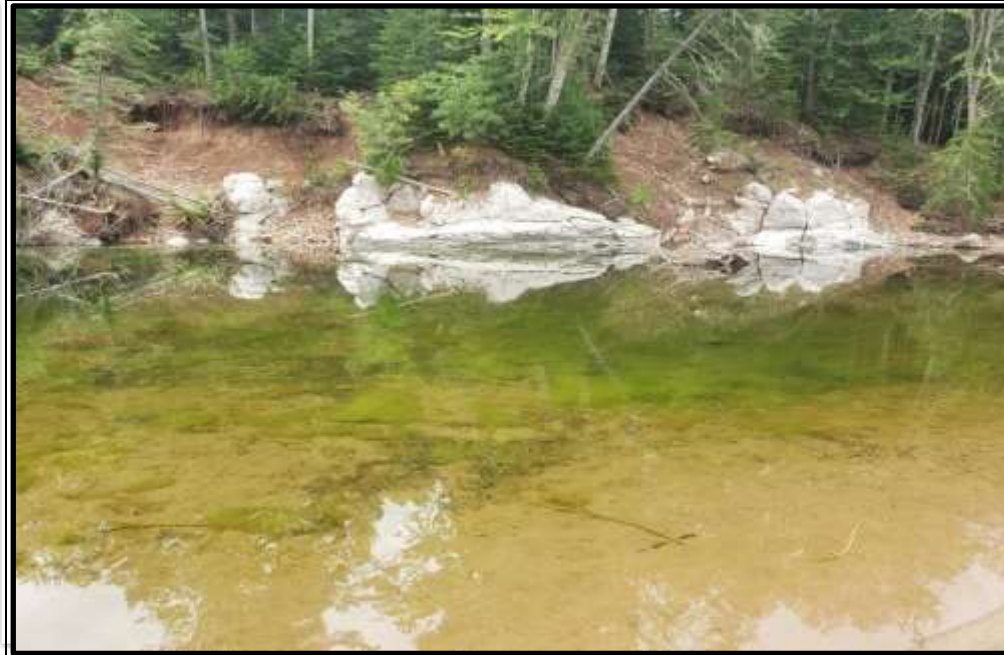
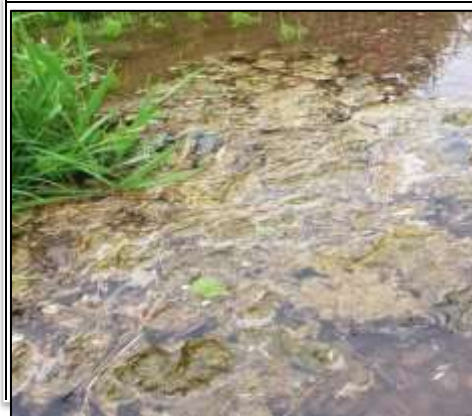
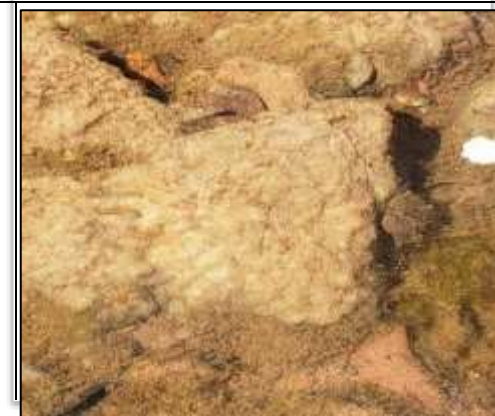
A robust water monitoring program may shed some light into the drastic color changes this pool experiences in the pinnacle of summer. Normally, this pool is quite tannin in color; however, as the summer water temperature increases, so too does the algal bloom and vibrant green discoloration of this pool. Benthic mats were scraped from many rocks in this location and sent to the University of New Brunswick for additional analysis, to determine if they contain cyanobacteria.

Figure 71 (a,b,c) Evidence of nutrient loading and filamentous algae growth in August, as well as floating benthic mats, and mats on substrate
Photo: S. Blenis

Action Points: In depth water quality analysis is warranted at this location. Gerald's Beach is approximately 600m downriver from Scoodic Brook, which regularly exceeds *E. coli*, coliform, phosphate, and nitrate recommended levels. A water quality monitoring program to sample for organic and inorganic chemistry should begin in 2021 on a monthly basis.

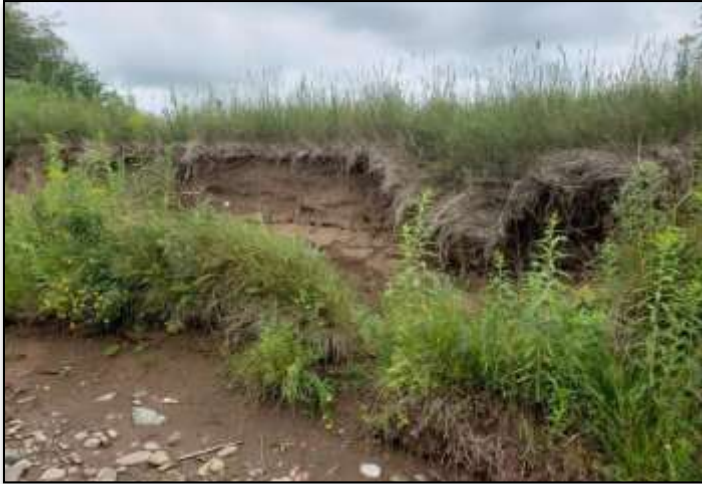
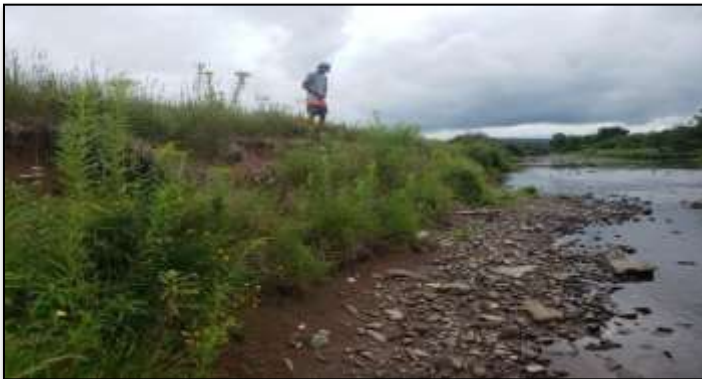
Figure 72. Sections of erosion along the riverbank near a hayfield.

Erosion exists along the banks for approximately 1km in length. This is increasing the sedimentation in the Hammond River, particularly into the pools below O'Dell Beach, including Swimming Hole Pool, Smith's Pool, Kilpatrick's Pool, and Station Pool, all of which are known holding pools for Atlantic Salmon.

HRAA should reach out to the landowner, JD Irving Ltd, to develop a collaborative plan to help address the significant erosion that is occurring along the left bank. Years ago, this beach and pool was predominately gravel, and a known spawning area; now the substrate is primarily sand. Addressing this issue is pivotal for the future success of the Hammond River, as this stretch is greatly influencing the sedimentation overload downriver, impairing salmon spawning grounds, and overall impacting the health of the ecosystem.

Landowner is interested in working with the HRAA to restore the riparian buffer, and HRAA has since submitted a large-scale proposal for restoration, approval is still pending.

Remediating this area is a top priority moving forward. Should we fail to promptly address this situation, it will have dire consequences for salmon migration to the northern part of the watershed.

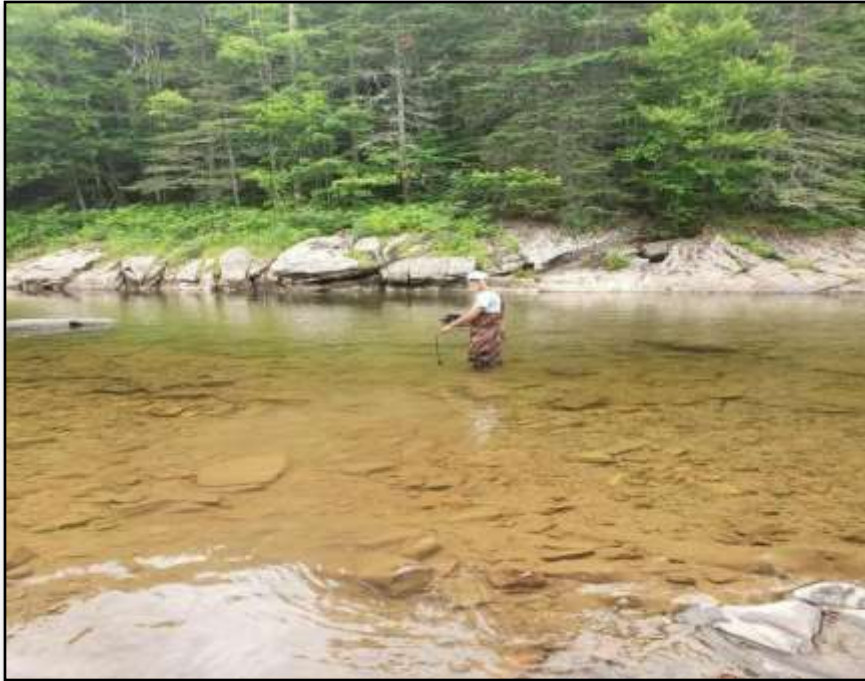
Figure 74. Josh Kelly taking a YSI reading from Swimming Hole Pool. *Photo: S. Blenis*

Site Characteristics: Sediment is very noticeable in this pool and might be caused by the severe erosion upriver at O'Dell Pool.

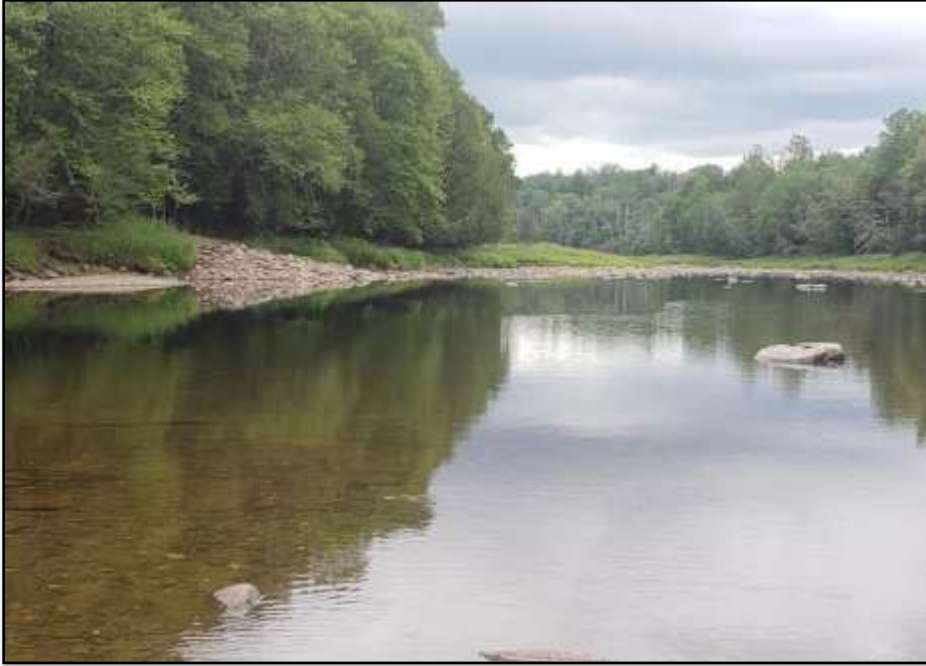
Figure 77. Standing in the middle of Twin Pool #2, looking downriver. *Photo: S. Blenis*

Site Characteristics: Downriver from Twin Pool #1, rock has been added on an eroding left bank, stabilizing the bank.

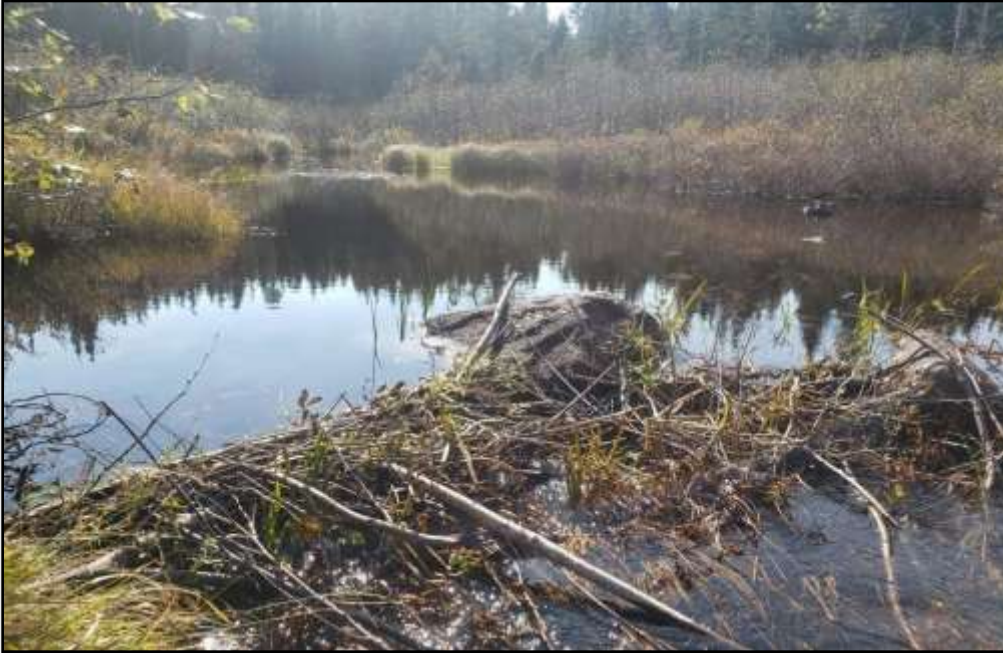
Figure 82. Swamp and wetland matrix region of the upper portion of Isaac Brook, with significant beaver activity. *Photo: S. Blenis*

A full habitat assessment of Isaac Brook was not complete during 2020 and should become a priority for the 2021 season. The headwaters for Isaac Brook is Tracy Lake, and eventually Isaac Brook meets up with Hanford Brook, to enter the main stem Hammond River. In the future, HRAA should undertake a full habitat assessment of Isaac Brook, including water quality samples and electro-fishing. Efforts were taken to determine if any historical HRAA work had been done on Isaac Brook; however, nothing has been found yet.

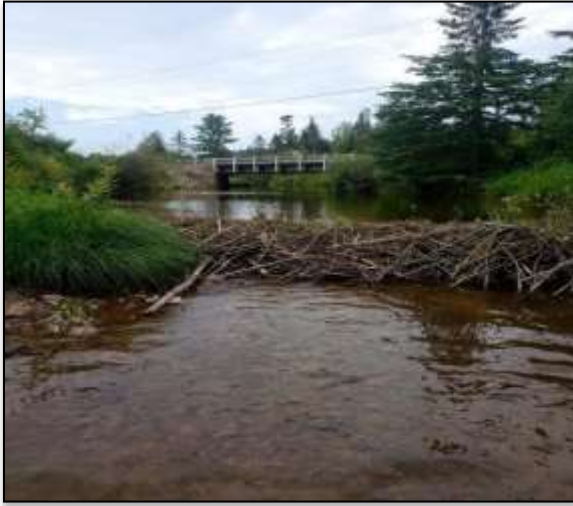
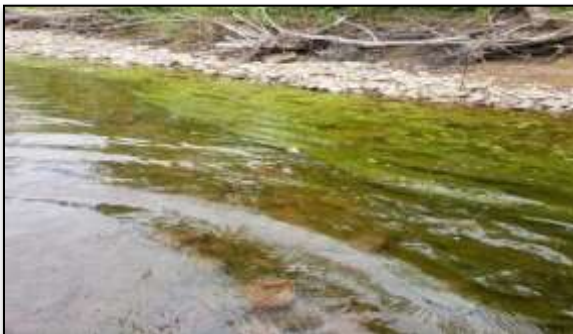
Figure 84 & 85. A large beaver dam at Hanford Bridge over Porter Brook. Evidence of nutrient loading & filamentous algae. *Photo: S. Blenis*

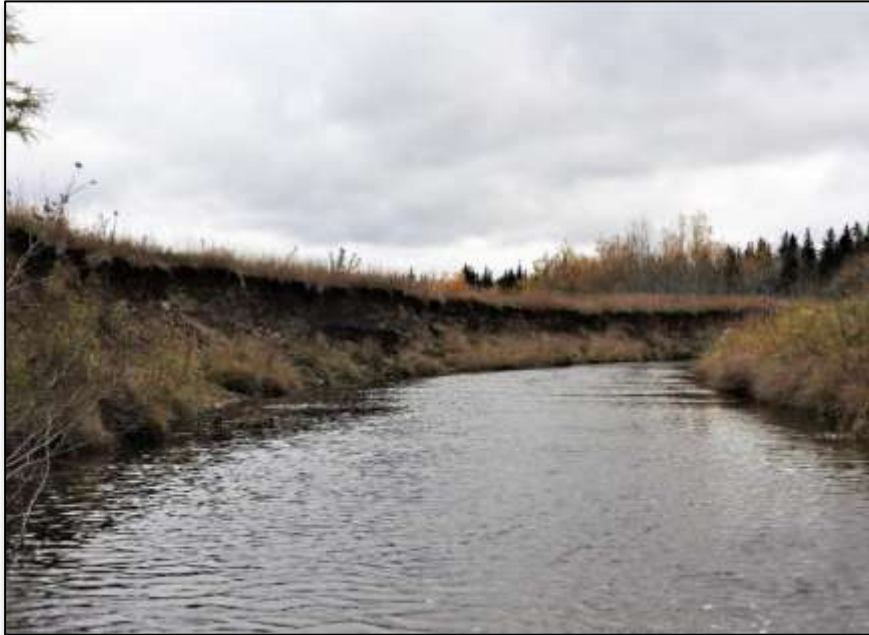
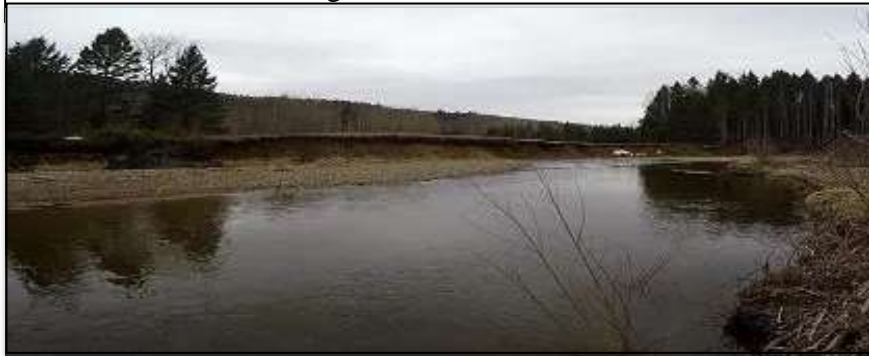
Figure 89 & 90 Lower portion of Germaine Brook, in an agricultural zone, with no riparian buffer. Significant erosion is occurring. *Photos: J. Blenis, 2019*

Restoration: In recent years, poorly vegetated banks and erosion has caused channel instability and a diversion of the brook from its original flow pattern. These changes have coincided with a significant decline in annual redd (salmon nest) and juvenile (fry and parr) counts in the brook. Erosion in Germaine Brook has led to accumulated fluvial deposits and the formation of bars on the stream banks and presumably siltation in the mainstem Hammond River downstream. In 2016 and 2017, a restoration plan was developed to stabilize the stream bank and control erosion in the area (funded by the Recreational Fisheries Conservation Partnerships Program). Detailed restoration plans were completed by Dillon Consulting. Both the restoration reach, and the downstream reach, are excellent salmon spawning habitat which would benefit from decreased sediment supply. Many pools on the mainstem of the Hammond River have experienced infilling and would also benefit from a decreased sediment supply.

Action Plan: Moving forward, HRAA needs to revisit these previous restoration plans. Updates should be made, and then HRAA should seek funding in order to carry out a large-scale restoration project as soon as possible. The basis of a plan exist now we need to find the right funding partners and contractors in order to carry out this project, and it needs to be done immediately. Restoration of Germaine Brook needs to be considered absolutely essential.

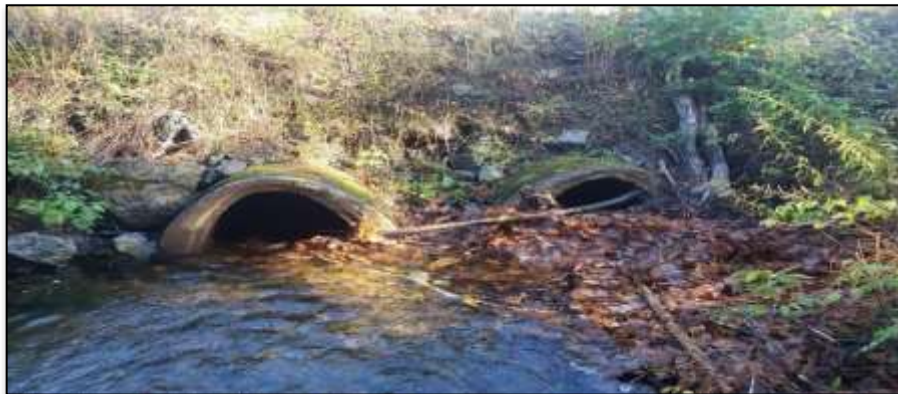
Figure 92 & 93. Older concrete arch culverts clogged with leaf litter, and another upstream view of the stunning Clyde Brook.

HRAA should also keep a close eye on these aging culverts- it should be a priority to keep Clyde Brook as it naturally occurs, with minimal interruption from degrading culvert systems.

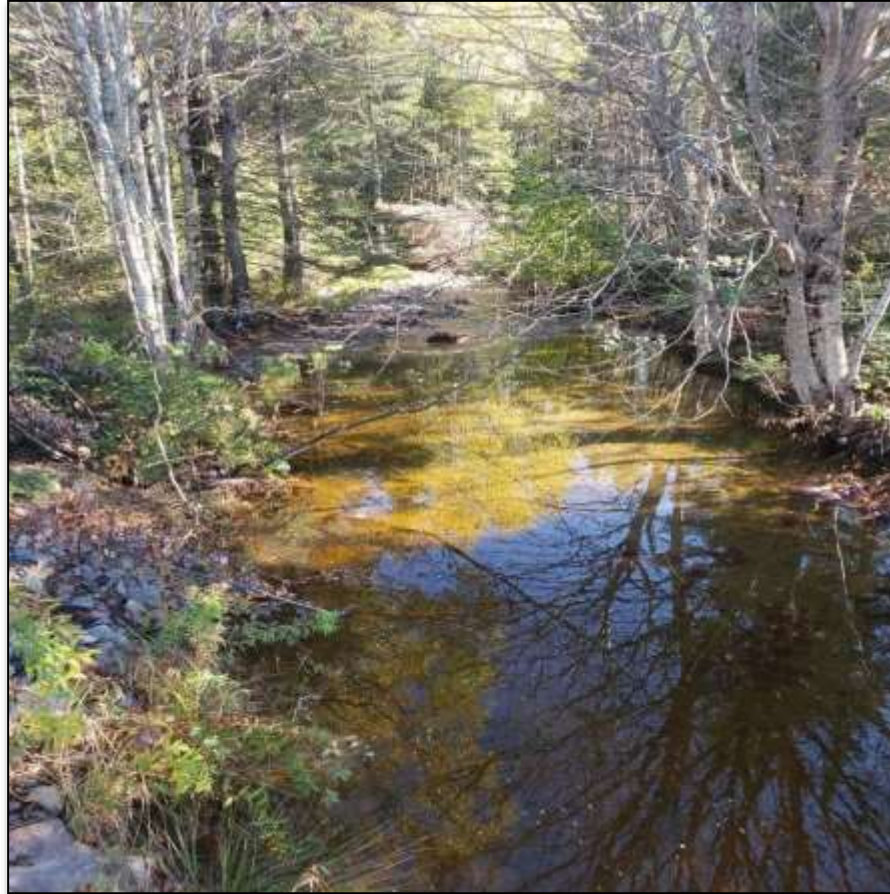
Figure 96. Unusual substrate that does not appear to be naturally occurring. *Photo S. Blenis*

Action Points: HRAA should undertake discussions with PCS Potash Mine and develop a routine water quality monitoring program of Monnett Brook, given its close proximity to the brine line. Any spills or leaks of the aging brine line would be detrimental to the Hammond River, and it is advised to begin a robust monitoring plan in 2021. The substrate in the brook within the first 200m upstream and downstream of the bridge do not appear naturally occurring- discussion should be had with PCS to determine if this was part of the brine line installation. Fish population in Monnett Brook is currently unknown; efforts should be taken to include this stretch in future electro-fishing efforts.

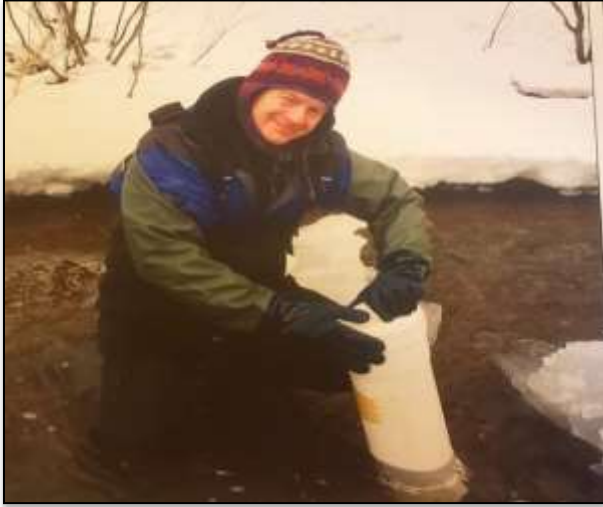
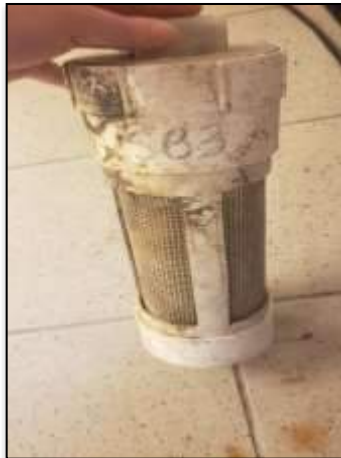
Figure 100. Sandy Mackay, former Director of Education and Public Outreach, with a sediment tube in Scoodic Brook in 2008.

Figure 101. The recovered tube in 2020!
Photos: S. Campbell & S. Blenis

Sedimentation Studies: Part of the Watershed Management Plan 2008 included a sediment study performed on Scoodic Brook to monitor survival rates of incubating salmon eggs. The results found high levels of sediment caused a mass die off in salmon eggs prior to reaching eyed development stage. In 2006, the first tube had a survival rate of 60%, while the second tube had a mortality rate of 100%. In 2007, the sediment study continued, and the first tube revealed an 86% survival rate; however, the second and third tube were lost during high water conditions, and the sediment study was then discontinued.

Sedimentation loading in Scoodic Brook continues in 2020. During the habitat assessment, staff noted that the substrate of Scoodic Brook contained a high density of sand and silt, and that the substrate is at least 50% embedded. By a stroke of luck, staff noticed a small, white piece of plastic sticking out of the substrate- it was a sedimentation tube from 2008! It weighed approximately 5lbs and was completely full of 12 years' worth of sediment.

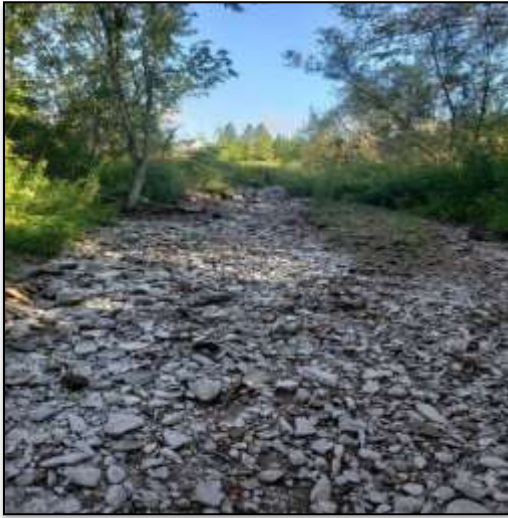
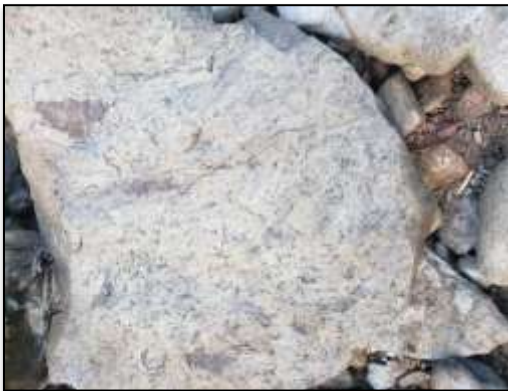
Figure 103. Upstream view of Scoodic Brook in the summer.

Figure 104. Potential cyanobacteria mat on rock. *Photos: S. Blenis*

Cyanobacteria Sampling: Given the high levels of phosphate, nitrate, *E. coli* and fecal coliforms, Scoodic Brook is a prime candidate for cyanobacteria growth. HRAA staff deployed a passive SPATT collection device approximately 600m downstream of Scoodic Brook, and results are still pending. Throughout the summer, staff also collected multiple samples of benthic mats. Some mats were taken when there was still water in the brook, and they were green in color. Other mats that were sent for processing were floating, brown mats. The last round of mat sampling occurred when Scoodic Brook ran dry, and evidence of benthic mats still clung to the rocks. These samples are still being processed by the RPC laboratory in Fredericton.
