The Hammond River Watershed Management Plan

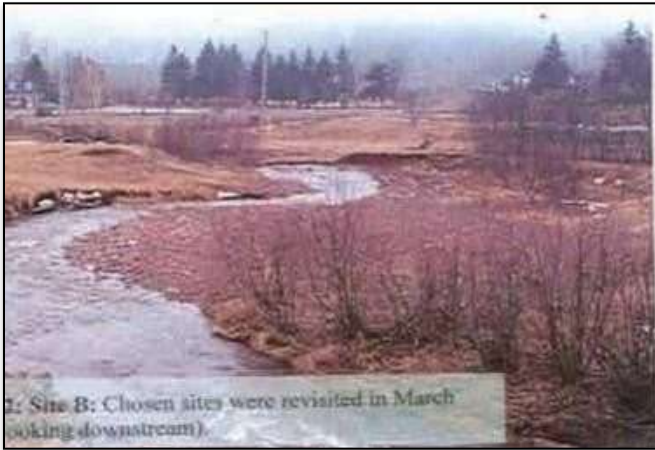
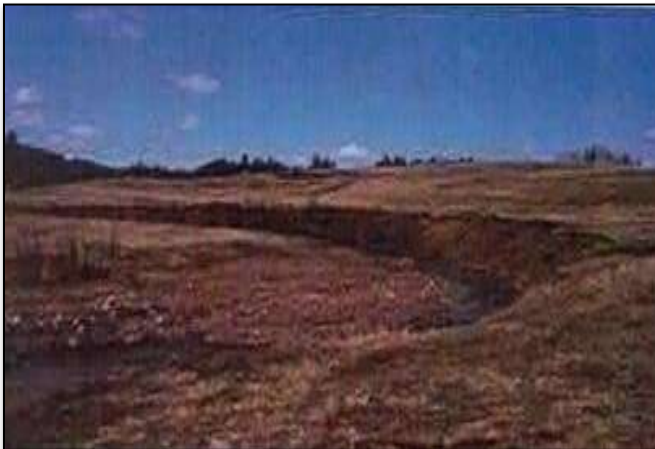
Figure 106. View of O'Dell Brook, and the steep, eroded bank. Photos from *HRAA's River Restoration 2000*.

The banks have almost completely restabilized. There is still one fairly steep slope that is bare stable; however, the landowner is open to having HRAA continue work revegetating these banks.

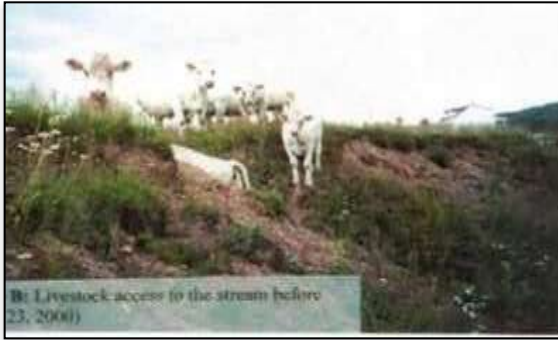
Figure 109. Pre-2000, livestock used to have full access to O'Dell Brook. This contributed to the bank degradation, as well as fecal coliforms and *E. coli* entering the watercourse. Water samples were taken after fence installation and determined there was 0 cfu/100mL of *E. coli* or fecal coliforms in the watercourse.

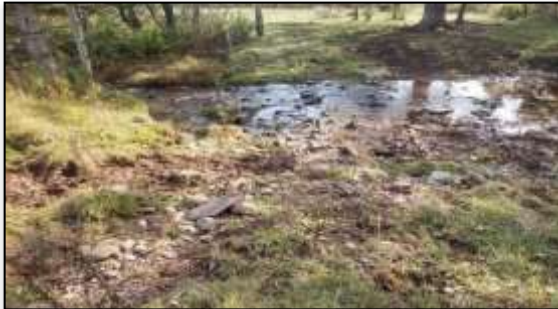
Figure 110. HRAA helped to install 300 meters of fencing along both sides of O'Dell Brook, and created a single area for livestock to access the brook, instead of allowing them to have free range. This access site still exists in 2020; however, some of the fence posts need replaced, and some of the barbed wire along the access point needs replaced as well. Further up O'Dell Brook, there are a few additional sites where livestock can access the brook- new discussions with the landowner should take place to determine if he would be willing to allow the HRAA to install additional fences.

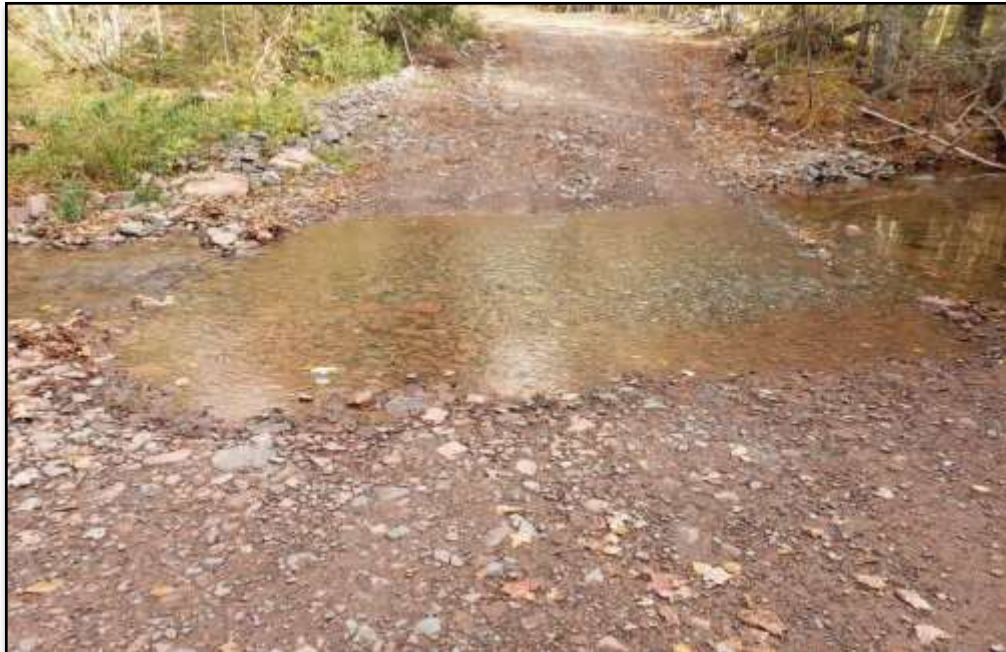
Figure 115. A dirt road crosses through the lower portion of Freddy's Falls tributary. A culvert or ford would assist in decreasing turbidity and sedimentation into the lower stretch of Freddy's Falls, and subsequently the Hammond River. *Photo: S. Blenis*

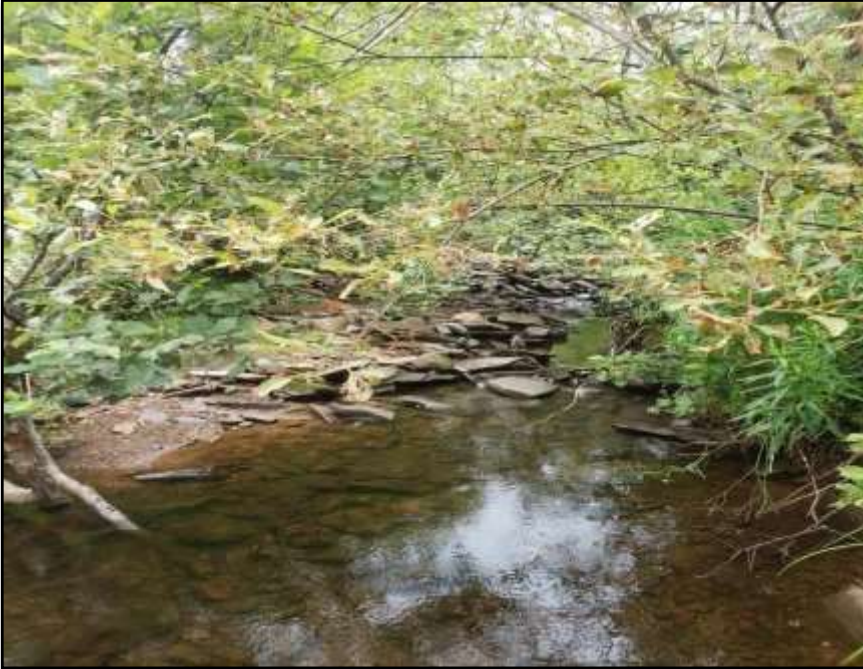
Site Characteristics: This cold-water tributary offers excellent juvenile habitat; however, there is a barrier to fish passage, and fish are not able to access the area above a severely hung culvert.

Action Points: This tributary was assessed during our 2020 Culvert Assessment, which determined that this culvert is ranked 2nd for priority for repair/replacement in the watershed. This culvert is significantly hung and completely obstructs fish passage, and many anglers visit this pool targeting trout. In advance of repair, HRAA should install an educational sign on the fishing restrictions at this pool. The landowners have expressed concern for the scouring and erosion- HRAA should make restoration a priority and begin planting willows and shrubs around the degraded banks in the spring of 2021.

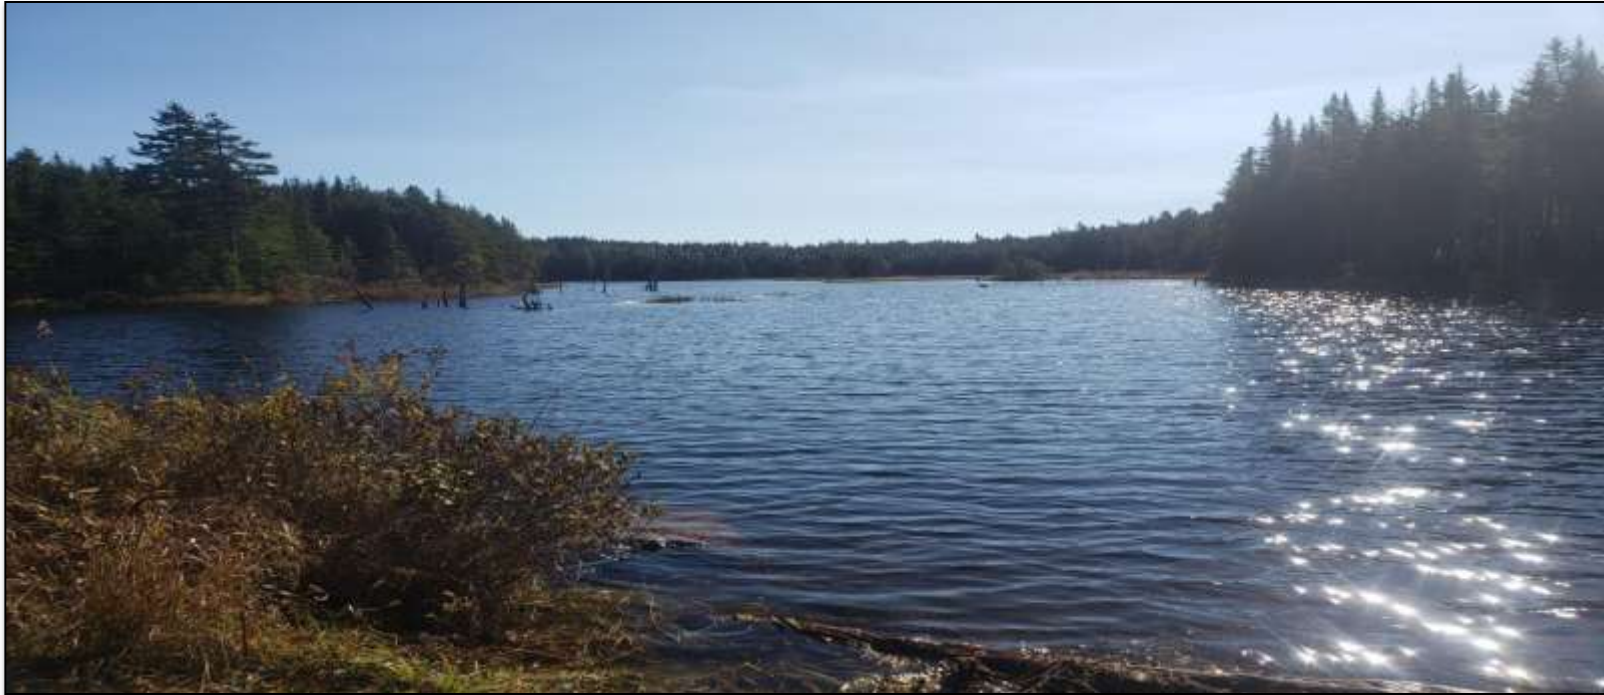
Tracy Lake is the headwaters for the Isaac Brook. This lake has not yet been assessed by the Province of New Brunswick, and no historical HRAA data on Tracy Lake has been found, and it does not appear that Tracy Lake was ever part of a provincial stocking program. Very little information in general has been obtained on Tracy Lake; however, this lake will be included in HRAA's 2021 Lake Assessment. Part of the lake assessment will include an examination on fish community, which may be extremely interesting in Tracy Lake, given the lack of current information. HRAA staff will set minnow traps in the lake at approximately 2 feet in depth and will leave the traps set for 2 hours before retrieving, counting & recording catch. HRAA will use a beach seine and comb the shallows of the lake, to capture any bottom-dwelling fish, and record our observations and each month, HRAA will set up 4 fyke nets in the lake, perpendicular to the shore. HRAA will retrieve the fyke nets and record the number of fish and species. Expanding our current knowledge on Tracy Lake and how it relates to the Hammond will be key in 2021! **Figure 119.** Tracy Lake. *Photo: S. Blenis*

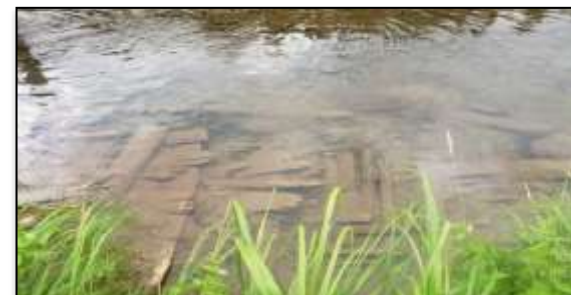
The Titus Mill area used to house a large wood mill over a hundred years ago, and remnants can still be found in the Titus Mill Pool (**Figure 129**). Oddly, HRAA's *Salmon Management Plan 2009* notes: "Historical information cites that damming for use in mechanically powering a lumber mill in the Titusville area caused the obstruction of passage and later the reduction/extirpation of returning spawners in Salt Springs brook (a tributary to the Hammond). Although this threat has been long since removed, very few juvenile Atlantic Salmon appear in electrofishing surveys in this area." Our findings in 2020 contradict these observations from 2009, as Titus Mill tested positive for salmon DNA, and Salt Springs Brook produced juvenile salmon, and had the highest density of redds in the watershed. Perhaps it was an off year in 2009!

Figure 129. Remnants still remain from the old wood mill. *Photos: S. Blenis*

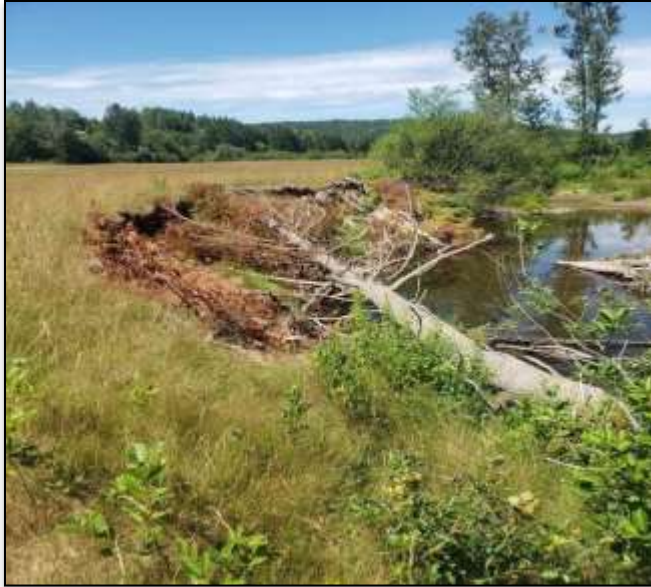
Riparian Rating: At Risk. The current condition of the riparian zone falls within the good to fair rating; however, increased degradation may rapidly reduce the riparian rating. These sites are typically found in agricultural land, and areas under high developmental stress. **Figure 134 & 135** highlight an area of high concern in the lower reach of Salt Springs brook, which occurred during the summer of 2020. A proposal for funding has been submitted by HRAA in 2020, in the hopes of remedying this major erosion as soon as possible. The landowner has worked with the HRAA for decades, and we hope that we will be able to restore this section of their property in the very near future.

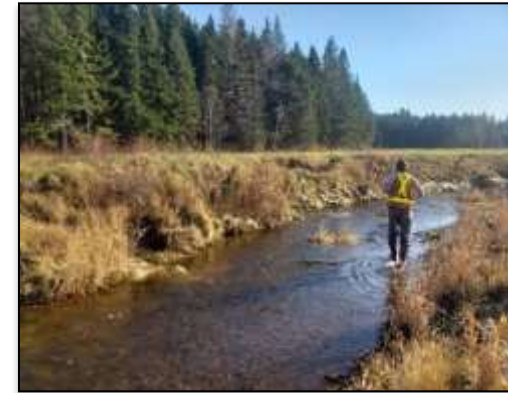
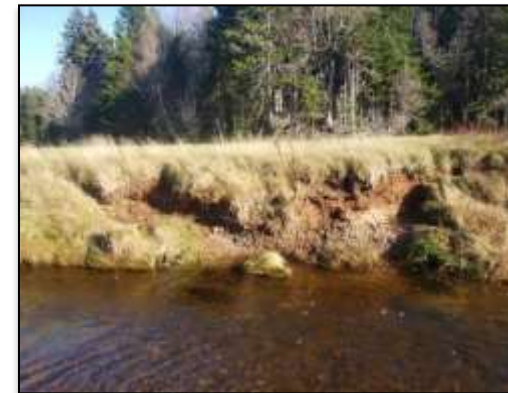
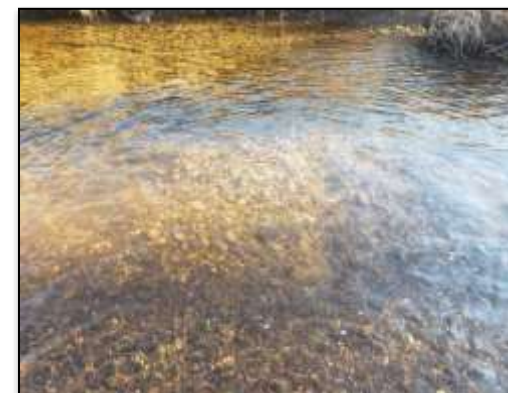
Figure 136 & 137- Erosion and undercut banks that will soon give way and increase sediment loading into Salt Springs were noted along a 1.5km stretch of the lower Salt Springs, in the area that had the highest density of salmon redds. Some of these redds, like **Figure 138**, were located almost directly below these unstable banks, and any heavy rain events may spell survival disaster for the eggs deposited in these redds.

Salt Springs brook should therefore be considered one of the most vital, and perhaps one of the most overlooked, salmon-bearing tributaries of the Hammond River. Salt Springs should be considered top priority for all future restoration efforts, due to its density of redds, suitable gravel substrate, and salmon parr found during electro-fishing. We need to be proactive, and begin an intense riparian restoration program as soon as possible, if we wish to preserve this critical salmon habitat.

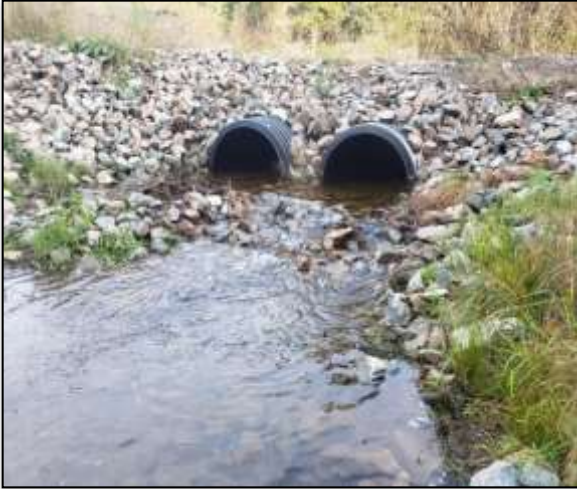
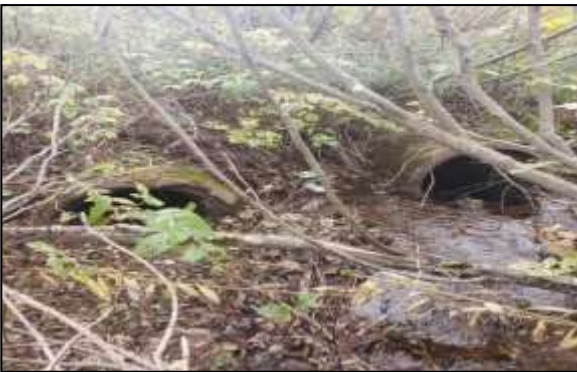
Figure 10. Salmon parr have been observed in the outflow pool of these dual culverts in the upper reach.

Figure 10. Severely compacted dual culverts offer little passage mid reach.

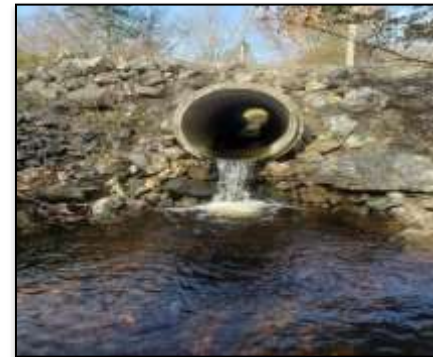
Observation: A significantly hung culvert is detrimental to this tributary. Landowners observed multiple dead trout in the summer, as they were not able to get further up the tributary into the shaded section. Electro-fishing or eDNA to determine salmon presence is a priority, to establish this as a worthy candidate for repair. Landowners also concerned about high water events- water floods the road, not through the culvert, increasing scouring of the outflow pool.

Figure 143. Severely hung culvert, does not allow fish passage, and poses a safety risk to motorists. *Photo: S. Blenis*

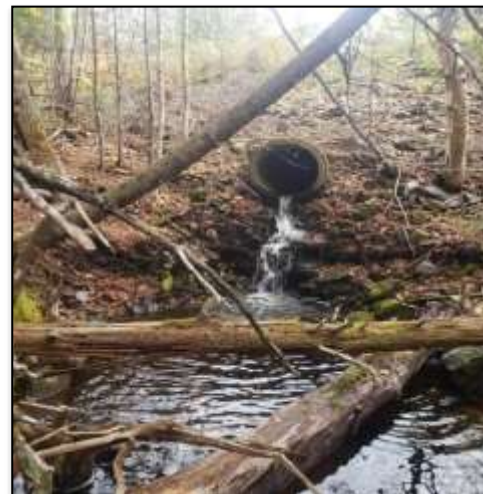
Figure 146. Hung culvert, with fairly deep outflow pool. Tributary should be assessed for fish presence, to determine priority of culvert replacement. Water Quality needs assessed in 2021. *Photo: S. Blenis*

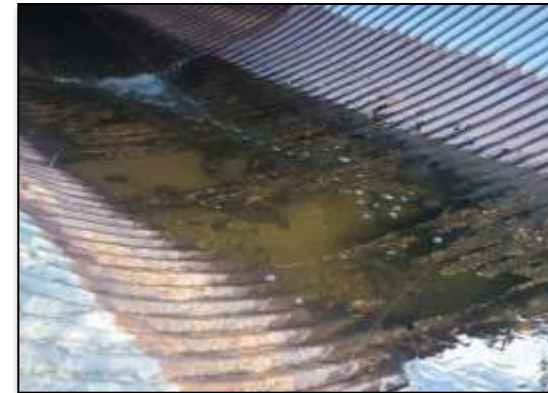
Site Characteristics: Cold-water tributary that enters the Hammond above Carson's and Carter's Pools. Culvert is slightly hung and is in terrible shape. Electro-fishing should be performed in Desmond Brook to assist in prioritizing culvert replacement.

Figure 150. Degraded culvert of Desmond Brook. *Photo: S. Blenis*

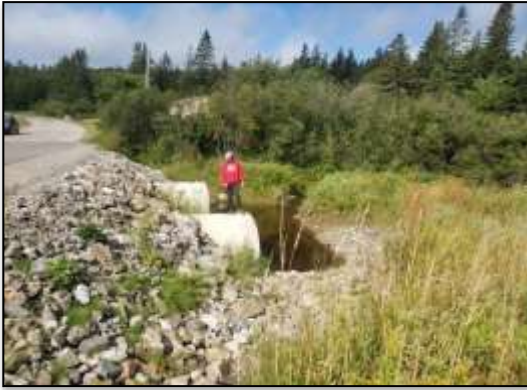
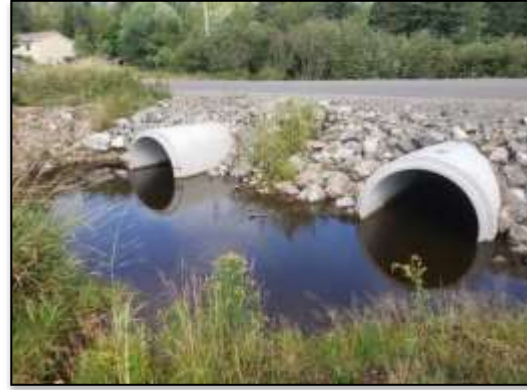
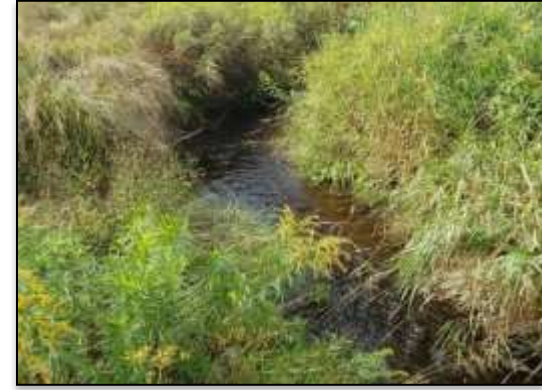
Over the past two years, significant work has occurred on route 860 to upgrade several degraded culverts. The water flowing through these culverts are unnamed tributaries of the Hammond River. **Figure 151 (a,b,c)**, at Lakeside Road, a site that frequently floods in the spring freshet. *Photos: S. Blenis*

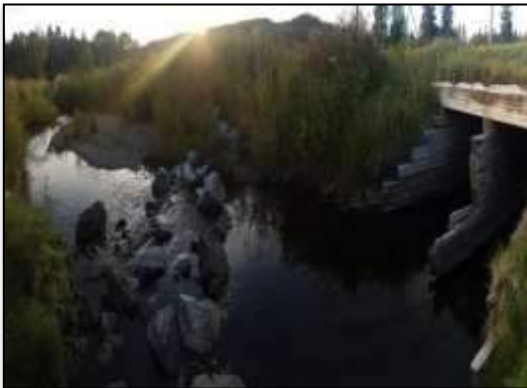
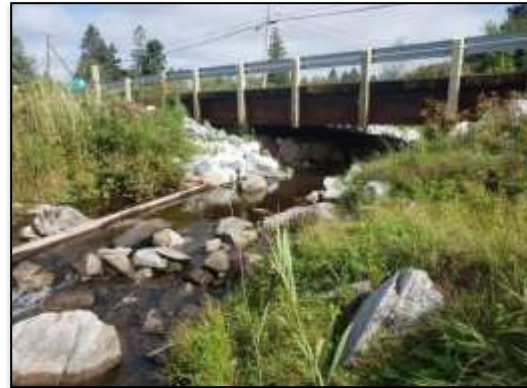
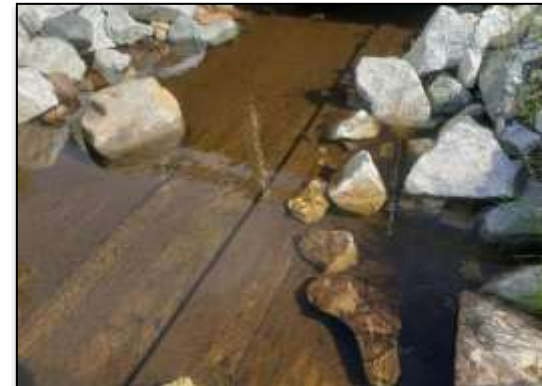
Figure 151 (d,e,f)- This area originally had a wooden box culvert, which miraculously survived many generations of ice shears. This ancient culvert has been replaced with a bridge; however, you can still see the original wooden base beneath the bridge. *Photos: S. Blenis*

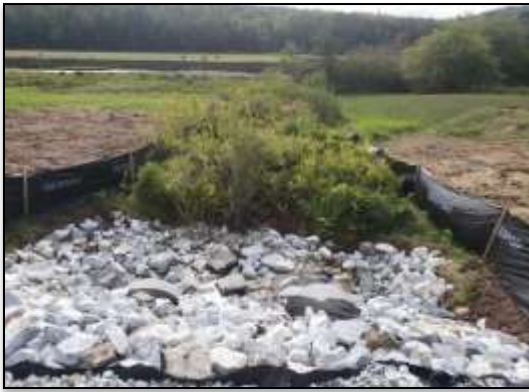
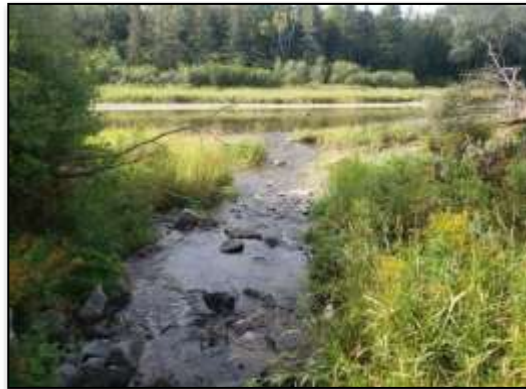
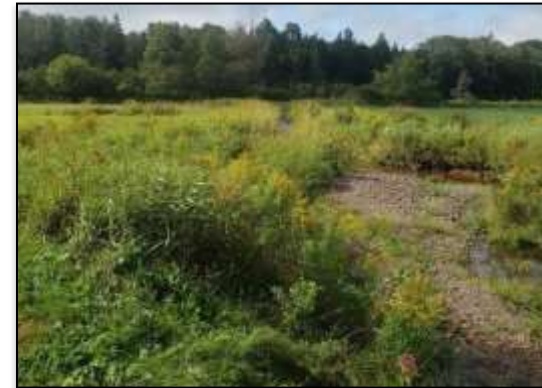
Figure 152 (a,b,c)- while new culvert installation is wonderful, each of these areas would benefit from riparian restoration, to increase the crown closure surrounding these minor tributaries, to ensure that the water that is entering the Hammond is as cool as possible. *Photos: S. Blenis*

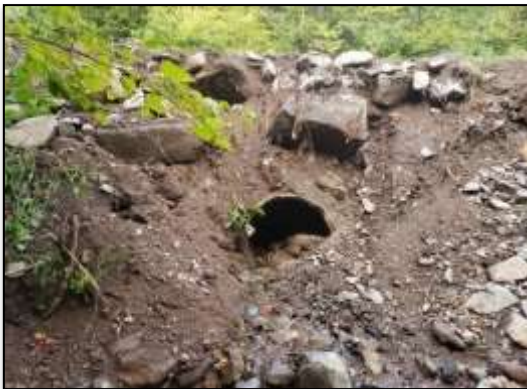
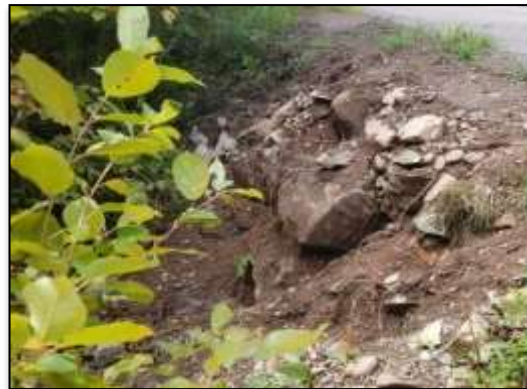
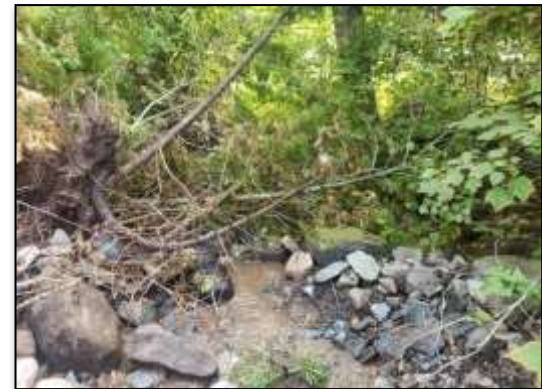
Figure 152 (d,e,f)- A problematic culvert still exists within this area, and is severely impacted, and a safety concern for traffic. The severe erosion is drastically increasing sedimentation, turbidity, and total suspended solids into the Hammond River. *Photos: S. Blenis*

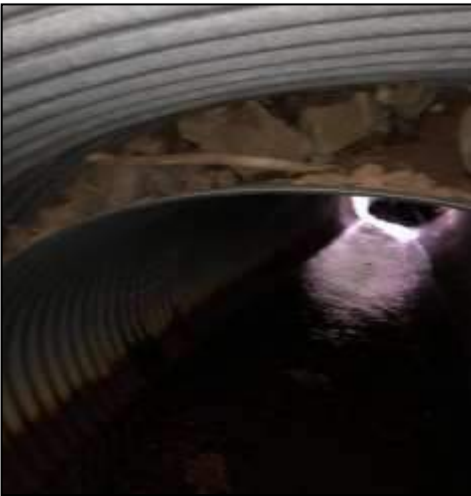
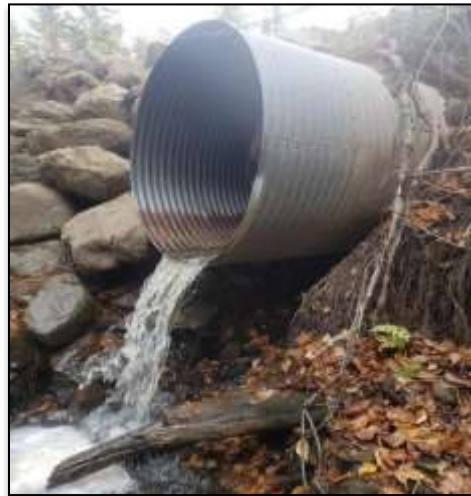
Figure 156 (a,b,c): A severely compromised culvert in the upper reach of Brawley Brook, at the historic 2nd electro-fishing site. This culvert does not allow fish passage, nor does it allow human passage, as the floor of the culvert is almost completely rusted out and it is not safe to walk through. The middle section of the culvert has become severely compacted, and this culvert poses a safety concern for traffic. This culvert is the #1 priority for replacement out of all culverts assessed in 2020.

eDNA: In an effort to justify rapid culvert replacement, HRAA staff decided to take an eDNA sample at the culvert pool, to determine if there was salmon presence, and if salmon were being impacted by the hung culvert. While the sample came back negative for salmon DNA, this culvert still does not allow for fish passage for other fish species, restricting them from entering the rest of Brawley Brook's reach.

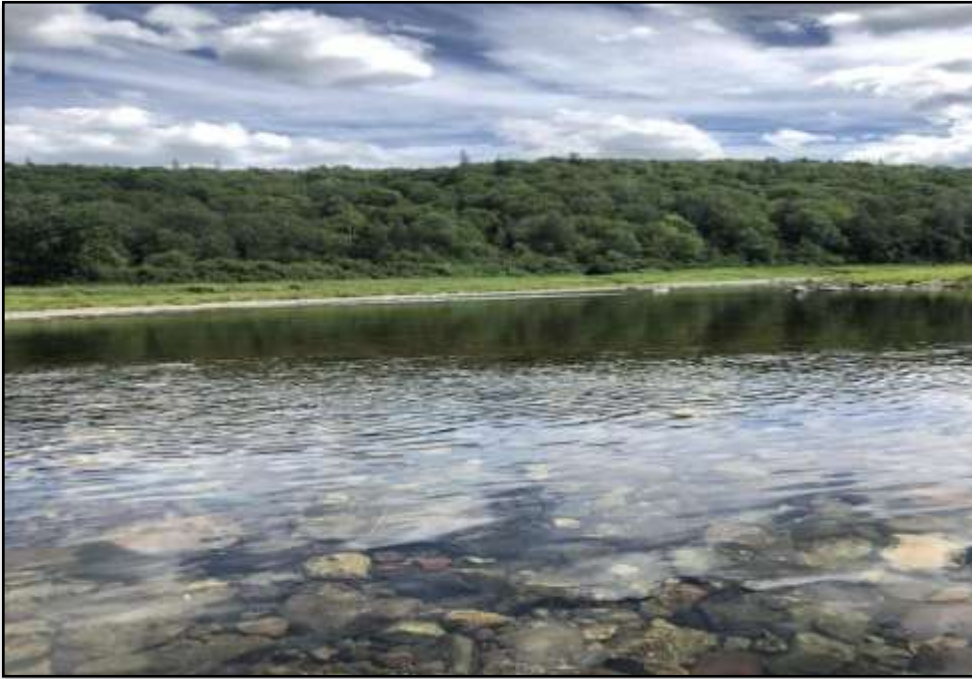
Figure 162. Looking across the pool at Schoolhouse Pool
Photo: J. Kelly

Site Characteristics: A lesser-known pool within the watershed, major erosion begins to occur downriver of Schoolhouse Pool as a result of lack of riparian buffer. Schoolhouse Pool is the first pool of the Tidal Zone.

Bank Stability: Minimal erosion is occurring on the left bank, as it is bare stable (50%). The right bank is a combination of stable (35%), bare stable (10%), and eroding (5%). Zero bank undercutting was noted for both banks.

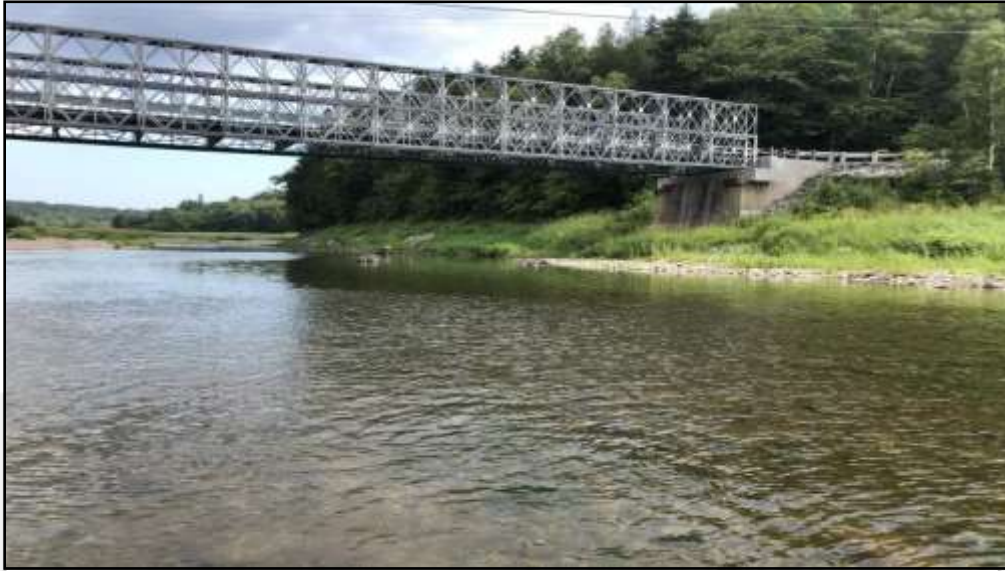
Figure 163. Looking upriver towards the French Village Bridge
Photo: S. Blenis

Site Characteristics: A contractor's overweight excavator crashed through the decking of the century-old, covered bridge spanning the Hammond River on Oct. 5, 2016, forever changing the look of French Village Bridge Pool.

Bank Stability: Vegetated banks are highly sloped, while those without vegetation were found to be shallow. Left bank is a combination of stable (5%), bare stable (40%), and slight erosion (5%). Right bank is less steep and is bare stable (25%) and eroding (25%).

Riparian Vegetation: The French Village area is dominated by agricultural land, and the rightbank is cause for concern. It is mainly grass with a few small wetland areas, and a riparian flood plain. Unfortunately, this is a site of high ATV activity, that continues to rip up the flood plain, increasing bank instability and sedimentation into the river.

French Village Pool, and surrounding area, should be a high priority for future restoration work in the flood plain- without continued monitoring and work, this area will continue to degrade, and have disastrous consequences on the river and its inhabitants.

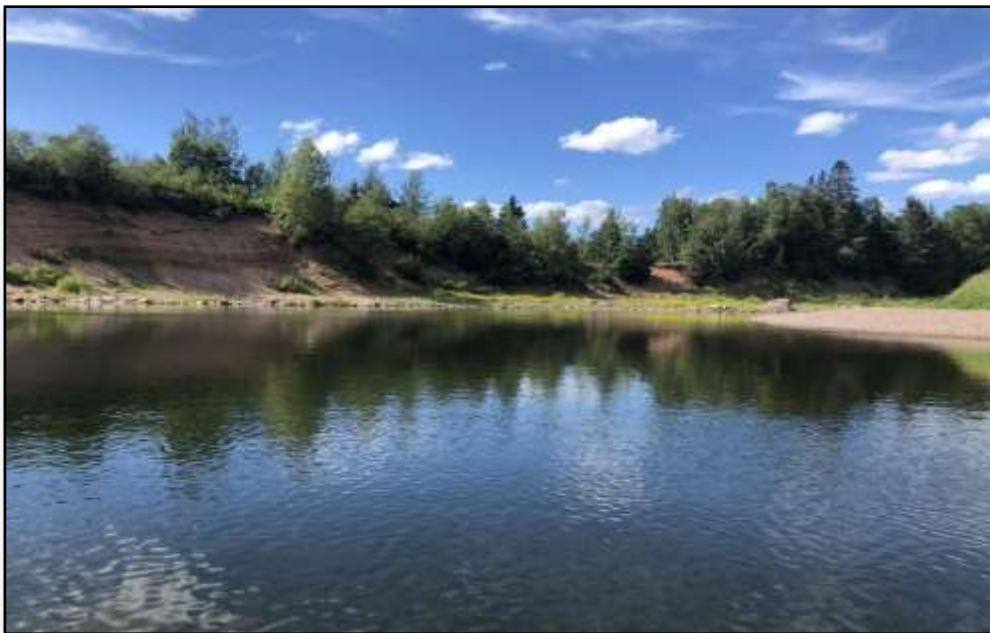
Figure 168. View of Crowley's Pool, taken from Len's Pool.
Photo: J. Kelly

Site Characteristics: A beautiful and productive fishing pool, Crowley's Pool is mired by extreme eroding riverbanks that pose a threat to the river below and the road above.

Bank Stability: Erosion is an understatement. The right bank is slightly more stable (25%) and noticeable erosion (25%); however, the left bank, as seen in **Figure 168** is completely eroding and not stable at all.

Between 2016-2017, HRAA enlisted the help of Dillon Consulting to perform a preliminary review of the hydraulic mechanisms threatening bank stability and infilling of Crowley's Pool. These drivers formed the basis of subsequent efforts to design remediation measures to stabilize the bank slope and restore habitat in Crowley's Pool. As part of this study, a set of conceptual design recommendations were provided to HRAA to guide future restoration activities at Crowley's Pool.

HRAA staff in 2020 have yet to find any follow up on Crowley Pool restoration proposal. The approximate budget proposed for this project is \$579,004.00, and it is recommended that HRAA staff begin to seek out appropriate funders as soon as possible, and to put this plan into action!

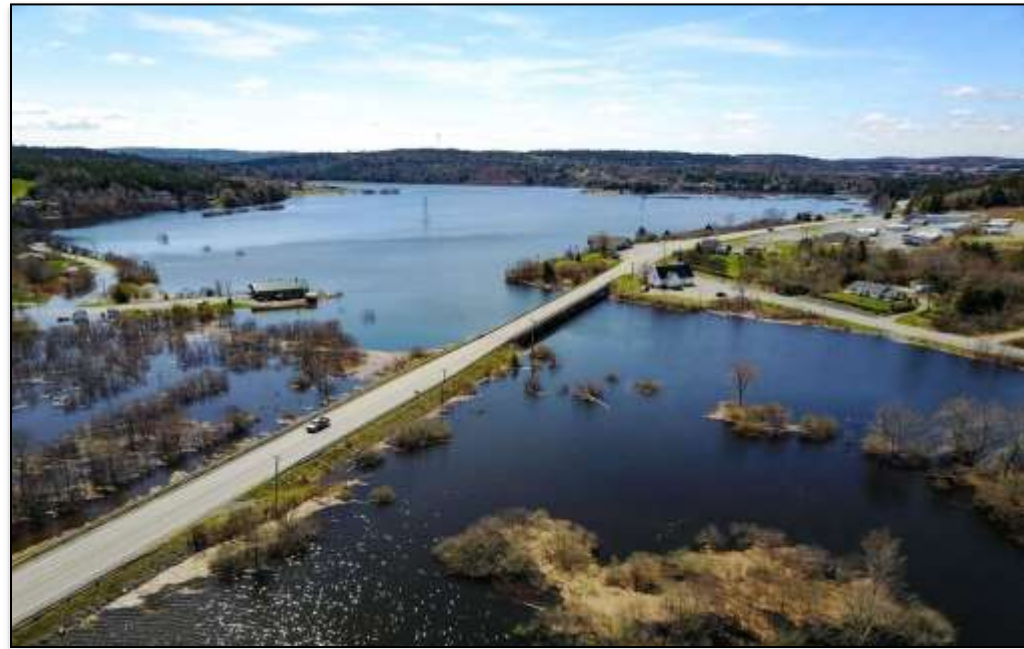
Figure 172. Flooding event in the spring of 2018, increasing the erosion and sedimentation issues at Bridge Pool, Steele’s Pool, Crowley Pool, et al.

HRAA should undertake riparian restoration throughout this tidal region, focusing on planting shrubs, instead of trees (as was the previous focus of restoration), as shrubs will be more resilient to climate change. Restoration is a priority, as sand and silt are creating sand bar islands in the river, increasing habitat fragmentation.

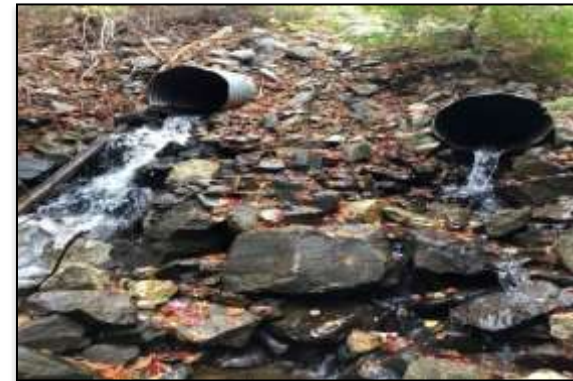
Figure 175. Dual hung culverts do not allow fish passage. Electro-fishing lower stretch and assessing confluence is a priority. *Photo: S. Blenis*

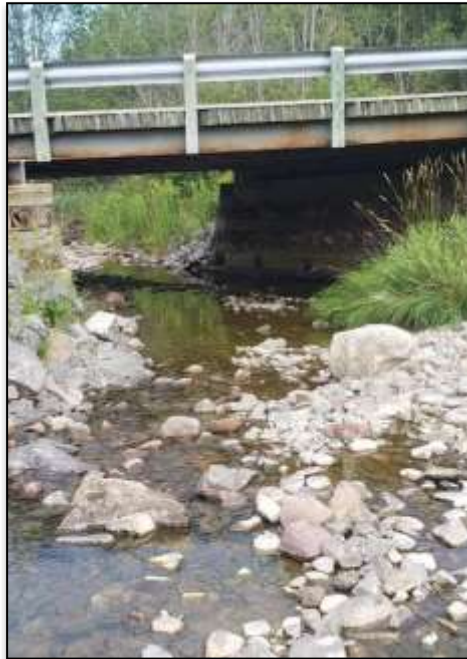
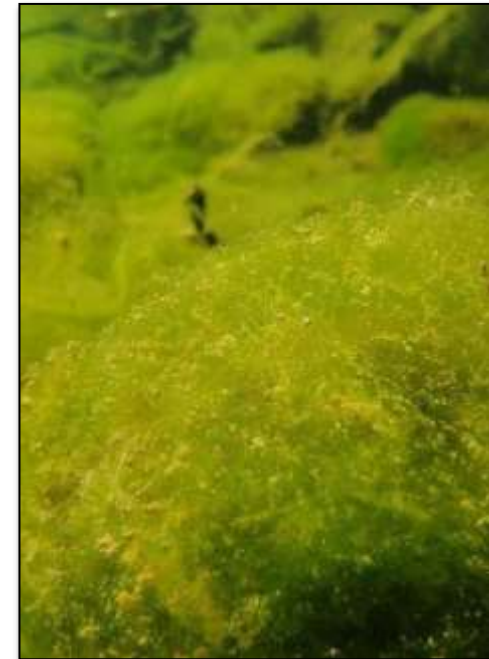
Figure 176 & 177. Evidence of nutrient loading & erosion in Jenny Langstroth. Abundance of filamentous green algae. *Photo: S. Blenis*

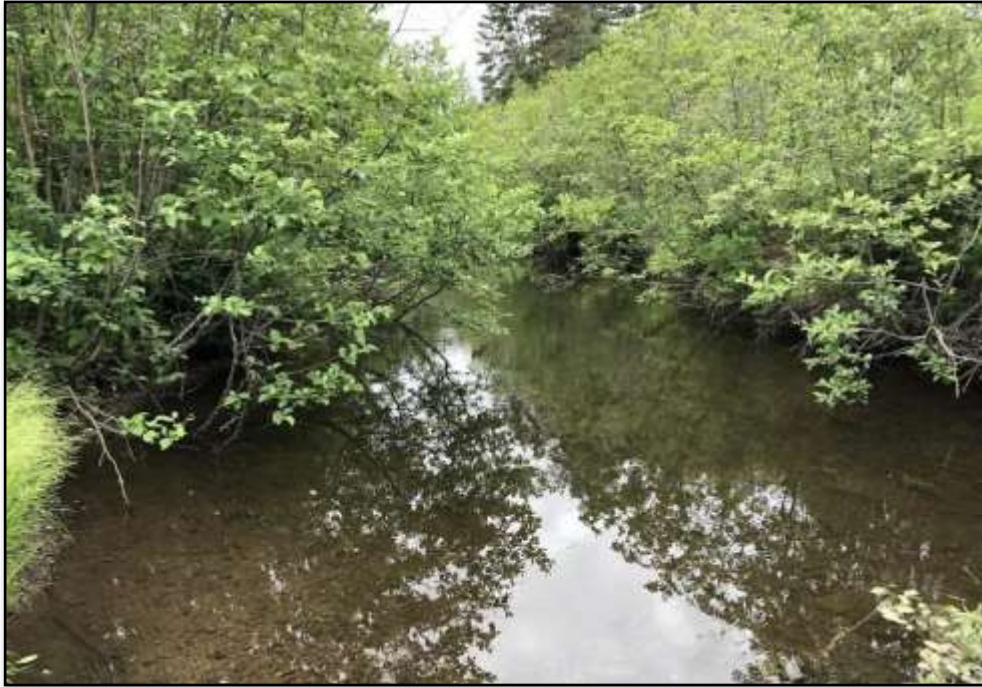
Figure 179. Looking upstream of Bradley Brook. *Photo: J. Kelly*

Bank Stability: While **Figure 179** shows heavily vegetated banks, the area surveyed for the habitat assessment tells a different bank stability story. The left bank can be described as stable (20%), and eroding (30%), while the right bank is stable (10%) and mostly eroding (40%). Both banks are experiencing high levels of undercutting, with the left being 30% undercut and the right bank being 40% undercut.

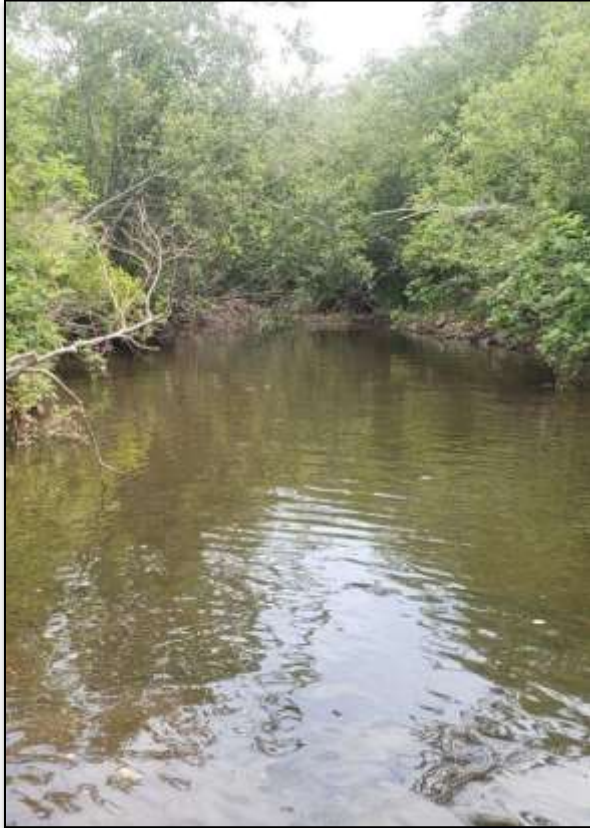
Figure 181. Another beaver dam in the distance. Note that you cannot see any of the substrate, as it is almost entirely embedded in the silt and sand. Water clarity is poor and brackish, and quite tannin in color.

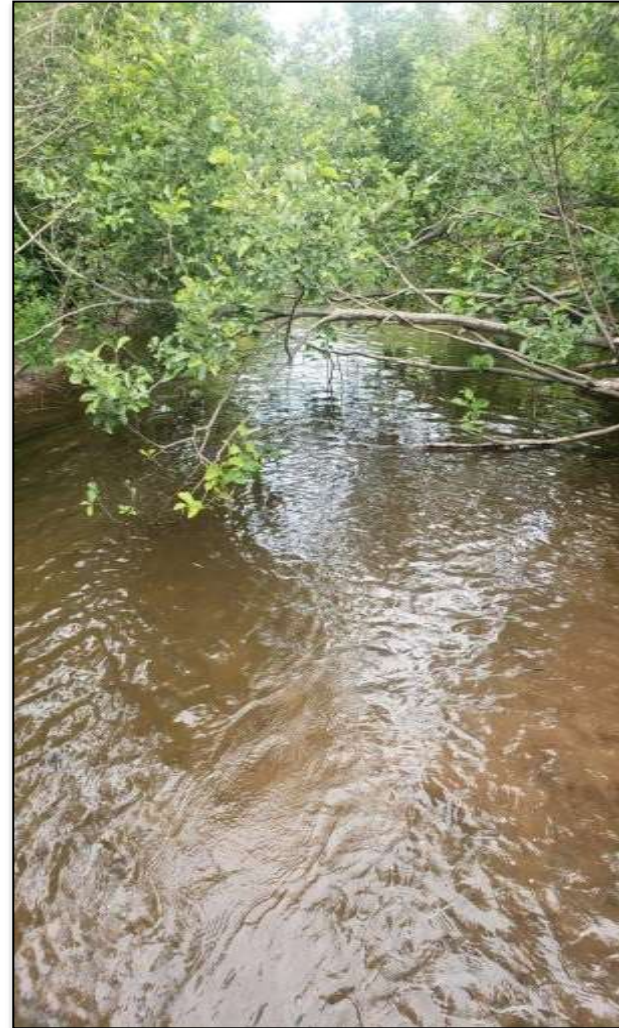
The problems in Bradley Brook may be impacted due to habitat fragmentation, the high density of gravel pits upstream, and surrounding land use and residential dwellings, particularly around the Bradley Lakes. In 2020, HRAA staff submitted a proposal for an in-depth lake analysis, which will focus on water quality and land use in the Bradley Lakes, which may, for the first time, shed more light on the issues within Bradley Brook.

Figure 182. Upper Bradley Brook- substrate is completely non-visible. Difficult to wade this stretch. *Photo: S.*

Efforts need to be taken in the future to identify all gravel pits and define whether they are active or inactive. Inactive gravel pits should become candidates for reclamation and revegetation plans. For active gravel pits, HRAA needs to develop effluent monitoring protocols, as these pits may be increasing sedimentation and turbidity into Bradley Brook. Some gravel pits may benefit from sedimentation fencing; however, the first step is identifying which gravel pits are potentially increasing the problems within Bradley Brook.

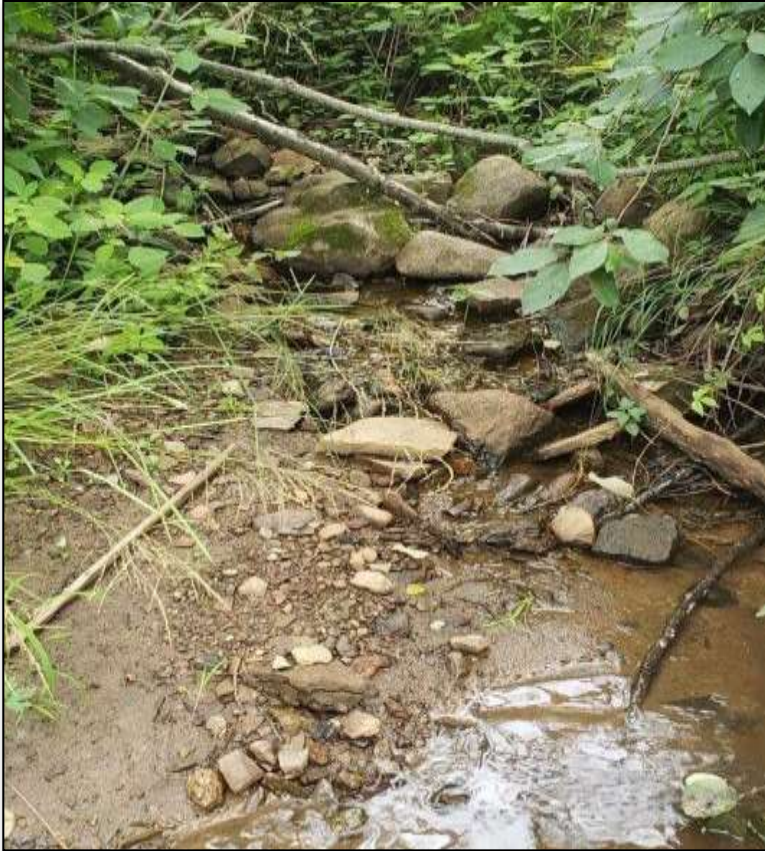
Figure 183. The Jenny Langstroth Brook, as it enters Bradley Brook. Photo was taken at the end of July, during peak summer temperatures; flow into Bradley Brook was minimal. *Photo: S. Blenis*

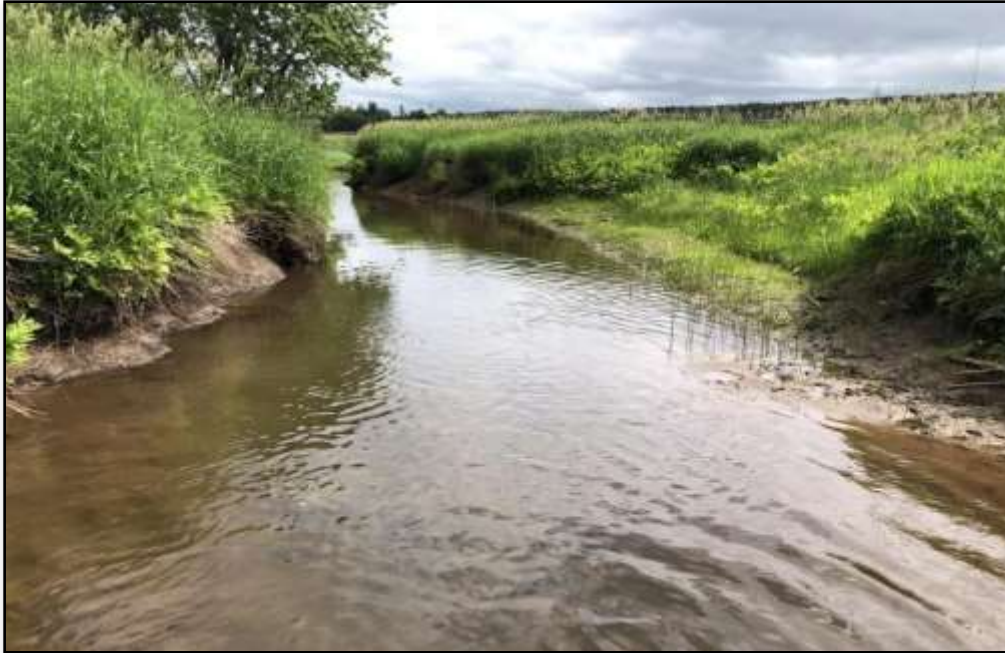
Figure 186. Downstream view of Palmer Brook. *Photo: J. Kelly*

Site Characteristics: Palmer Brook is 8.5km in length, and is one of the most stressed, impacted, tributaries within the watershed.

Crown Closure: The crown closure varies, depending on which section of Palmer is investigated. The upper reach has significant canopy coverage, where the middle section has decent, shrub-based crown closure, while the lower portion, as seen in **Figure 186** has 0% crown closure.

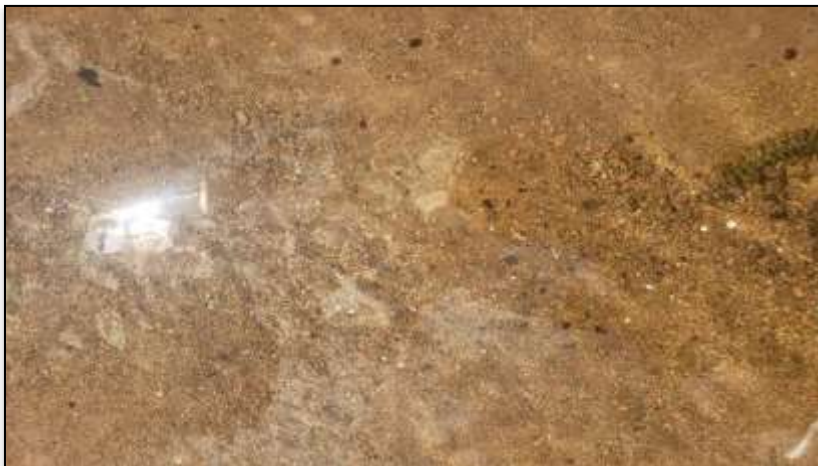
Figure 190. Substrate of lower Palmer Brook- unsuitable for salmon spawning. *Photo: S. Blenis*

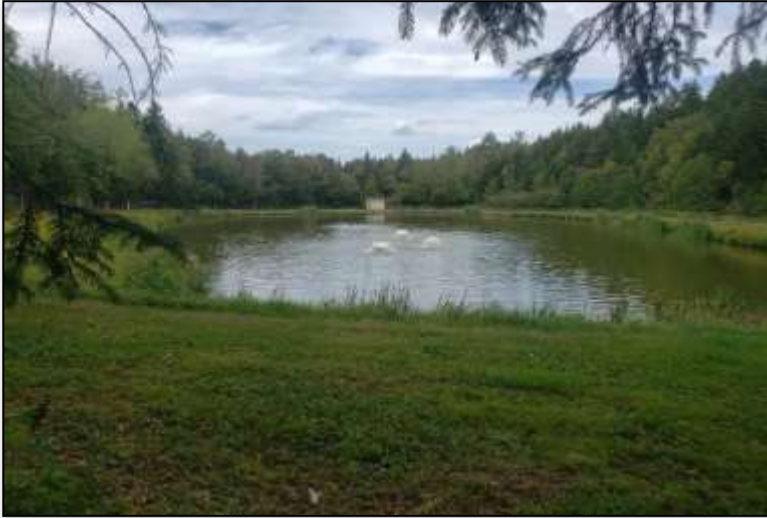
Figure 192. Pine Valley sewage lagoon in the upper reach of Palmer Brook. *Photo: S. Blenis*

In the *Bridging the Gap Report*, it was noted that the upper reach of Palmer Brook is downstream of a sewage lagoon. This site contains phosphorus levels that exceed guidelines for the protection of aquatic life, and it is believed that this lagoon is changing the system from mesotrophic to eutrophic.

The phosphorus exceedances reported coincide with HRAA's findings in 2020- increased phosphorus levels can cause excessive macrophyte and periphyton growth, increasing organic matter and turbidity, while decreasing dissolved oxygen content. This exceptional growth of epilithic algae on rocks was noted on the few rocks that were visible in the lower stretch of Palmer Brook, which are ultimately increasing the retention of fine particulates, further reducing the quality of juvenile salmon habitat.

Action Items: It is time to revisit the 2003 study on the lagoon and begin with an intense water quality sampling program to determine that the lagoon is contributing to these unacceptable levels of *E. coli* and fecal coliforms in Palmer Brook. Emphasis on this sampling program should be placed on sampling around the lagoon after heavy rain events, as that is when the lagoon would be most susceptible to breaching its berms and transporting coliforms into Palmer Brook. A survey of potential wetland areas should also be completed, to determine the possibility of creating wetland areas to naturally treat lagoon effluent. The results should then be conveyed to the public and town of Quispamsis.

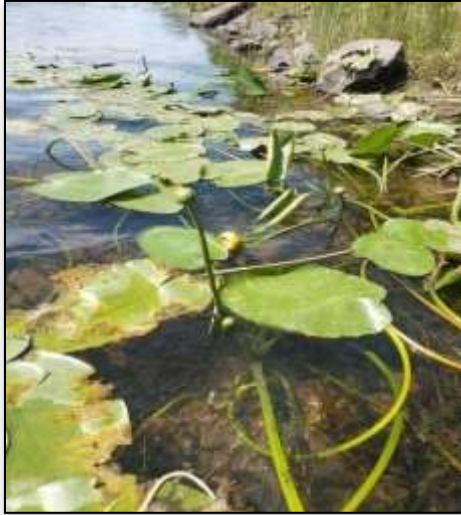
Figure 193 & 194- aquatic plants found in Palmer Brook.
Photos: S. Blenis

Spatterdock, as seen in **Figure 193** dominates the lower stretch of Palmer Brook. Spatterdock is not considered invasive; however, its extensive rhizome system allows it to grow and reproduce rapidly if not managed. Rapid growth occurs in shallow water bodies when there is an excess of nutrients allowing the plants to completely cover the surface in just a few years and control becomes necessary. Potential nutrient sources include runoff from numerous sources, including lawns, agricultural fields, waste from livestock, pets and wildlife, and poorly functioning septic systems. Dense growth of spatterdock in shallow water areas can interfere with boating and other forms of recreation and causes light reduction and oxygen depletion that can kill fish or other plants.

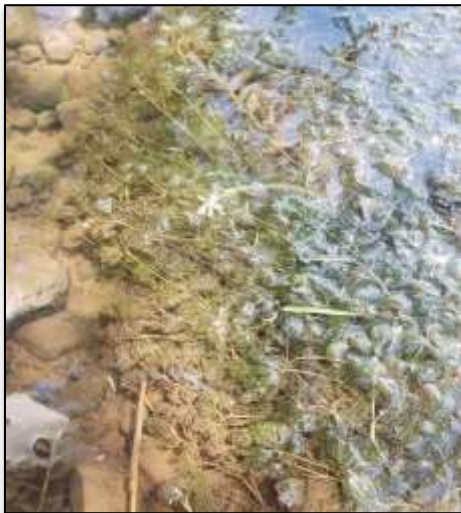
Dense mats of native milfoil are also a predominant aquatic plant in the lower stretch of Palmer Brook. Much like the spatterdock, these dense mats also reduce light and deplete oxygen in the tributary. Given the close proximity to a known location of Invasive Eurasian Water Milfoil (EWM) at Darling's Lake, plus the higher boat traffic near the mouth of Palmer Brook, and its ability to spread through fragmentation, introduction of EWM into the Palmer Brook system should be carefully monitored.

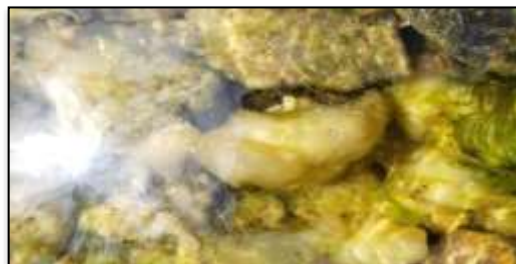
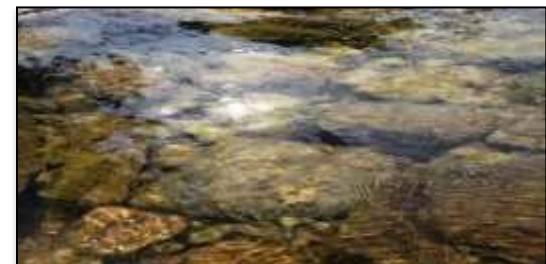
Benthic algae mats, as seen in **Figure 195** were also documented throughout the lower reach of Palmer Brook, and a SPATT collector was installed at the confluence point, to determine if cyanobacteria was present within Palmer Brook. While the results have not yet been determined from the cyanobacteria study, it is recommended that Palmer Brook continue to be monitored and sampled in the upcoming years.
