The Hammond River Watershed Management Plan

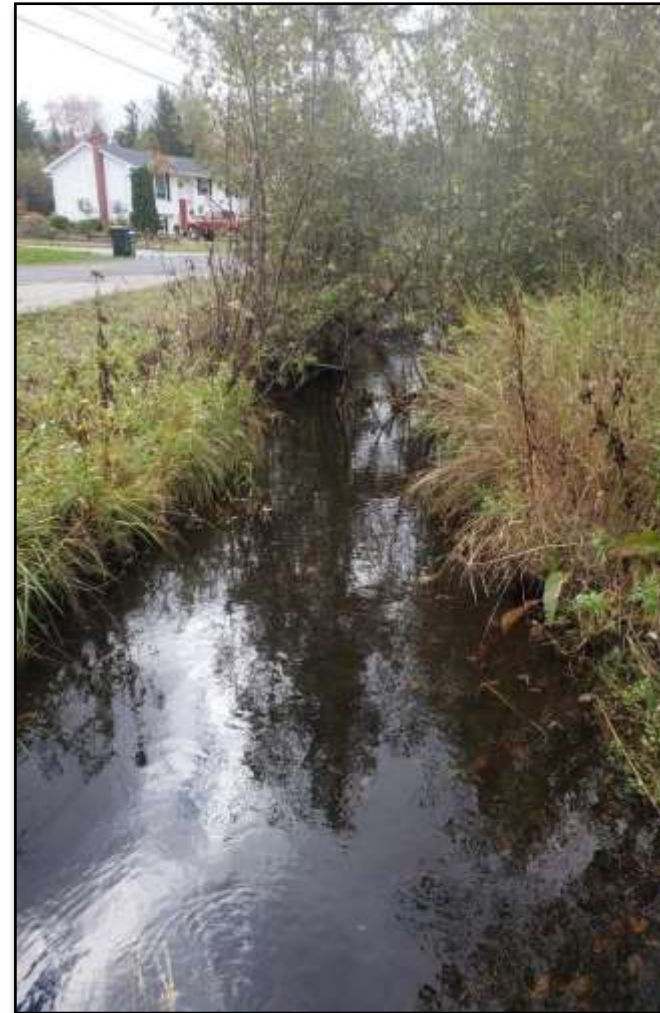
The *Bridging the Gap Report* noted that this brook received a moderately stressed rating, due to surrounding land use and development. It also noted that *E. coli* greatly exceeded acceptable levels by 505%.

Figure 10. Urban Colton Brook, in close proximity to the road.
Photo: S. Blenis

There has been a significant shift in the land surrounding the overflow culvert; it would be reasonable to believe that this site is continuing to deposit large amounts of sediment into Palmer Brook, based on the eroding slopes seen in Figure 10.

Moving forward, it would be worthwhile to conduct additional water quality samples, particularly *E. coli*. Colton Brook converges with Palmer Brook, a major tributary of the Hammond River, which has had many *E. coli* exceedances over the past decade. Determining the source of *E. coli* and working with the town of Quispamsis to develop an action plan, should be a priority. There exists a fairly large data gap on Colton Brook, and HRAA should seek to remediate this in the future, so we can have a clear picture of what is happening in this brook. It may also be worthwhile expanding the water quality sampling to explore salinity (given proximity to road/road salts), microplastics, and soil sample analysis for bioaccumulation of polychlorinated biphenyl (PCB) and hydrocarbons.

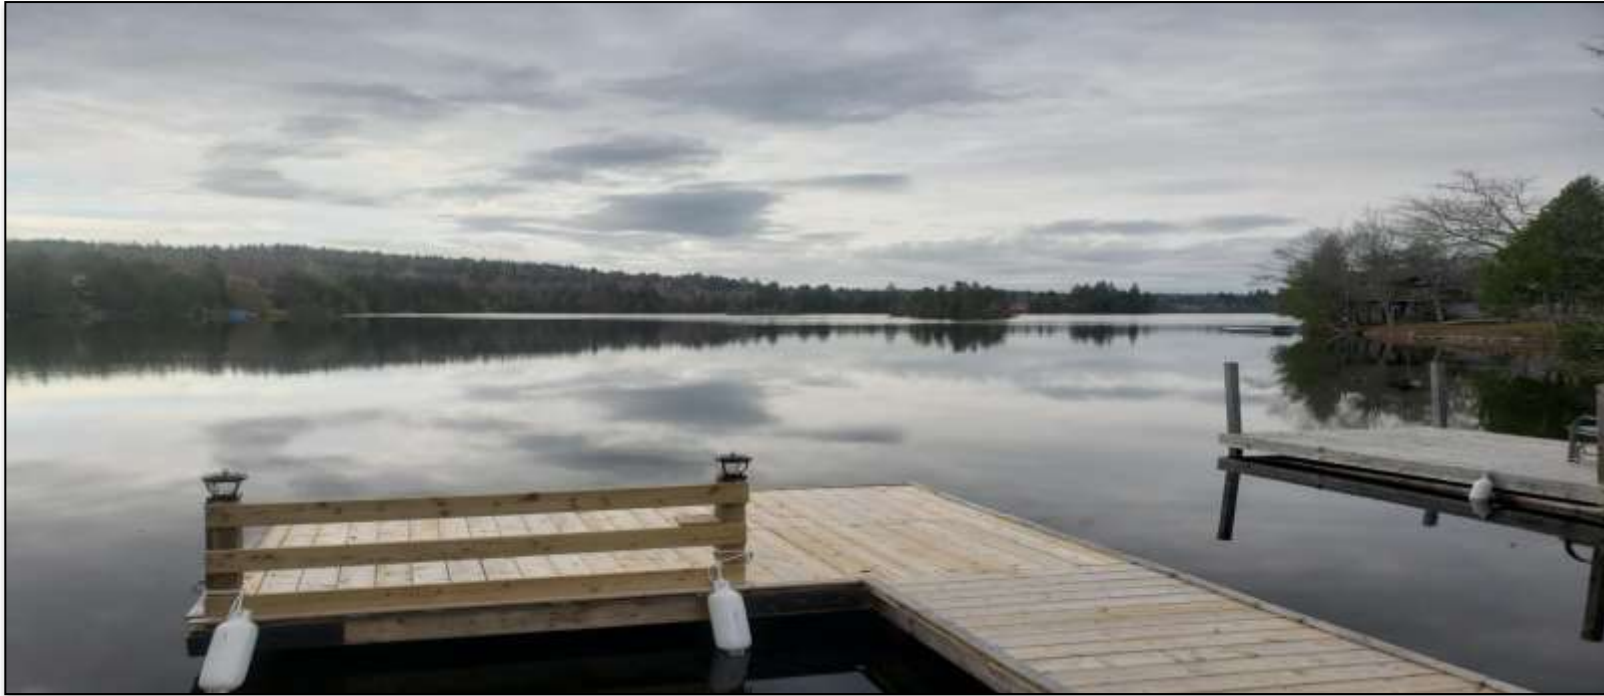
There are 2 interconnected lakes that make up the Bradley Lake area. During our site visit, HRAA staff spoke with a landowner, who described an industrial dumping operation into the lake that occurred in the early 1990's. According to this landowner, it made the lake toxic, and resulted in fish kill. Staff have yet to find any supporting evidence of this report; however, the search for additional information is on-going. This landowner also related that after the fish kill incident, the lake became overpopulated with Brown Bullhead. Bradley Lake is surrounded by multiple mining and quarry operations, as well as multiple cabins and residential dwellings. An in-depth water quality sampling program is warranted at this location, as well as landowner engagement- it may be possible that this lake is contributing to E. coli levels in Bradley Brook. This lake will be included as part of the 2021 *Lake Assessment*, and it will be interesting to determine the fish community in this lake. This lake is also a high boat traffic area, and native milfoil can be found along the shorelines. Testing to determine if this lake has been exposed to Eurasian Water Milfoil is also warranted, as is raising awareness of Clean, Drain, Dry with the locals. **Figure 198:** Multiple docks along Bradley Lake. *Photo: S. Blenis*

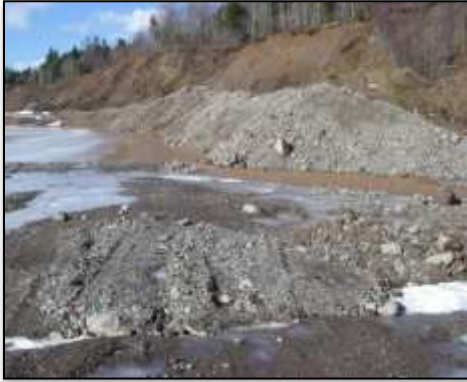
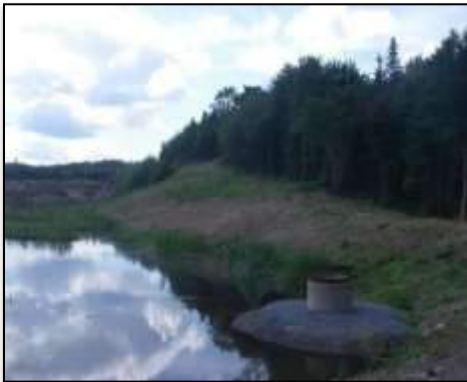
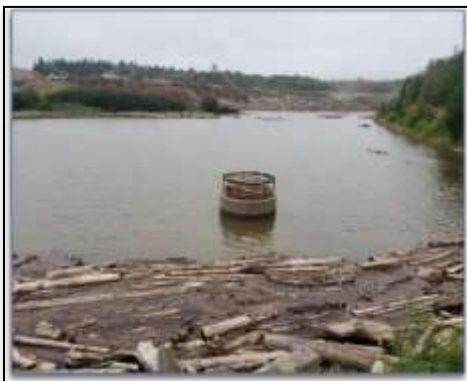
Renforth Pit Lake was one of the main sources of sedimentation running into Palmer Brook. Action instigated by DENV resulted in landowner's major renovation of the site, and coupled with planting by HRAA volunteers, resulted in new fish and wildlife habitat instead of causing a net detrimental effect to wildlife. There is a solid area of successful riparian vegetation surrounding the outflow tributary of this lake, and there is still an HRAA Riparian Restoration sign in the area, 12 years later.

Figure 200 a shows the site in February 2008, before work had begun. **Figure 200 b** demonstrates the same view in July 2008 after major restoration work. **Figure 200 c** shows the same view, only in July of 2020, 12 years after project completion.

Additional work and assessments need to be performed at this location, including in-depth water quality analysis, and a possible sediment study. Conversations with the landowner should be resumed, especially concerning the inorganic debris that is entering the lake. Taking a cue from past HRAA executive, a Palmer Brook Stakeholders Meeting should happen again in the near future.
